Management Unit 19

Ulster County - Town of Shandaken
Chichester Bridge to Between Cross Section 186 & 187

Management Unit Description

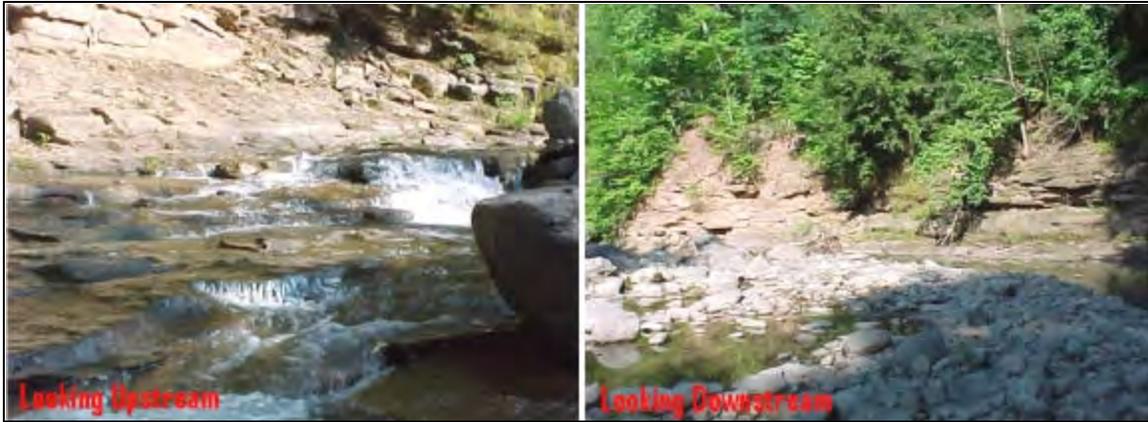
Figure 6 Bedrock

As the stream reconnects with its floodplain on the left, stream type transitions to C3b for the next 394 ft. reach. The slope of this reach increases to 2.6%. As seen in Figure 6 looking downstream, a mid-channel bar has begun to form near the top of this reach. This channel *aggradation* is likely resulting from a backwater effect caused by the hard bend to the left just downstream. The stream channel is beginning to widen and may eventually lead to increased bank erosion in this area. On the left stream bank there is an overflow channel which conveys water during high flow events.

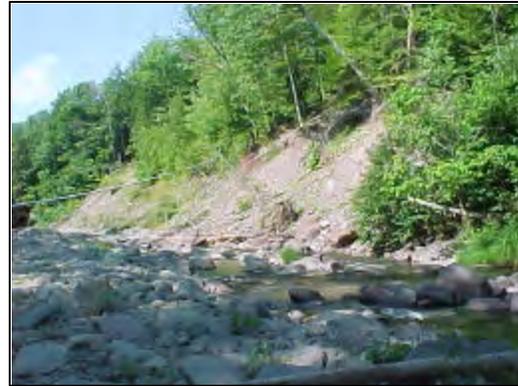
Figure 12 Bank erosion site #25

reach (Inset C). The stream flows directly against the valley wall, increasing the *shear stress*, or force of flowing water, on the stream bank during high flow events. This hillslope, composed primarily of lodgement till, is being undermined by toe erosion, resulting in the mass wasting of the bank. Compounding this erosion problem, the face of the stream bank has been stripped of vegetation, leaving it vulnerable to erosion resulting from runoff from the steep hillslope above. The exposed lodgement till has a high silt and clay content, and contributes significant suspended sediment loads during high flow events. Clay inputs into a stream are a serious water quality concern because they increase *turbidity*, degrade fish habitat, and can act as carriers for other pollutants and pathogens.

The Bank Erodibility Hazard Index (*BEHI*) score of site #25 is ranked “High”, the third highest prioritization category in terms of its vulnerability to erosion (Fig. 12). This bank erosion site is considered one of the highest priorities for restoration due to its large eroding area, high shear stress, and its significant threat water quality.

Bank erosion monitoring site #25 is located along 506 ft. of the right stream bank of this

From visual observations, it appears this bank erosion site is growing in severity and areal extent with each heavy rainfall. During the 2001 survey, it was estimated that the total erosion area of this site was 27,572 ft.², qualifying it as the largest eroding area along the Stony Clove Creek.

Recommendations to restore this site would include stabilizing the toe of the right stream bank, and installing a bioengineered treatment of the hillslope. In-depth survey and design would be required to plan a stream restoration project at this site.

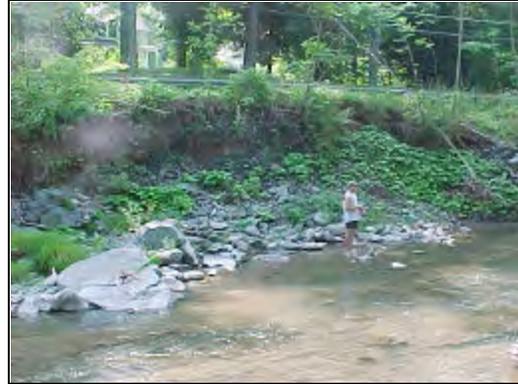
Figure 14 Bank erosion site #26

While the right stream bank is armored with bedrock, along the left stream bank the NYS Route 214 embankment is experiencing erosion. Bank erosion site #26 (Inset B) begins at the top of this reach and extends 304 ft. along this stream bank. Shear stress during high flow events has severely eroded the toe of this road embankment, and presents an imminent threat of road failure.

The BEHI score of site #26 is ranked “High”, the third highest prioritization category in terms of its vulnerability to erosion (Fig. 14). This bank erosion site is considered a

medium priority for restoration due its threat to infrastructure and water quality from eroding clay.

Recommendations to restore this site include regrading the stream bank and installing a low floodplain bench planted with appropriate native shrubs. Willow fascine and sedges should be installed along the toe of the bench to reduce erosion susceptibility. If necessary, rock vanes could be used to redirect shear stress away from the stream bank. In-depth survey and design would be required to plan a stream restoration project at this site.

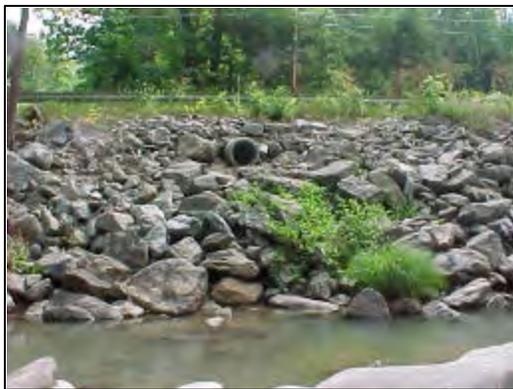
Figure 15 Rip-Rap and Culvert

For the next 354 ft., channel slope decreases to 1%, as the stream transitions to an F3 stream type. Beginning at the top of this reach, the NYS DOT has installed 611 ft. of rip-rap (Inset E) along the left stream bank to protect the NYS Route 214 embankment (Fig. 15).

Two stormwater culverts outfall along this rip-rap. Both culverts outlet on the rip-rap, reducing the risk of erosion from stormflow.

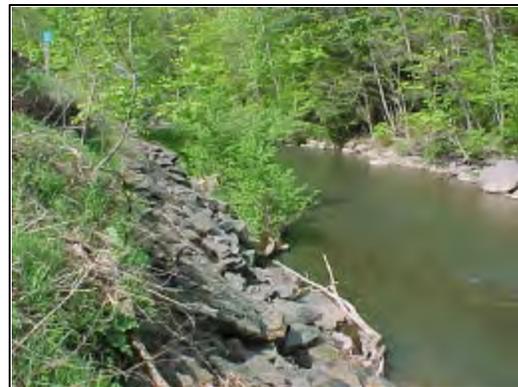
Figure 18 Planting Site #50

Planting site #50 is located near the top of the management unit along NYS Route 214 (Fig. 18 & Inset F). Some failure is occurring at the toe of rip-rap installed on a steep slope. Japanese Knotweed has begun to grow through this rip-rap.

Recommendations at this site include *joint planting* the existing rip-rap, by inserting plantings into the soil between the openings in the rip-rap rocks. Joint planting will strengthen and increase the longevity of this rip-rap. These plantings will also improve the aquatic habitat by providing shade, resulting in cooler water temperatures. This planting requires coordination with the NYS DOT, as they are responsible for the maintenance of the rip-rap. It is also recommended to remove the Japanese Knotweed, which is an invasive non-native species. Japanese Knotweed does not provide adequate erosion protection because it has a very shallow rooting system.

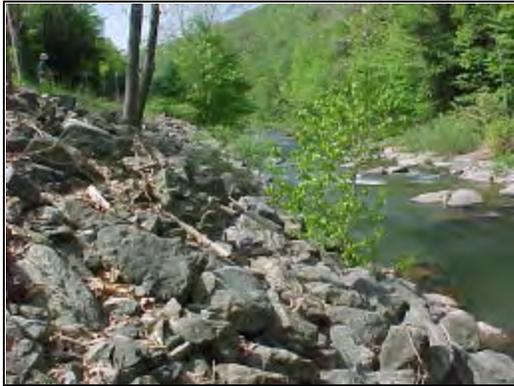
Figure 20 Planting Site #52

Planting site #52 is located at the rip-rap along NYS Route 214 near the bottom of the management unit (Fig. 20 & Inset E). This rip-rap is on a steep slope with two invasive species, Japanese Knotweed and Honeysuckle, present.

Joint planting of the existing rip-rap and removal of the invasive species is recommended. The planting of this rip-rap requires coordination with the NYS DOT, which is responsible for maintenance of the rip-rap.

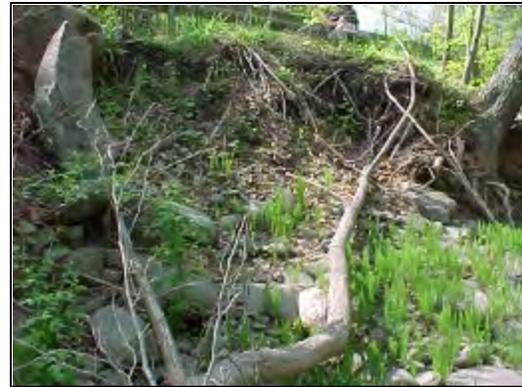
Figure 19 Planting Site #51

Planting site #51 is located at bank erosion site #26 (Fig. 19 & Inset B). This site is experiencing minor erosion with loss of vegetation. Stabilization of this site is critical for protection of the NYS Route 214 embankment.

Recommendations to restore this site include regrading the bank and installation of a low floodplain bench, planted with appropriate native shrubs. Willow fascine and sedges should be installed along the toe of bench to reduce erosion risk.
