Schoharie Creek Management Unit 18

Town of Prattsville – County Route 23 Bridge (Station 10486) to Station 0

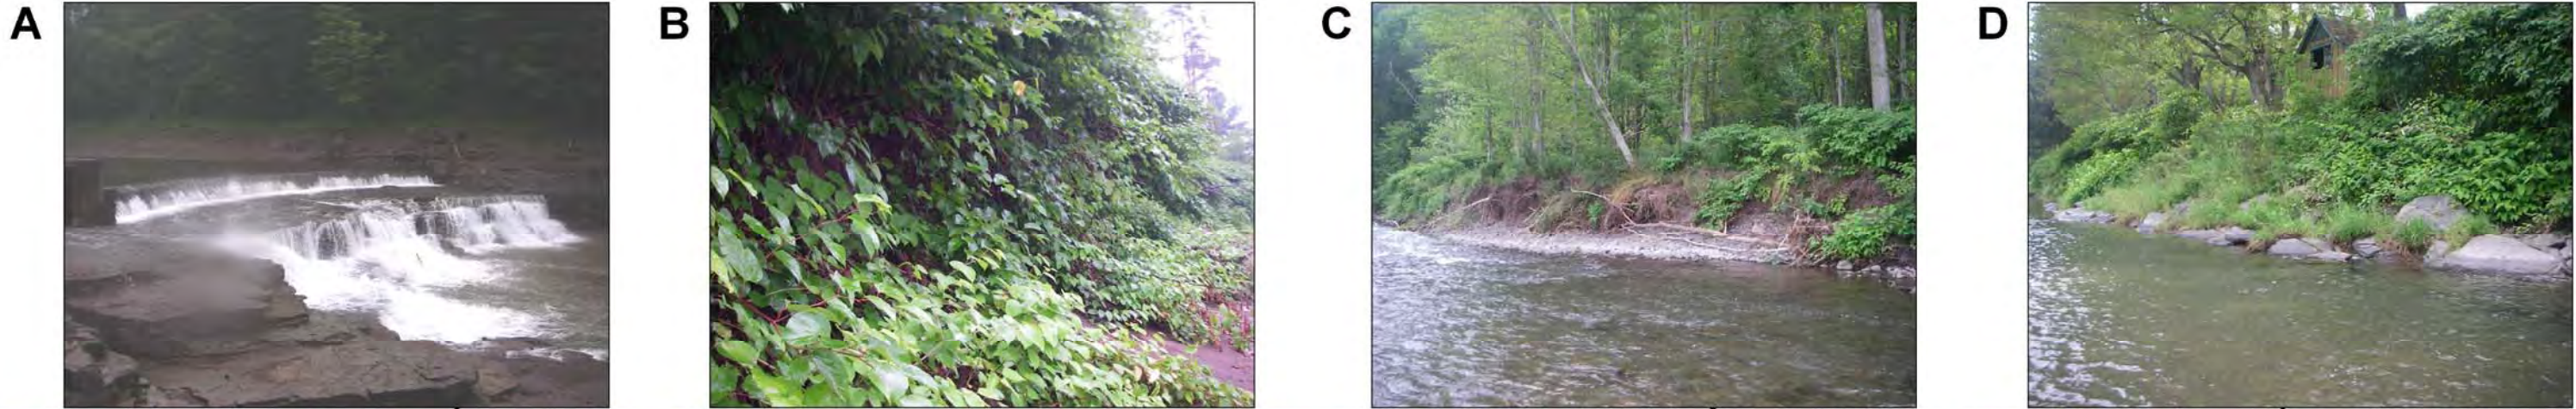
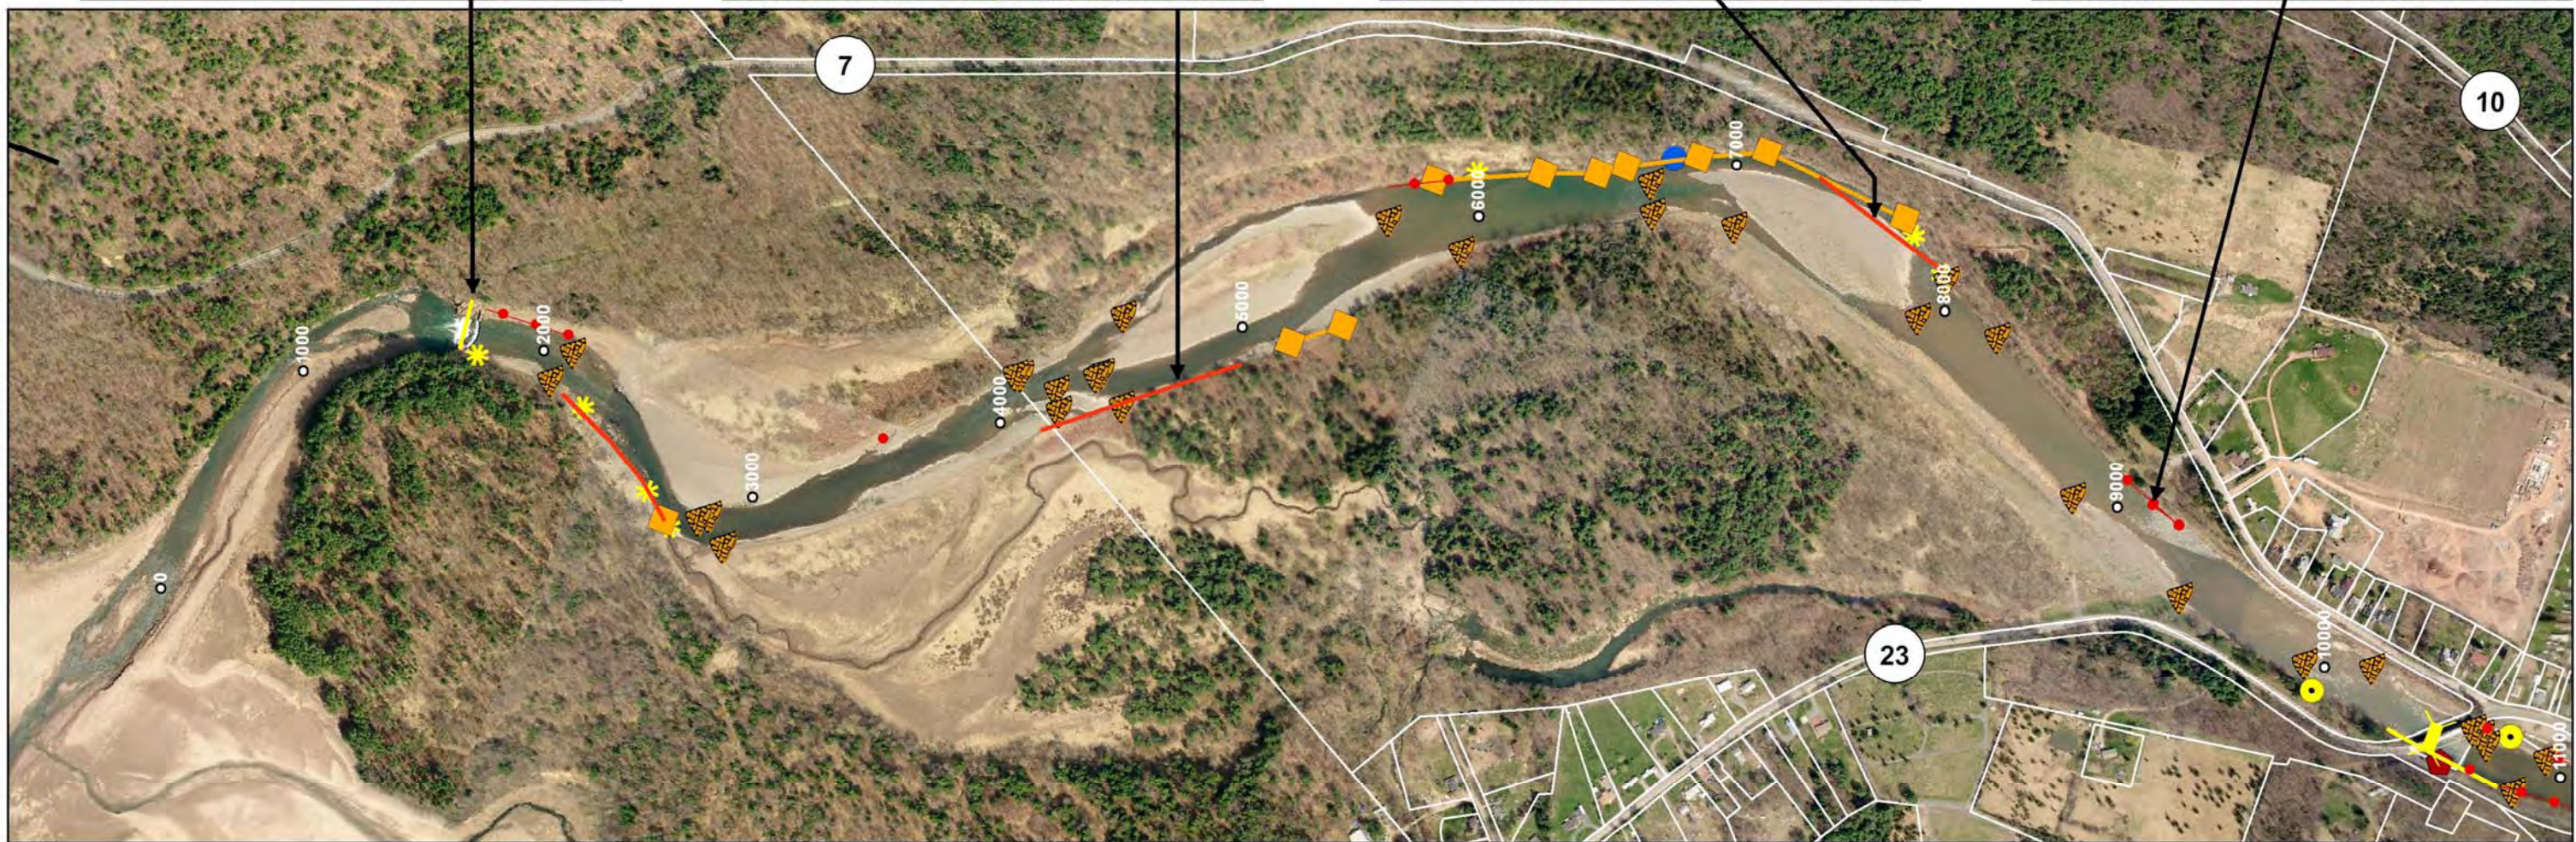
Figure 4.18.1 Management Unit 18 - 2006 aerial photography with stream feature inventory

The 2006 stream feature inventory revealed that 9.7% (2,024 ft) of the streambanks exhibited signs of active erosion along the 20,973 ft of total channel length in the unit (Figure 4.18.1). The total surface area of active erosion totaled approximately 66,585 ft². *Revetment* had been installed on 5% (1,040 ft) of the streambanks. No *berms* were identified in this management unit at the time of the stream feature inventory.

The stream channel downstream from the County Rt. 23 bridge in Prattsville appeared overwide and aggrading. Revetment including 131 ft of rip-rap and 316 ft of stacked rock wall had been installed along the right streambank (Inset D, Station 9200). While rip-rap and other hard controls may provide temporary relief from erosion, they are expensive to install, degrade habitat, and require ongoing maintenance or may transfer

erosion problems to upstream or downstream areas. Alternate stabilization techniques should be explored for streambanks whenever possible. Native shrub and sedge species should be interplanted through the rip-rap and along the toe of this streambank to help strengthen the revetment and enhance aquatic habitat.

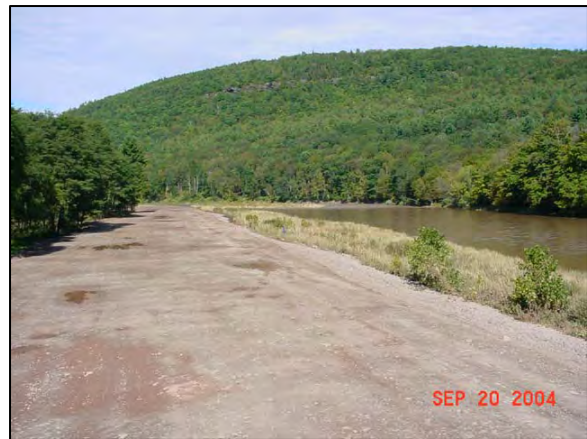
In 1979, a 10 ft high gravel berm had been constructed along the left streambank (Station 9300). This berm restricted flood waters from accessing the available floodplain and appeared to exacerbate ice jamming on the Schoharie Creek, causing flooding problems within the hamlet of Prattsville. The berm also had caused stream channel entrenchment and an increase in channel width to depth ratio which promoted deposition in the reach. Deposition can trigger the lodging and adhesion of ice to the bed and formation of ice jams. The top of the berm was at an elevation higher than the road and homes on the east side of the stream causing flood water to encroach on the adjacent homes and roadway before flowing onto its natural floodplain on the west side of the creek.

*Prattsville flood redemption project
post construction*

In 2004, the GCSWCD and the Prattsville Highway Department completed a flood-reduction project by re-grading the berm to match the elevation of the existing floodplain in order to allow flood waters to access the natural floodplain. The natural floodplain can also act as an ice storage area during large seasonal flow events and provide a release for flood waters in the event of a localized ice jam. Construction encompassed approximately 2,200 feet of streambank along the western floodplain of the Schoharie Creek.

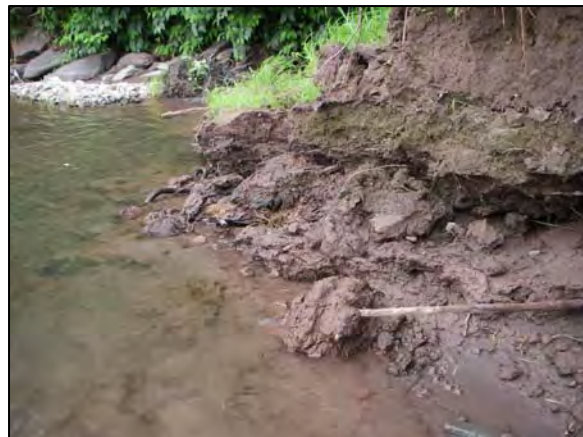
Downstream, the stream split into two channels, flowing around both sides of a large center bar (Station 7900-6700). During high flow events, the *thalweg*, or deepest part of the stream channel, was forced to flow against the right stream bank, undermining the toe of the bank along 591 ft (Inset C, Station 7900). Numerous areas of exposed of glacial lake silt/clay were documented along the bed and banks of the right streambank (Station 7600-5850). Fine sediment inputs into a stream can be a serious water quality concern because they increase *turbidity*, degrade fish habitat, and can act as a transport mechanism for other pollutants and *pathogens*. At the downstream end of the silt/clay a 237 ft stacked rock wall had been installed along the edge of the water.

Clay exposure at Station 7600-5850

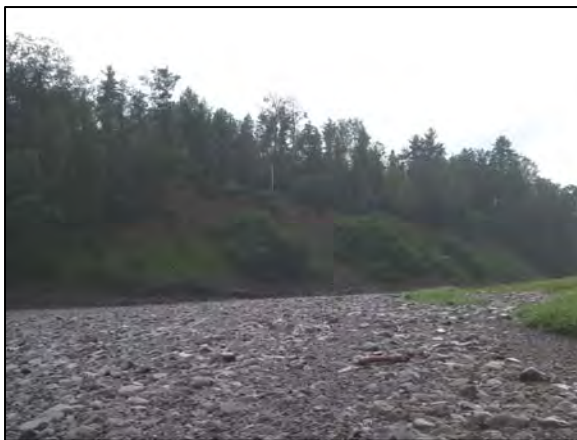
Bank erosion at Station 2250

At the meander bend downstream, the hillslope was undermined by toe erosion, resulting in the mass wasting of a 53,285 ft² area of the left streambank (Station 2250). This erosion left the face of the stream bank

unvegetated. The exposed lodgement till soil had a high silt and clay content, and appeared to contribute a significant suspended sediment load during rainfall events.

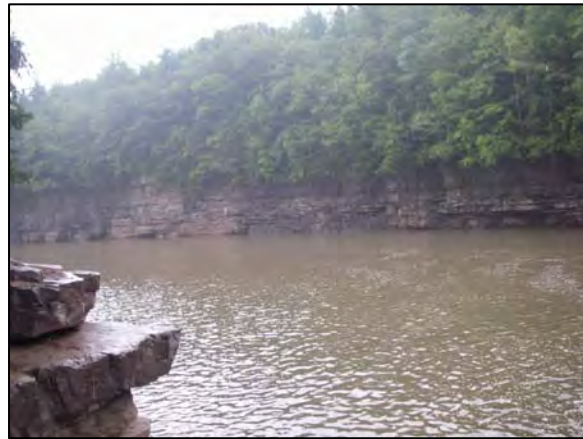
Near the end of this management unit the stream flowed over Devasago Falls (Inset A, Station 1700). These falls are usually submerged but due to low water levels in the Schoharie Reservoir for upgrades to the Gilboa dam, the falls were visible. Downstream of the falls the streambanks were lined with bedrock into the Schoharie Reservoir where this management unit ended. The Schoharie Reservoir contributes approximately 15% of NYC water annually (Joint Venture, 2004).

Bedrock along streambanks downstream from falls
