# West Kill Management Unit 10

## Management Unit 10

Between Station 32092 and Station 30263

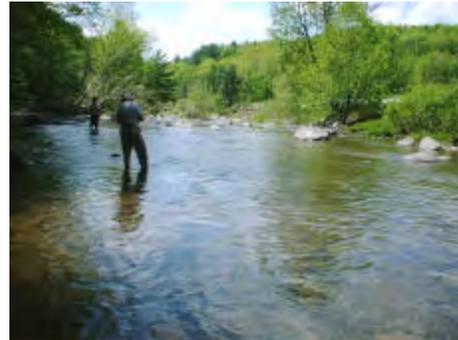
**Aggradation**

Downstream of the bend, evidence of aggradation in the streambed was observed, and the channel slope begins to flatten again. As the channel makes a gentle bend back to the left, a mid-channel bar is developing. In a stable sediment regime, this typically would be a point bar, with an overflow channel on the left and the main channel to the right.

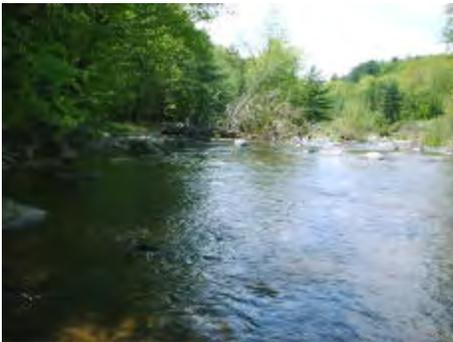
**Debris Jam**

Several jams of woody debris, however, were documented on the bar, which appear to obstruct bankfull and higher flows, impeding sediment transport, causing aggradation and directing flows right and left. Several occurrences of Japanese knotweed were also documented on the bar, to the left of the main channel. The valley wall on the left remains forested, but the low terrace on the left has patchy mature vegetation, and a pasture on the right has essentially no buffer protection.

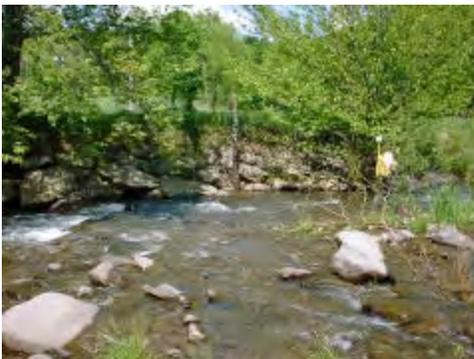
Proceeding downstream, the right bank and horse pasture beyond it has been protected by 221 ft. of placed rip-rap. Willows and sedges have intergrown the rip-rap, providing additional stability at the upstream end (see Inset D, Fig. 4.10.2).

**Rip Rap**

Downstream, however, the toe of the installation has failed, apparently the result of a *headcut* passing up the reach. Evidence of bed degradation is also seen downstream.

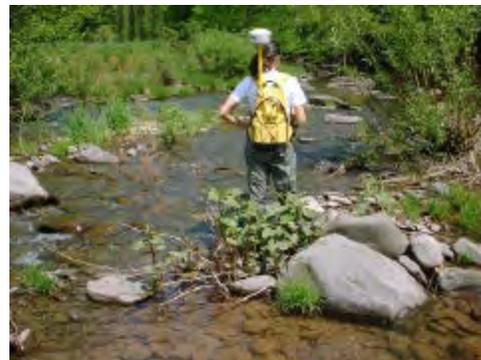
**Knotweed**

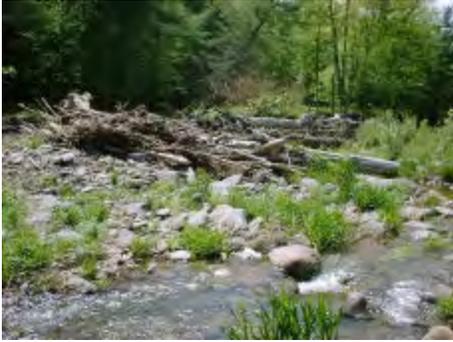
**Debris Jam**

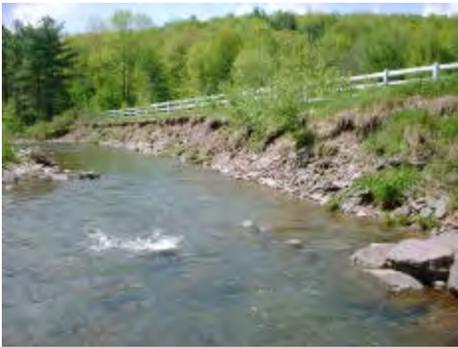
Moving downstream, bankfull channel width increases, and the mid-channel bar deposits push the erosional force of the stream at higher flows to the right and left. On the left side of the mid-channel bar, a low terrace exhibits approximately 122 ft. of cut bank (see Inset G, Fig. 4.10.2), with mature trees leaning over and falling into the left channel thread, from the poorly vegetated floodplain. This bank cutting is the result of excessive floodplain connection, aggradation and lateral channel migration.

**Bank Erosion, 2004**

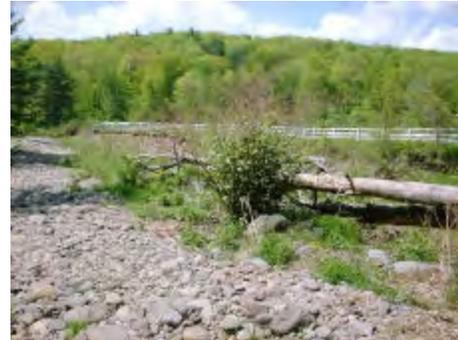
**Knotweed on bar**

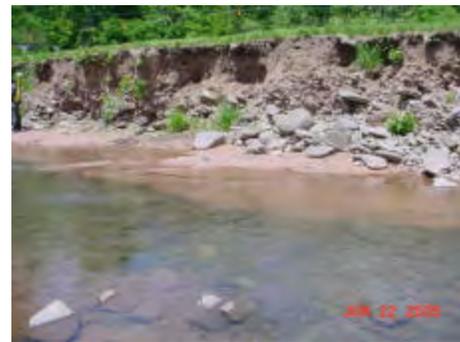
On the right, the main thread of the channel closely parallels the fenced horse pasture, devoid of any mature vegetative buffer. Approximately 206 ft. of erosion on the right bank has been monumented as a Bank Erosion Monitoring Site BEMS #10-31201

(see Inset B, Fig. 4.10.2). In a prioritization of twenty-one BEMS sites throughout the West Kill watershed (see Section 3.3, Watershed Inventory and Assessment), this site ranked as a High Priority. The *thalweg*, or deepest part of the stream channel flows up against the bank, which is being undermined by toe scour, leaving most of the stream bank unvegetated. Previously placed rip-rap has also apparently been destabilized by extreme near bank shear stress. The bank retreat as a result of high flows in the spring of 2005 has exposed extensive clay deposits in the bed, and destroyed 180 ft. of horse fencing.

**Worsening streambank erosion in 2005**

The *alluvial* and *lacustrine* soils in the bank and bed have a high silt and clay content, yielding a significant suspended sediment load during high flows. Clay inputs into a stream are a serious water quality concern because they increase *turbidity*, degrade fish habitat, and can act as a carrier for other pollutants and pathogens. Because the bankfull channel appears to be widening here, it is recommend that an additional monumented classification cross-section be added between Stations 31100 and 31400, if an appropriate location can be found.

Full restoration is recommended at this site. Ideally, this would involve establishment of a well-vegetated bench on the right at the base of the pastured terrace, rock vanes to direct stream flows away from the bank, revegetation of the bank face and bench with bioengineering stabilization, establishment of a vegetated buffer on both the right and left, and possibly a decrease in bankfull channel width and increase in sinuosity. In-depth survey and design would be required to plan a stream restoration project at this site.

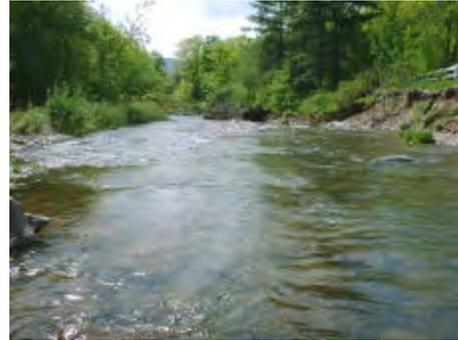
The channel bends back to the left at the downstream end of the erosion, and aggradation is observed again, caused by increased entrenchment and the narrowing of the bankfull channel further downstream. Channel narrowing, whether due to encroachment by road embankments, bridge abutments or valley pinch points, can cause

**Aggradation downstream of erosion**

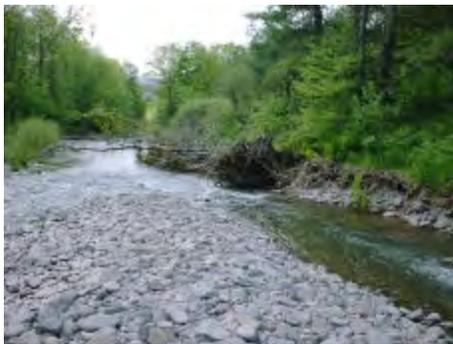
**Debris Jam**

backwatering, slowing down streamflows, and result in a building up of the streambed, as seen here. As the stream bed aggrades, woody debris can become immobilized and accumulate, which also is observed here along the right bank. This debris jam creates an obstruction at all flows; it does, however, provide some habitat cover.

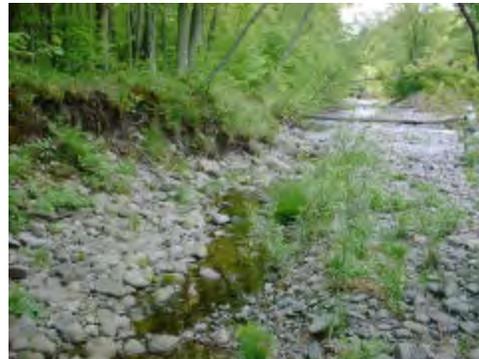
The aggradation described above is putting pressure on both right and left banks, undercutting 230 ft. of the terrace on the left, and undermining trees which have fallen across the channel. These fallen trees further obstruct flows and exacerbate the aggradational trends.

**Bank Erosion, left**

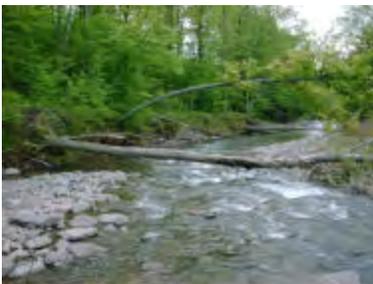
**Undermined trees, left**

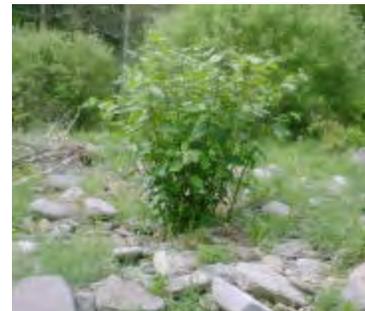
**Japanese knotweed**

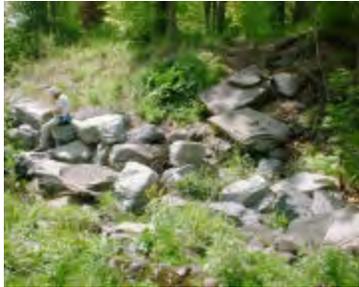
**Large, stacked revetment at mouth of tributary**

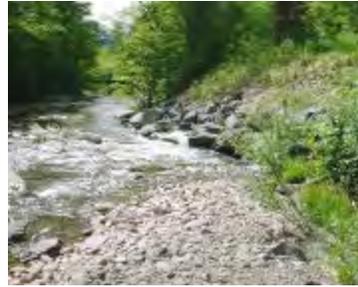
and dumped on the right bank, to stabilize the RCH driveway embankment. The installation appears to further narrow the channel, and likely aggravates the associated aggradation upstream.

**Rip Rap, right, narrowing the channel**

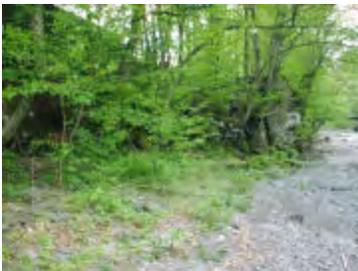
**Bedrock bank, left, encroaching on channel**

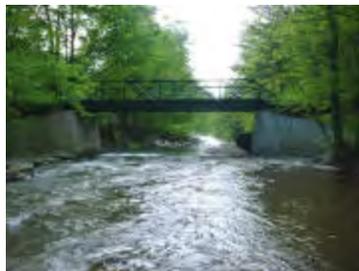
On the approach to the bridge crossing at RCH stables, the bedrock on the left extends into and across the bed, providing grade control. At the bridge itself, the abutments narrow the channel considerably. As described earlier, this undersized bridge opening causes water to back up upstream of the bridge, reducing stream velocity,

which results in sediment deposition. In such settings, higher stage floodwaters may seek conveyance through alternative paths, forming new channels around the bridge constriction. No such paths exist here, however, due to the extent of entrenchment and revetment. Additional

**RCH bridge, new abutments**

*floodplain drainage*, using culverts set at the floodplain elevation under the right bridge approach, may help mitigate this problem. Alternatively, when the landowner eventually must replace or renovate the bridge, lengthening the bridge span should be considered to further reduce backwatering here and aggradation upstream.
