# Neversink River West Branch

## MANAGEMENT UNIT 12

WEST BRANCH MANAGEMENT UNIT 12  
BETWEEN STATION 43700 AND STATION 49100

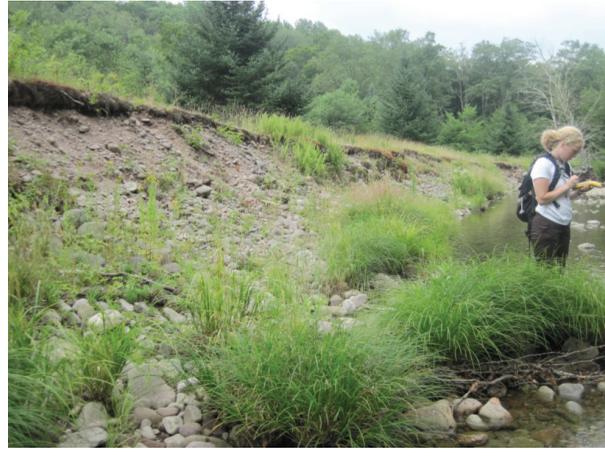
From Station 48580 to Station 48400 an eroding bank segment was observed on the left bank (BEMS NWB12\_48400). Although large material is accumulating at the toe of the bank, hydraulic erosion during high flow events entrains fine sediments in the bank. An exposed root wad at the end of the eroding bank segment was contributing to formation of a deep scour pool downstream, followed by a depositional center bar composed of cobble and gravel. (A963, A969) A headcut was observed in the cobble bed of the main channel near Station 48300. The absence of bedrock control in this section of the stream suggests that this headcut could migrate upstream to the pool and bank scour segment.

*Left bank erosion (A963)*

**BANK EROSION** One area of erosion was documented in the management unit during the stream feature inventory. From Station 48580 to Station 48400 an eroding bank segment was observed on the left bank (BEMS NWB12\_48400). Although this site appeared to be hardening at the toe, hydraulic erosion during high flow events appeared to be continuing to dislodge fine sediments in the bank.

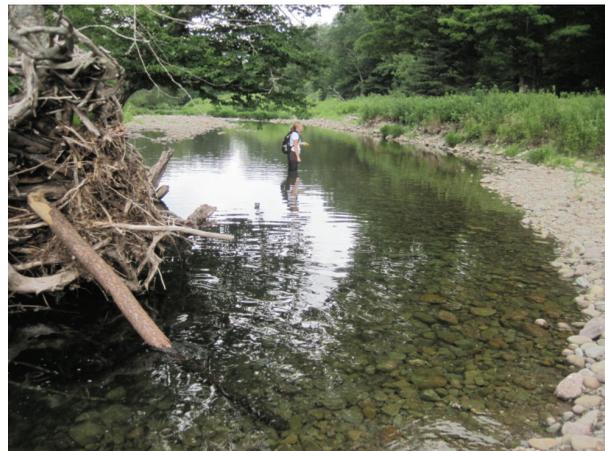
*Root wad contributing to scour (A969)*

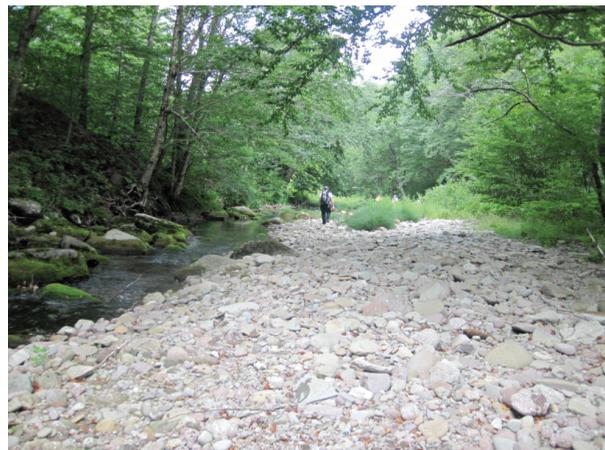
*Cobble side bar on right bank (A977)*

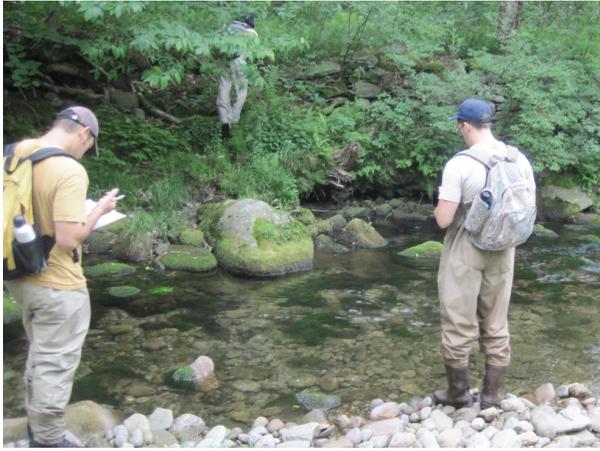
*Boulder toe protection on left bank (B853)*

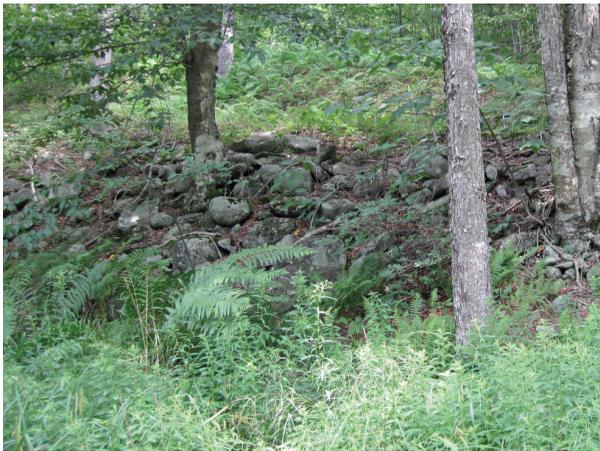
*Stacked rock revetment protecting dirt road on right bank (B856)*

stone berm was observed on the left bank which appeared to be designed to protect a campsite on the left bank during high flow events. Across from the berm, stacked rock revetment was observed on the right bank extending 120 feet from Station 47520 to Station 47400. The revetment appeared to be designed to protect a dirt road on the right bank from erosion during high flow events, and was documented in good functional condition and fair structural condition. (B856)

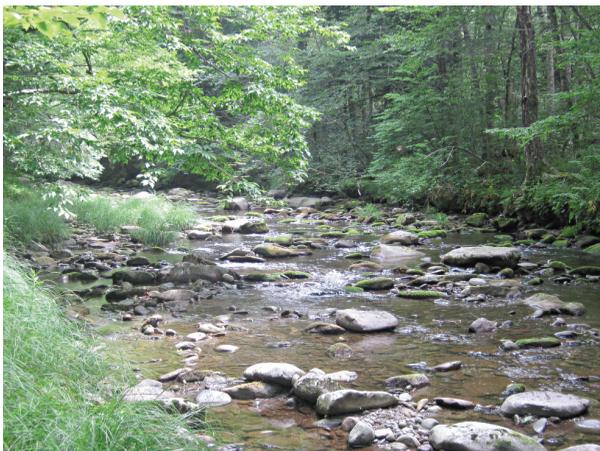
*Full channel aggradation (B884)*

The river leaves NYS land near Station 44800, and the entrenched conditions begin to diminish. This reach of the river is straight until it begins a slight meander toward the right valley wall with full channel aggradation beginning at Station 44000 (B884) and a side channel diverging into the forested floodplain on the left bank near Station 43950.
