Neversink River West Branch

MANAGEMENT UNIT 14

WEST BRANCH MANAGEMENT UNIT 14
BETWEEN STATION 54300 AND STATION 59000

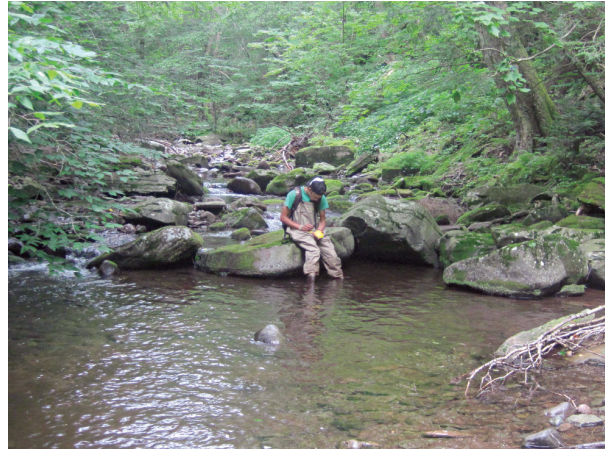
WBMU14 begins on New York State land in “forever wild” status; no recommendations are made for lands in forever wild status. Mudstone bedrock controls stream grade near Station 59000, where two tributaries were observed conveying flow off the left valley wall. Near Station 58750 there is a natural

rock weir grade control structure followed by convergence of another seep draining the left valley wall with the main channel. (B709, B714)

Natural rock weir grade control (B709)

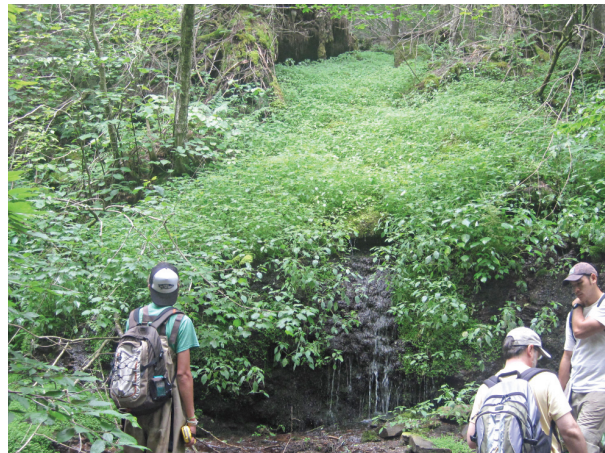
Seep entering from left valley wall (B714)

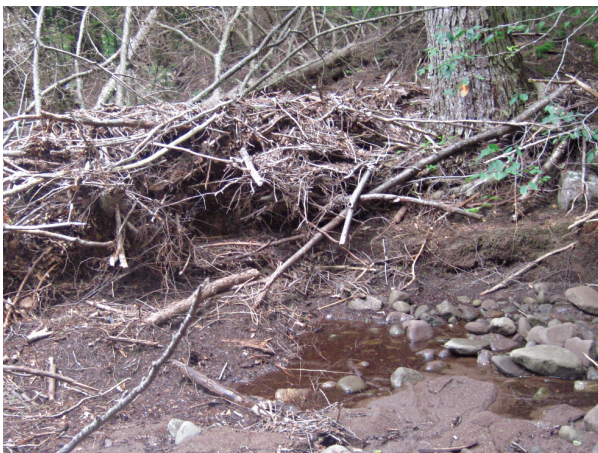
At Station 58700 the river crosses back into private property. 150 feet downstream there was a depositional side bar composed of gravel with no vegetation observed on the right bed. The depositional feature begins downstream of a large boulder and ends 100 feet downstream at the first of a series of large woody debris jams composed of both large logs and condensed branches. (B721, B715)

Woody debris jam (B721)

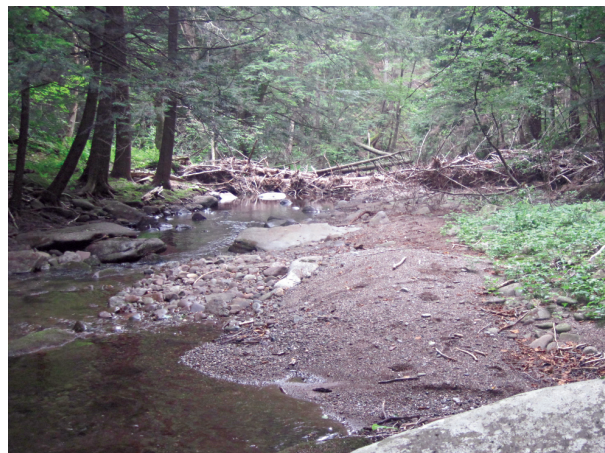
Gravel side bar (B715)

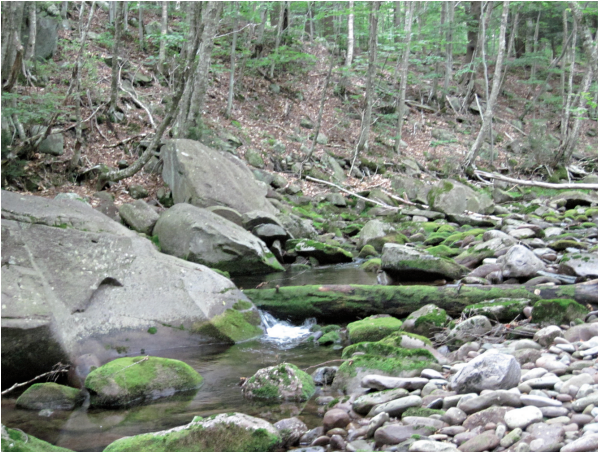
Large boulder and downed tree forming grade control (A874)

At Station 57950 a boulder in the main channel near the right bank with a downed tree spanning the remainder of the channel control grade at this location, with deposition accumulating upstream and a scour pool immediately downstream. (A874)

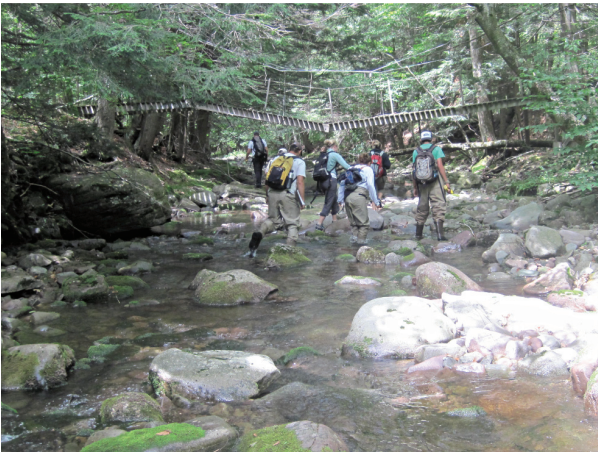
Recreational stream crossing (B742)

At Station 57590 a footbridge made of boards and ropes was observed stretching across the main channel from the backyard of a house within 50 feet of the stream bank. (B742) This structure is within the 100-year floodplain as identified on the FIRM maps for the Neversink valley. It is recommended that these landowners investigate flood proofing options to protect their residence from damage during a flood event.

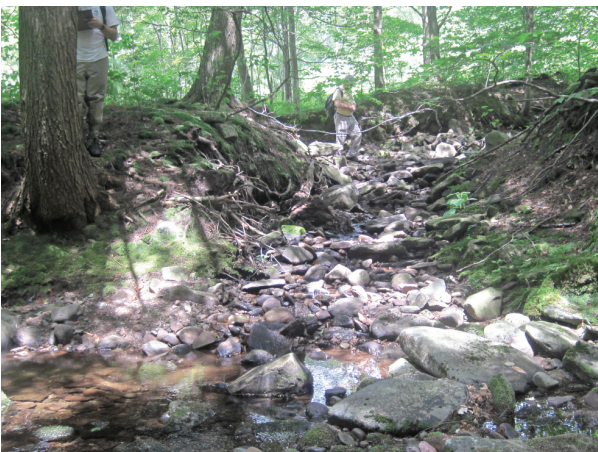
Tributary entering from right floodplain (B743)

At Station 57330 a tributary joins the mainstem from the right floodplain upstream of a group of three open freshwater ponds covering approximately 1.25 acres. (B743) It is not clear if this is the small, unnamed tributary that drains the south slopes of Spruce Mountain, or if significant flow is diverted into the pond system. The outfall from the constructed ponds begins at Station 56850 and meanders through a wetland before it converges

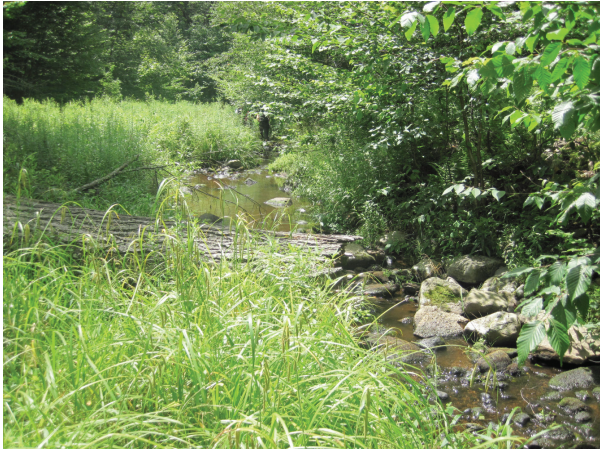
Wetland from outflow of constructed pond (A884)

with the main channel near Station 55850. (A884) A stacked stone berm was observed from Station 57180 to Station 57080 that was placed between the main channel and an ATV path observed connecting the house and ponds along the right bank. (B748)

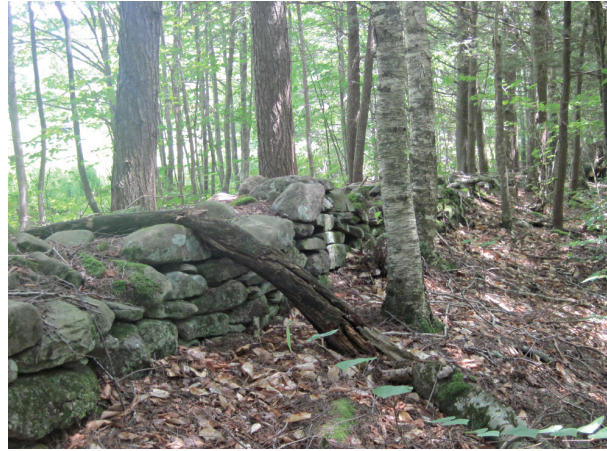
Stacked stone berm (B748)

A stacked stone berm was observed from Station 57180 to Station 57080 that was placed between the main channel and an ATV path observed connecting the house and ponds throughout the right floodplain.

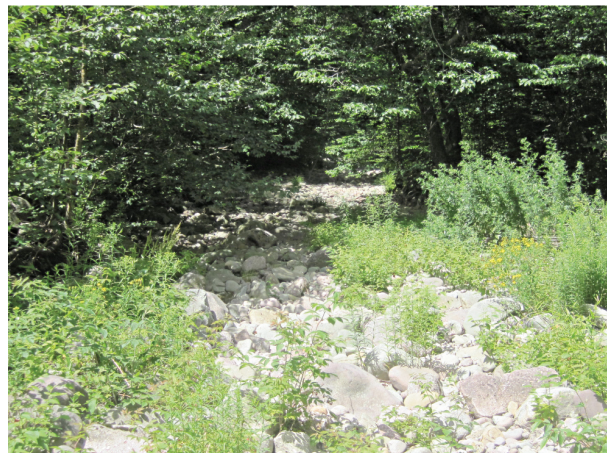
Downstream of the ponds, near Station 56550, a dry side channel diverges as the main channel continues a meander to the left. (B754) The side channel converges with the wetland drainage channel to the right of the main channel near Station 56000. (A885) Two woody obstructions were observed in the main channel downstream of the obstruction. The first, located at Station 56340, is a series of two downed trees spanning the channel width which have trapped sediment leading to depositional bars on the upstream side and scour pools downstream. (B760) The second, located on the left bank at Station 56230, is a woody debris jam with a minor eroding bank segment upstream and scour on the left bank downstream. (B764) 200 feet downstream a cobble depositional side bar was observed on the right bank with some woody vegetation. The deposition ends at a woody debris jam near Station 55950. (B771, B776)

Divergence with dry side channel (B754)

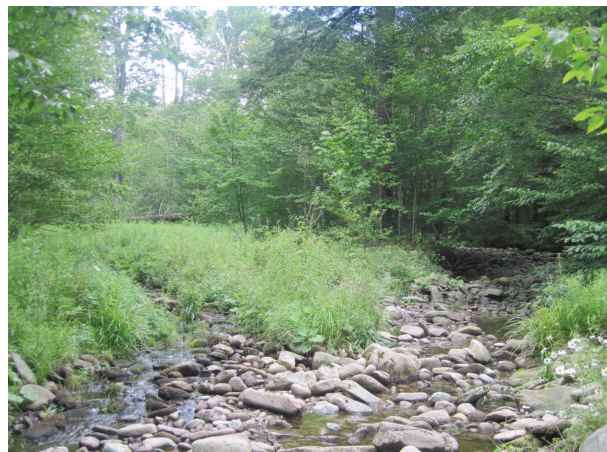
Side channel converging with wetland area (A885)

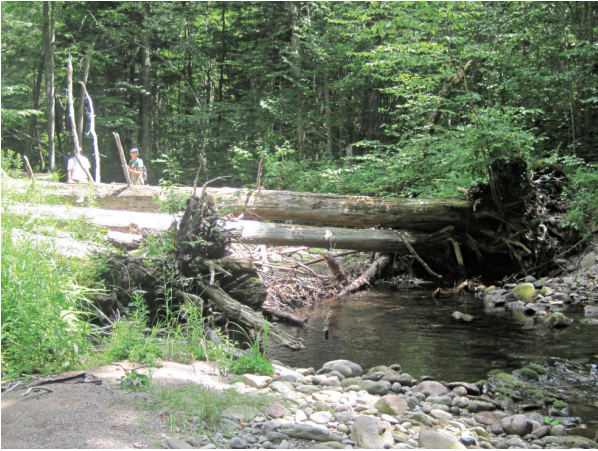
Downed trees causing deposition upstream and scour downstream (B760)

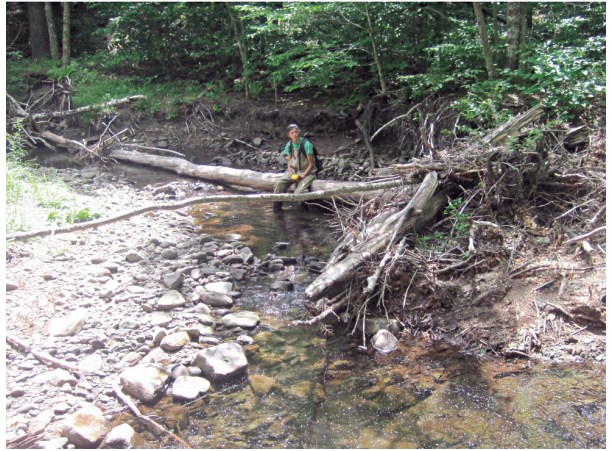
Woody debris jam causing erosion upstream (B764)

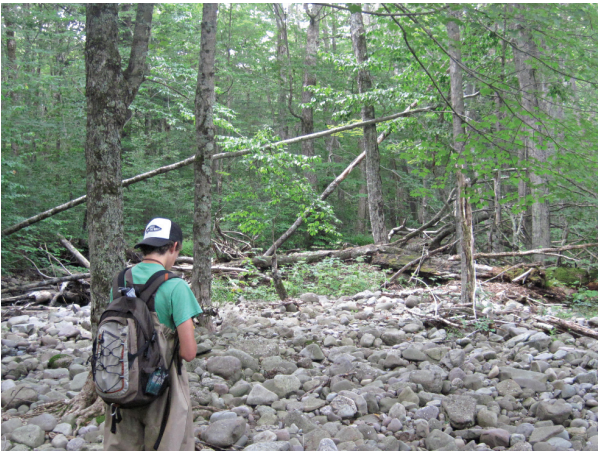
Cobble side bar (B771)

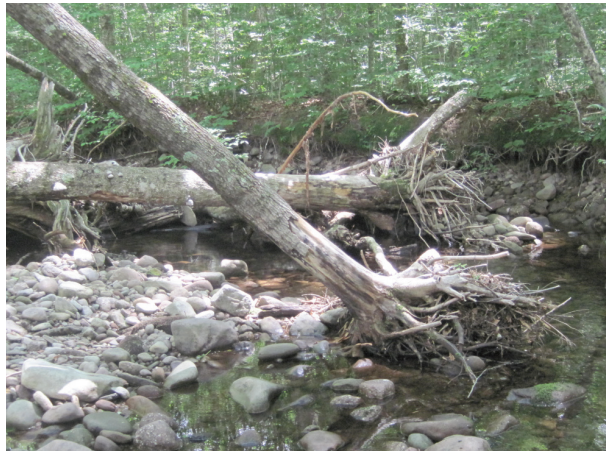
Woody deposition (B776)

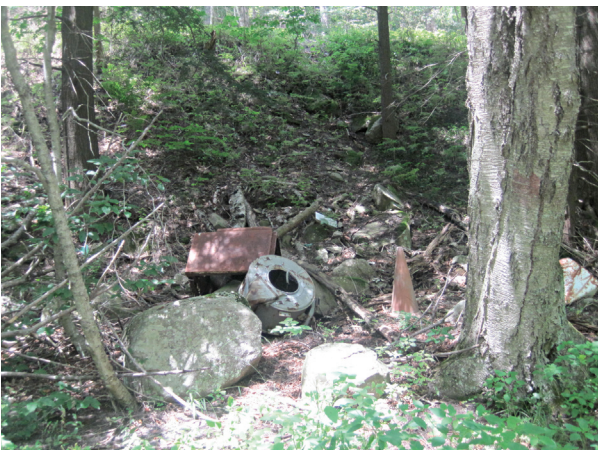
Inactive dump site (A887)

Downstream of the woody debris jam the channel begins a meander to the right across the valley floor towards Frost Valley Road. A boulder grade control was observed on the right bank at the apex of the meander slightly downstream of an inactive dumping site and a downed tree causing scour on the steep right bank descending from Frost Valley Road. (A887, A890, A892)

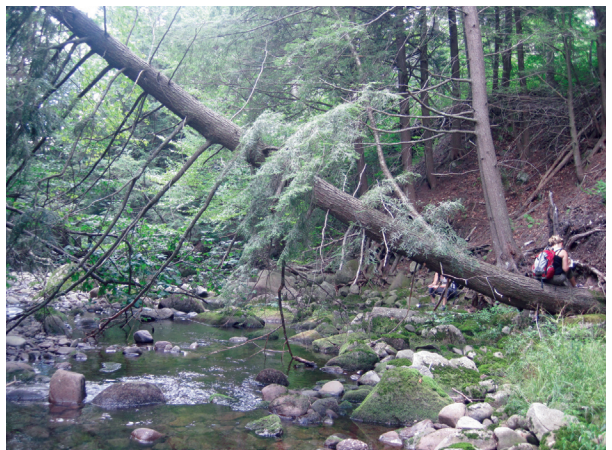
Downed tree spanning channel width (A890)

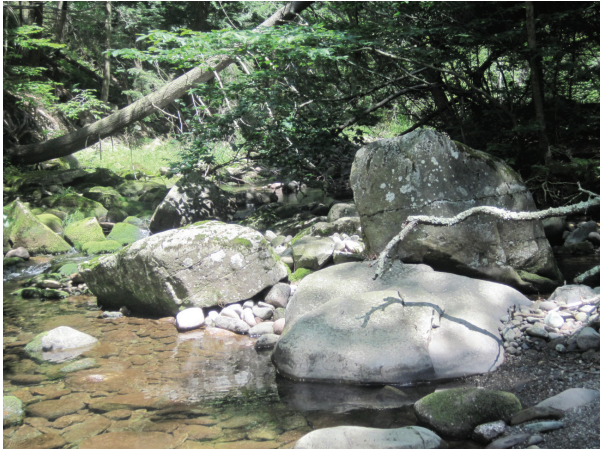
Boulder grade control (A892)

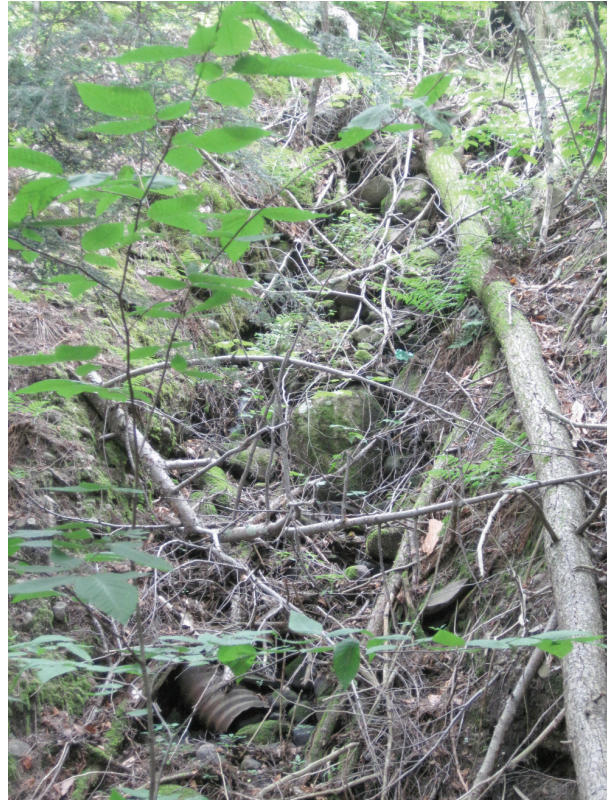
New York State land, in “forever wild” status, begins again at approximately Station 55500, ending at Station 55000; no recommendations are made for lands in forever wild status. Near Station 55400 the divergence of a man-made side channel into the right bank forested floodplain was observed. A segment of gullying bank erosion was observed slightly downstream in the side channel, apparently caused by surficial flow from roadside drainage along Frost Valley Road (BEMS NWB14_55300). A concrete wall structure that likely served as a gate for the diversion channel into the manmade pond just downstream was observed at the toe of this erosion site. (A897, A898) There was little evidence of regular inundation of this side channel. Woody vegetation was observed for the length of the eroding segment so it is anticipated that this bank will revegetate and stabilize without treatment (*passive restoration*).

Erosion on right bank (A897)

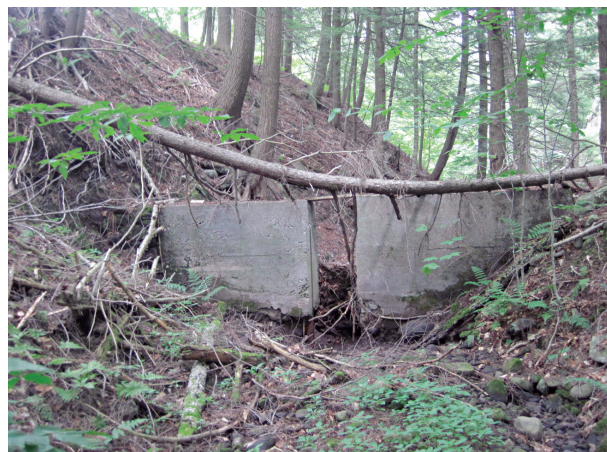
Concrete structure possibly once used to control flow of side channel (A898)

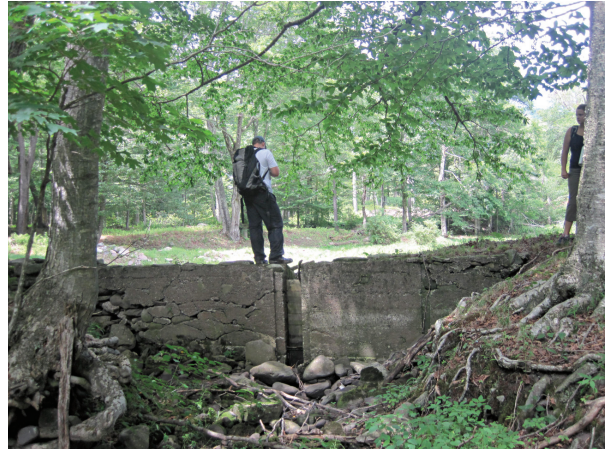
The side channel continues through the right floodplain until it meet with a man made pond. A poured concrete revetment was observed between the pond and a blue spruce grove for approximately 80 feet. The revetment was documented in fair structure and functional condition as it is likely that is once controlled drainage from the now dry pond. (A903) A significant perennial tributary, draining the notch between Spruce and Fir Mountains, converges with the main channel at Station 54400. (B785)

Revetment once used to control drainage from pond (A903)

INFRASTRUCTURE A poured concrete revetment was observed between a dry pond and a blue spruce grove for approximately 80 feet in the right floodplain near Station 54500. The revetment was documented in fair structure and functional condition.

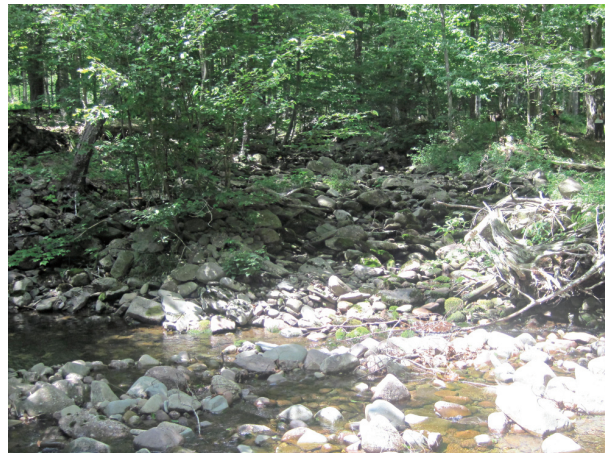
Tributary converging with main channel (B785)

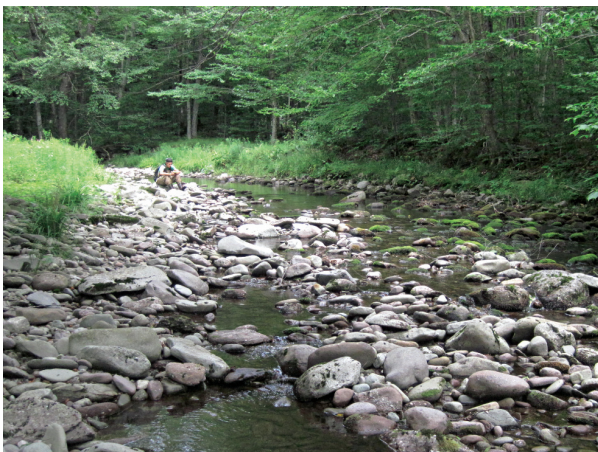
Aggradation was observed throughout the main channel downstream of the man-made diversion, with a significant cobble bar stretching 200 feet from Station 54800 to Station 54600. A dry flood chute was observed on the left channel. (B780, B783)

Aggradation throughout main channel (B780)

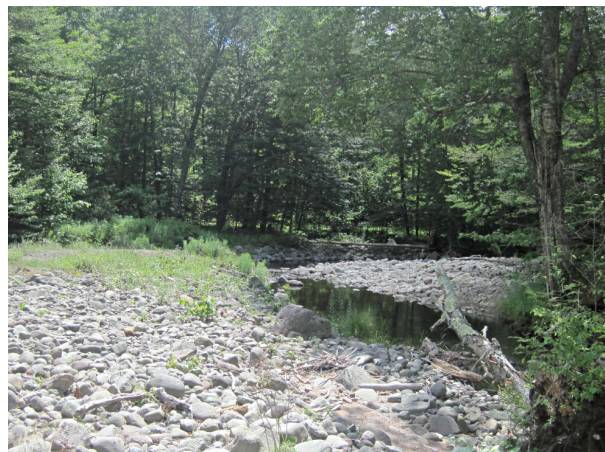
Large side bar (B783)

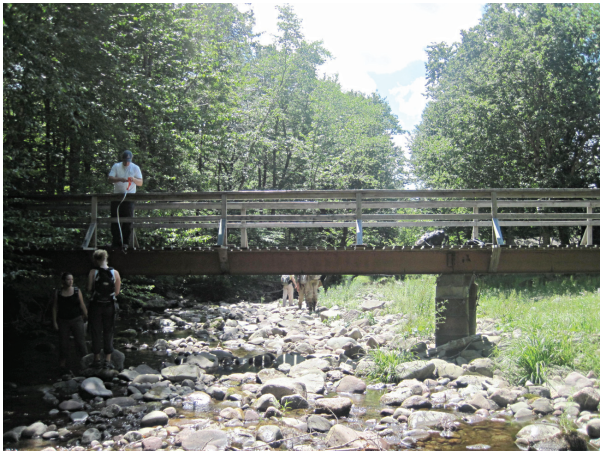
WBMU14 ends at Station 54300, where a private footbridge crosses the main channel connecting the forested left bank with land occupied by an emu and ostrich farm. The bridge is composed of 2"x4" wooden timbers on piers constructed of 55-gallon steel drums, documented in fair structural and functional condition; the owner

Private footbridge (A907)

reported that the bridge had been damaged and washed out in past flood events. The bridge was documented with a *normal span* of 69 feet and an *effective span* of 51 feet with 6 feet of encroachment on the right bank and 3 feet of encroachment on the left bank. Aggradation was observed upstream of the bridge. Depositional features often form upstream of bridges where the bridge approaches restrict flows that would otherwise effectively transport sediment. While this bridge may obstruct floodplain flows, it doesn't appear to obstruct bankfull channel flows. A stable bankfull width for this location, as estimated by regional hydraulic geometry equations (Miller and Davis, 2003), is about 43 feet, and it is unlikely that the bridge is the cause of the aggradation in the reach upstream. It is possible that the channel is over-widened due to ineffective channel management activities. (A907, A909) The overbank area from Station 54370 to Station 54320 (and adjacent areas at the start of Management Unit 13) should be investigated for potential improvement of riparian vegetation and development of a plan for channel management to more effectively protect the landowner's infrastructure.

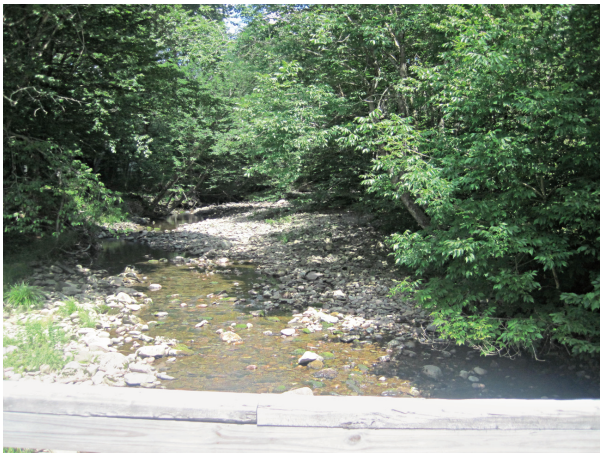
Aggradation upstream of bridge (A909)
