Management Unit 12

Ulster County - Town of Shandaken
Cross Section 147 to between Cross Section 149 & 150

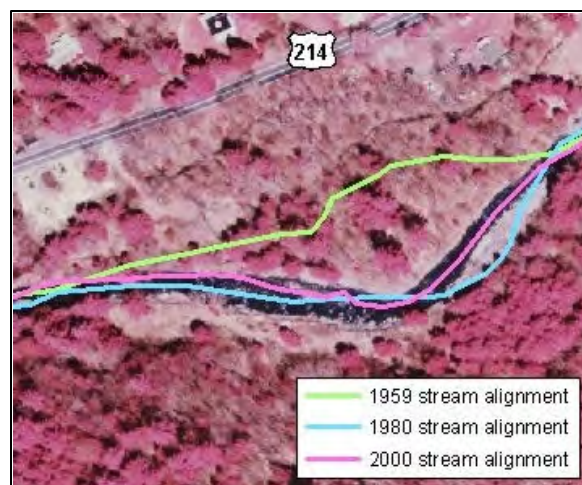
Figure 4 Historical stream channel alignments in Management Unit 12

Between 1959 and 1980 this stream reach shifted approximately 200 ft to the left. This dramatic change most likely took place during a flood event. From 1980 to 2000, this reach adjusted its channel alignment slightly back to the right as a gravel bar has formed at the top of the management unit.

As seen from the historical stream alignments, this management unit has experienced significant lateral channel shifting over the years (Fig. 4).

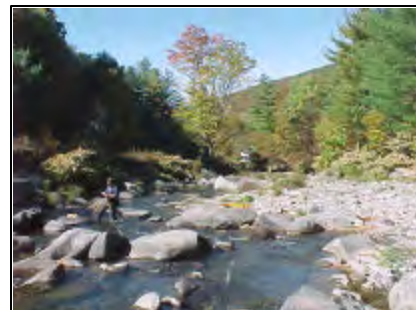
Figure 6 Cross-section 148 Stream Type F3

As the stream becomes entrenched, stream type transitions to F3 for the next 784 ft. of stream reach (Fig. 6 & Inset C). This stream type dominates the management unit. The slope of this reach decreases to 1.2%.

At the top of this reach, a large gravel bar has formed on the left stream bank. Gravel bars help maintain channel stability during flood events. In stable streams, the bars will erode away while the channel is in flood stage. The bars then are rebuilt as flow decreases, helping the stream maintain its stability by reestablishing its pools and riffles. If gravel bars are removed, these processes do not occur and instead, the flood water often dissipates its energy by eroding banks and scouring the stream bed.

As the stream *meanders* to the right, the channel widens. This reach is overwide with no overhead vegetation. Deposition of bed materials is common in overwide channels because they lose their ability to transport the stream's *bedload* material. In this situation streams often *aggrade*, or rise in stream bed elevation due to excessive deposition. Although many large boulders have been deposited throughout this reach, dominant bed material remains cobble.

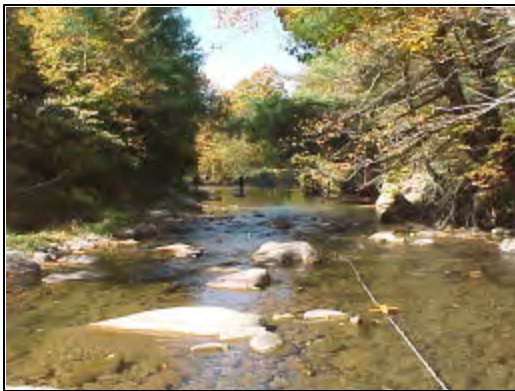
**Figure 7 Cross Section 149
Stream Type B3**

Once again the channel becomes moderately entrenched and changes back to a B3 stream type for the last 61 ft. of this management unit (Fig. 7). Channel slope of this reach increases to 1.9%.

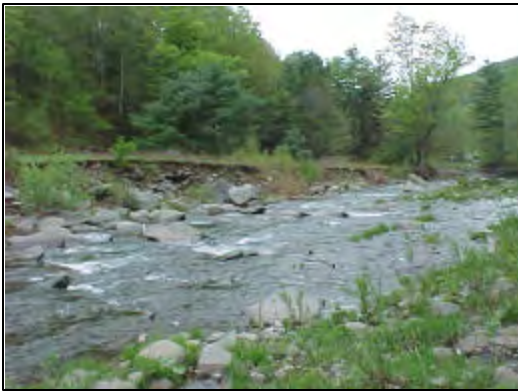
Figure 10 Planting Site #40

Planting site #40 is located in the overwide reach at the middle of the management unit (Fig. 10 & Inset C). The left stream bank in the reach has experienced minor erosion which has stripped away most of its vegetation. The angle of this bank is quite low and can support vegetation establishment in its current condition. At the top of the bank is a large mowed grass area. Japanese Knotweed is present on both stream banks.

In-channel plantings of willow fascines and native sedges along the toe of the stream bank are recommended. These planting will encourage the stream to narrow into a more stable morphology. Native shrubs should also be installed on the face of the bank. There is a small amount of willows along the right bank, the tops of which could be harvested as cuttings, without damaging the root system, and used to revegetate the left stream bank. This practice actually increases the vigor of the parent willow, as the root system is strengthened and the crowns of the harvested willows will sprout new branches. The upland grass area should be converted to forest to improve the stream buffer and overhead cover. These plantings will help to stabilize this stream bank, while adding aquatic habitat value by improving shading, resulting in cooler water temperatures. Aggressive Japanese knotweed management is recommended throughout the unit, but particularly in those locations where treatments disturb and expose soil in the banks.

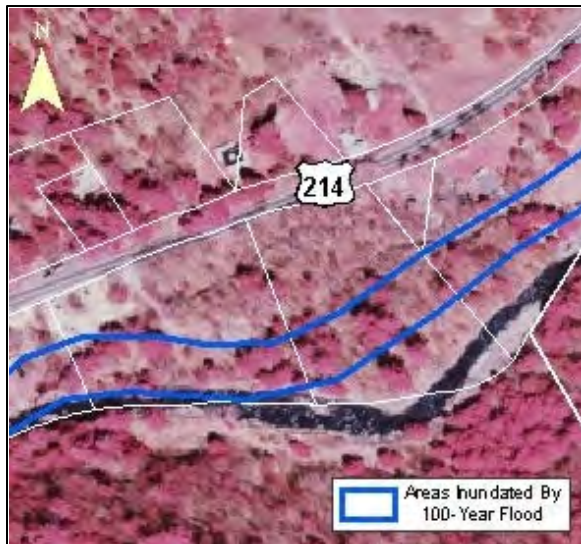
Figure 11 100-year floodplain boundary in Management Unit 12

According to NFIP maps, there are no houses located within the 100-year floodplain boundary in this management unit (Fig. 11). The current NFIP maps are available for review at the Greene and Ulster County Soil & Water Conservation District offices.
