Management Unit 13

Ulster County - Town of Shandaken
Between Cross Section 149 & 150 to Cross Section 153

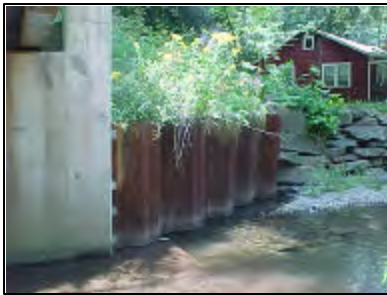
Figure 11 Sheet Piling

In response to repeated erosion which threatened Stony Clove Lane, the Ulster County DPW installed 13 ft. of sheet piling along the left stream bank downstream from the bridge. Immediately downstream of the sheet piling, the landowner has installed a 63 ft. stacked rock wall (Inset E) and 55 ft. of log cribbing (Inset A) to protect the left stream bank from erosion. At the top of this bank is a grass lawn extending to the stream bank edge.

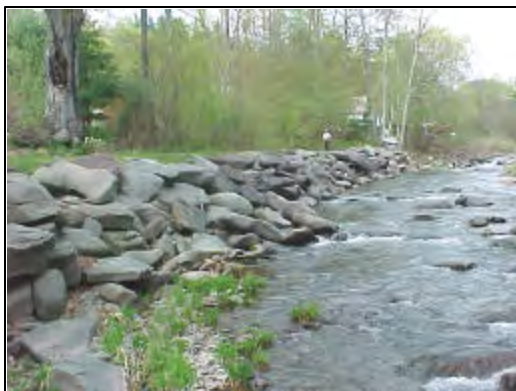
Figure 14 Planting Site #39 looking upstream

Planting site #39 is located on two residential properties along rip-rap on the right stream bank upstream from the Stony Clove Lane Bridge (Fig. 14). This stream bank is heavily armored with rip-rap, with grass lawn mown to the edge of the stream bank (Inset C).

Recommendations for this site include *joint planting* the existing rip-rap, by inserting plantings into the soil between the rip-rap rocks. Joint planting will strengthen and increase the longevity of this rip-rap. These plantings will also improve the aquatic habitat

by providing shade, which maintains cooler water temperatures. Upland plantings of native trees and shrubs in the mown areas will also improve the long-term stability of this bank and increase the buffer functionality.
