*DELHI
LOCAL FLOOD ANALYSIS
FLOOD ENGINEERING ANALYSIS REPORT
TOWN AND VILLAGE OF DELHI
DELAWARE COUNTY, NEW YORK*

Delaware County Soil and Water Conservation District

Woitd Engineering & Consulting, PC
11 South Washington Street
Binghamton, New York 13903

Final - December 8, 2017

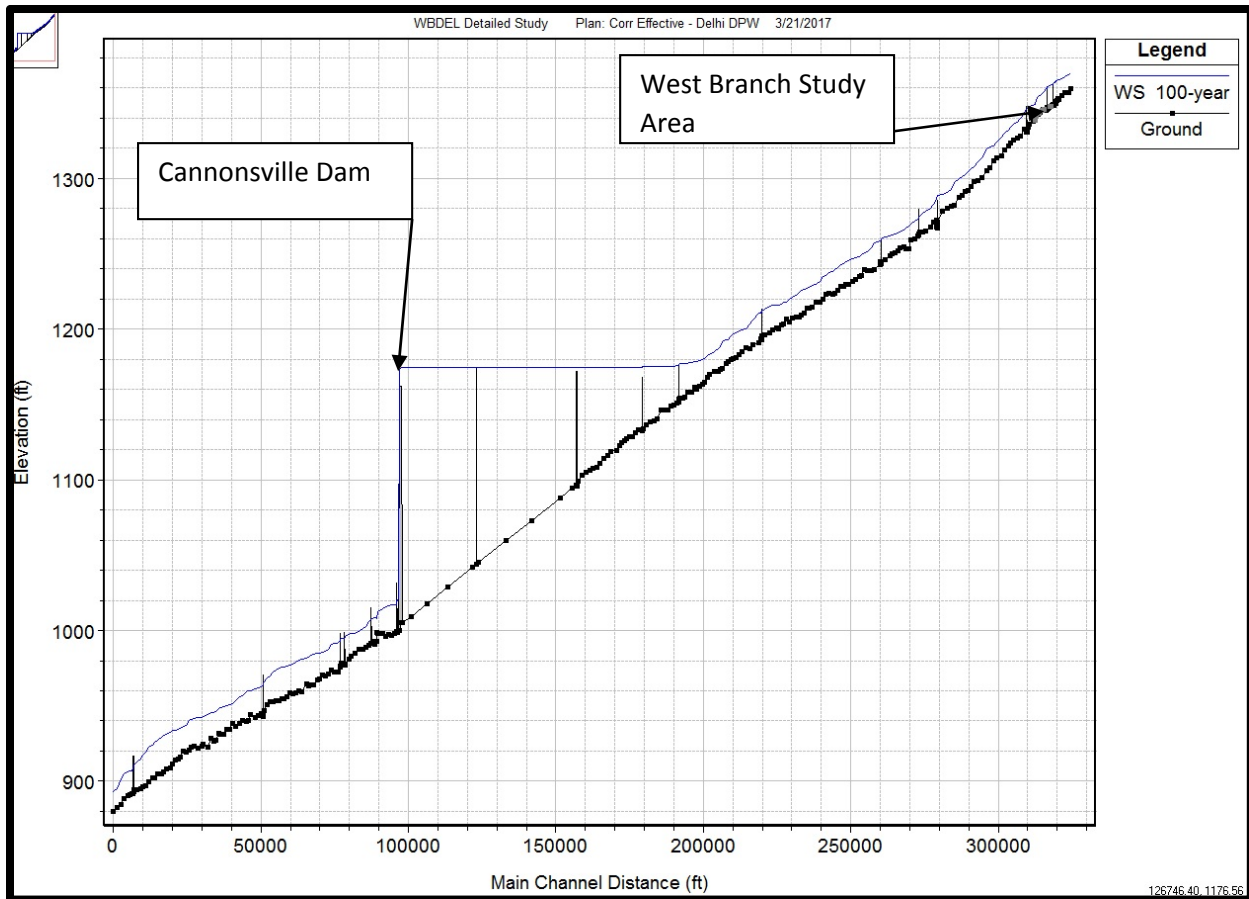
Figure 4: 100-Year Return Interval Profile of West Branch Delaware Duplicate Hydraulic Model

The first reviewed model assumption was the appropriateness of the downstream boundary condition. In the HEC-RAS model, a normal depth calculation was used to set the boundary condition at the downstream cross section. The energy grade line slope used for this normal depth was 0.0025 slope which is an acceptable approach for non-backwater flow conditions. The Cannonsville Dam lies between the most downstream cross section and the West Branch Study Area and causes a backwater flow condition as seen by the relative flat 100-year return interval water surface elevation in Figure 4. This dam is located 36.4 miles downstream from the West Branch Study Area and has no impact on the Study Area as seen by the water surface elevation profile that roughly parallels the ground profile between the dam and the Study Area.

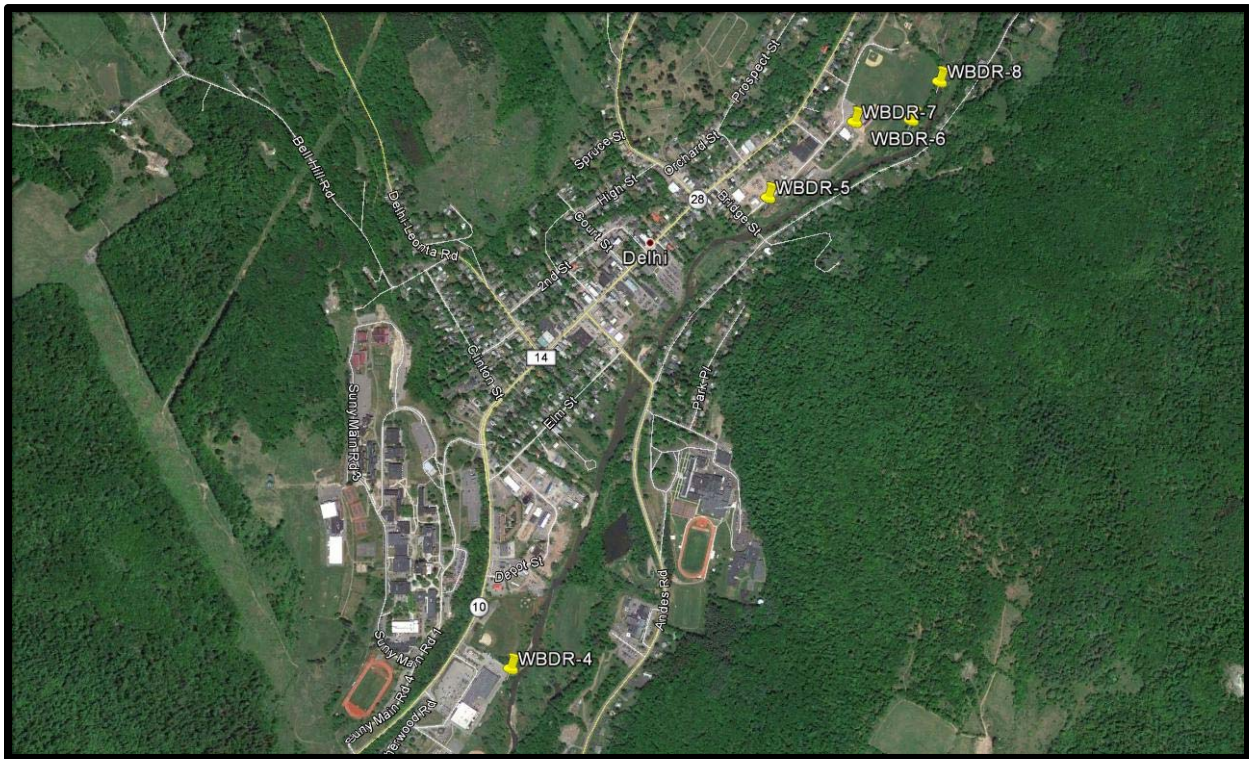
Figure 5: Location of High Water Marks in Delhi during June 2006 Flood

High Water Mark ID	Elevation (NAVD 88)	Latitude	Longitude
WBDR-4	1348.7	42°16'0.5"N	74°55'15.6"W
WBDR-5	1361.3	42°16'44.4"N	74°54'43.2"W
WBDR-6	1363.6	42°16'51.6"N	74°54'25.2"W
WBDR-7	1363.6	42°16'51.6"N	74°54'32.4"W
WBDR-8	1364.0	42°16'55.2"N	74°54'21.6"W

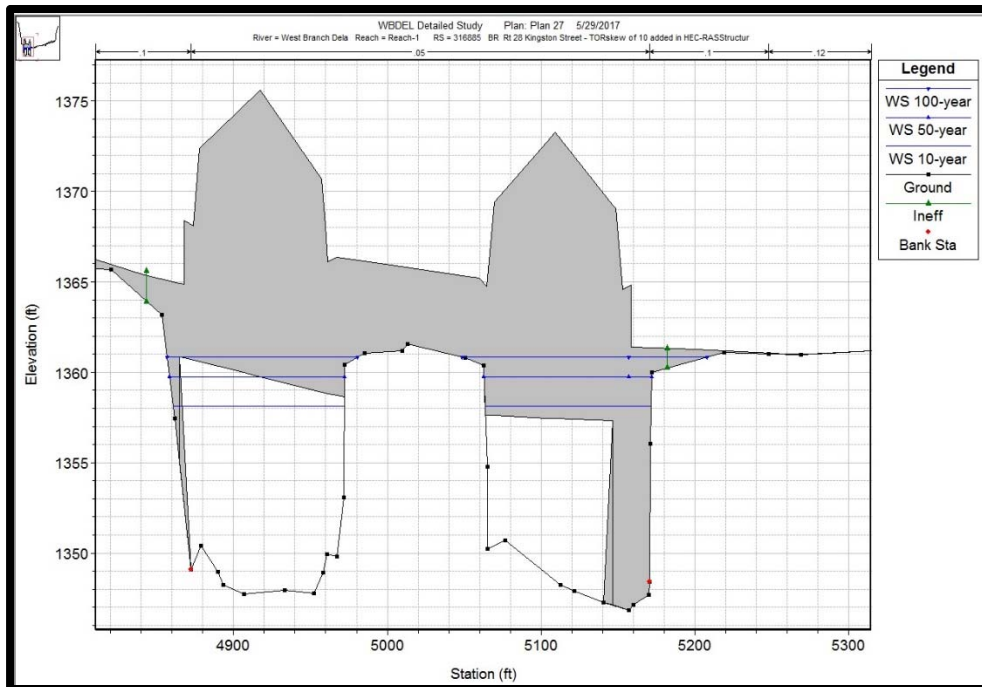
Figure 6: Representative Cross Section of Ineffective Flow in the West Branch Study Area

The third reviewed assumption was the application of ineffective flow areas (inundated areas where the velocity of water is assumed to be zero). Areas in an ineffective flow area do not convey water longitudinally and therefore are not used in the calculations for water surface elevations. There was little ineffective area used to model the obstructions caused by the Kingston Street Bridge and the Bridge Street Bridge. A representative cross section of ineffective flow can be seen in Figure 6. The ineffective flow areas are the space landward of the green vertical lines. Bridge infrastructure block the flow of water which causes hydraulic ineffectiveness (contraction and expansion losses) that are typically modeled using ineffective flow areas. The FIS (effective date June 2016) did not mention any reasoning to why this wasn't used. It was assumed that the duplicate model was the best tool to calculate water surface elevations so the duplicate model was used for the LFA.

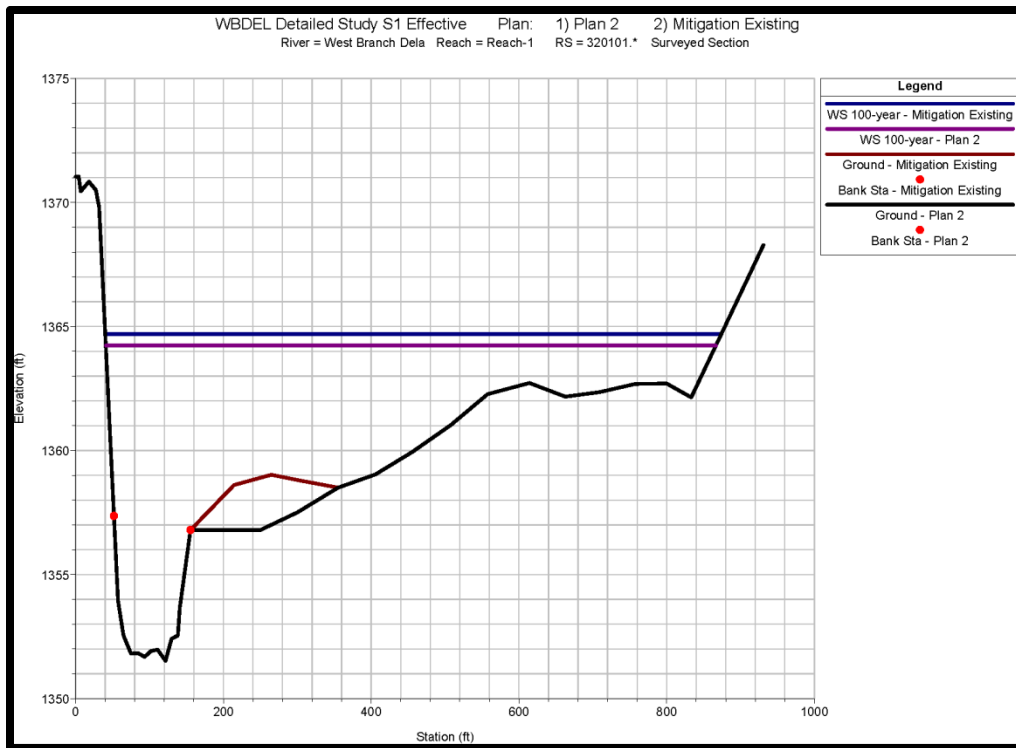
Figure 14: Typical Section View of Plan #2

To accommodate the wider floodplain (the floodplain bench) the Bridge Street Bridge crossing was widened which would require the removal of two residential homes. If left unchanged, the sudden constriction of floodwater width from the proposed floodplain bench into the narrower bridge crossing would offset any gain the floodplain bench would have provided.

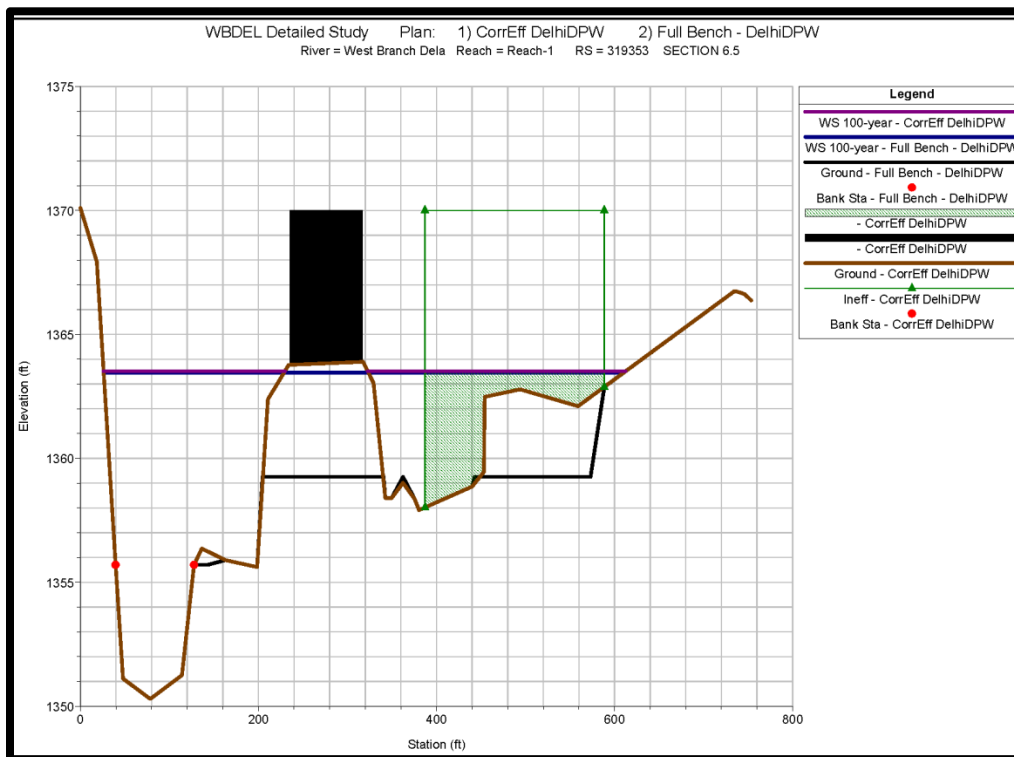
Figure 16: Typical Section View of Plan #3

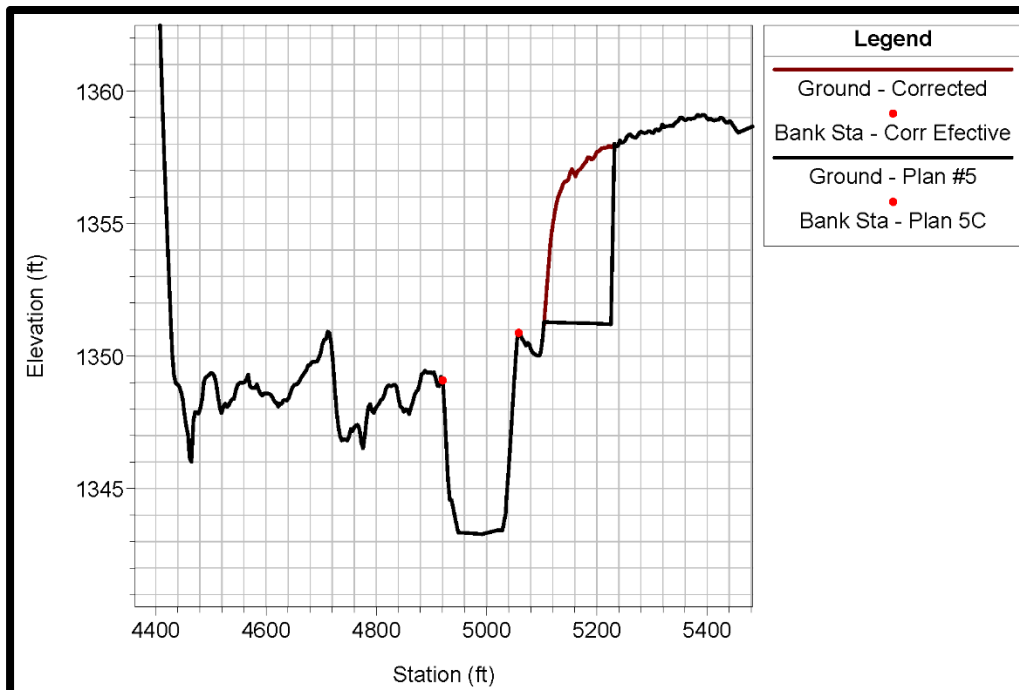
Figure 20: Typical Section View of Plan #5

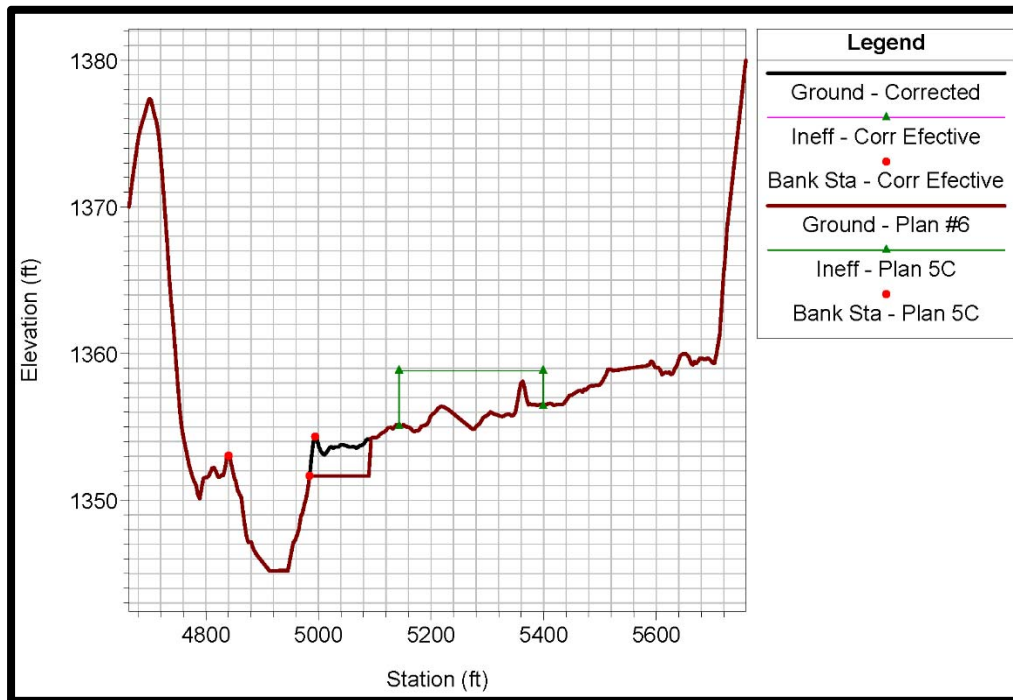
Figure 22: Typical Section View of Plan #5

The proposed flood protection project would excavate a floodplain bench into the western floodplain of the West Branch as seen in Figure 23. The excavation would start 300' upstream of the SUNY ball fields and extend 1,000' upstream, including lowering the area around the confluence between Steele Brook and the West Branch. Per Figure 23, there is a high terrace (the dark brown coloring) on the north shore of Steele Brook which was more than likely caused by human activity when gravels and cobbles were removed from the Brook. The average width of the bench is 100' with an average depth of 2.0'. Figure 22 shows a typical section through the floodplain bench.

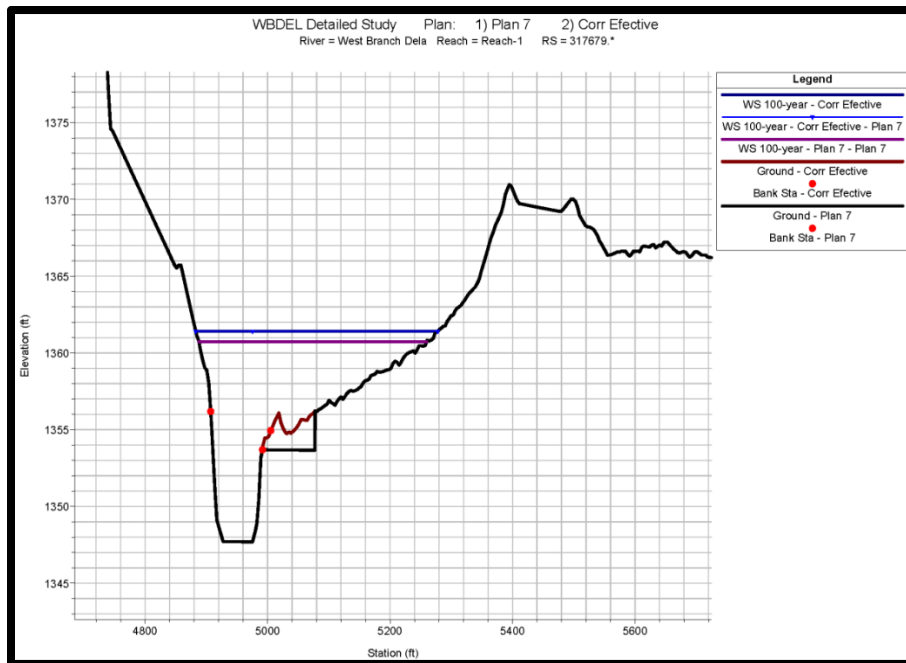
Figure 24: Typical Section of Plan #7

The proposed flood prevention project would require the Delhi Telephone outbuilding to be relocated. This outbuilding is used for storage of vehicles and equipment as seen in Figure 25. Approximately 20% of the county owned parking (171.6-10-9, 171.6-10-6) and 25% of the bank parking lot (171.6-10-5) would need to be lowered or removed. The flat section of the floodplain bench is set at an elevation that would be inundated with floodwaters starting at the 2-year return interval flood. The portion of the floodplain bench where the lowered parking lot is proposed would be more frequently inundated than under existing conditions when these sections of the parking lots are inundated with flood water starting at the 10-year flood. Flood Mitigation Plan #7 would also disturb the Riverwalk, built along the west shoreline of the river. The Riverwalk would need to be removed and rebuilt at the new elevation of the floodplain bench.

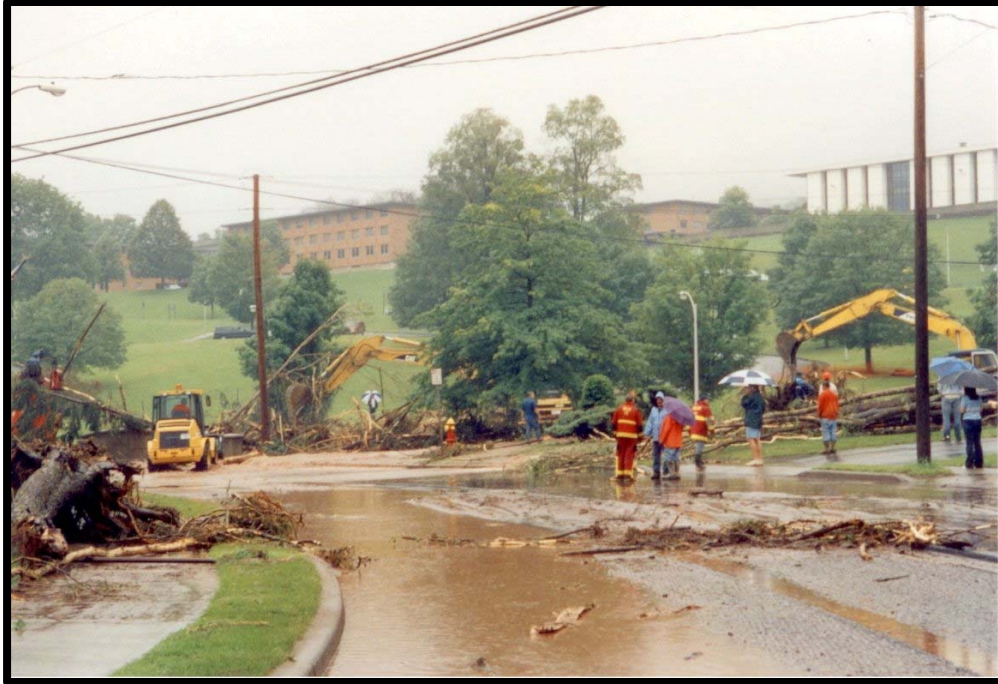
Figure 28: Photo of Flooding Aftermath. Looking West at Main Street Bridge

The most notable recent flooding event occurred in Steele Brook in 2006. Comments gathered from the initial public meeting and flood commission meetings described the debris jam that formed at Main Street and caused floodwaters to jump out of the stream channel and flow across Main Street to the west. This resulted in floodwaters flowing through a retirement community building as seen in Appendix A Figure A-20 (the blue flow arrow). Overbank flooding also occurred at the Elm Street Bridge (the green flow arrow). Another flooding event occurred in 1973 when water sheet flowed across Elm Street.

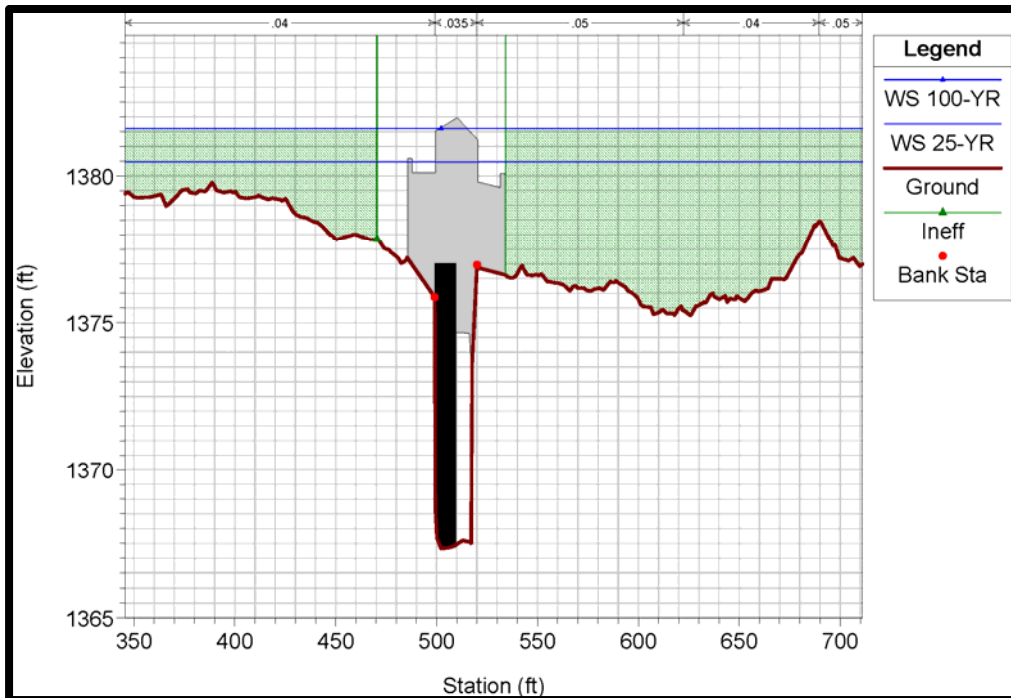
Figure 31: Cross Section View of Obstructed Main Street Bridge

The water surface elevation of the obstructed 100-year flow returns to the same elevation of the 100-year flow elevation under clear water conditions (i.e. no obstruction) by the next downstream cross section (as seen in Appendix A, Figure A-23). This contradicts anecdotal evidence that some river water flowed across Main Street into several buildings on the west side of the river. This is one of the limitations of one dimensional hydraulic modeling since water surface elevations are interpolated between cross sections longitudinally and do not consider how water may flow laterally across a broad feature such as the topography between Main Street and Elm Street.

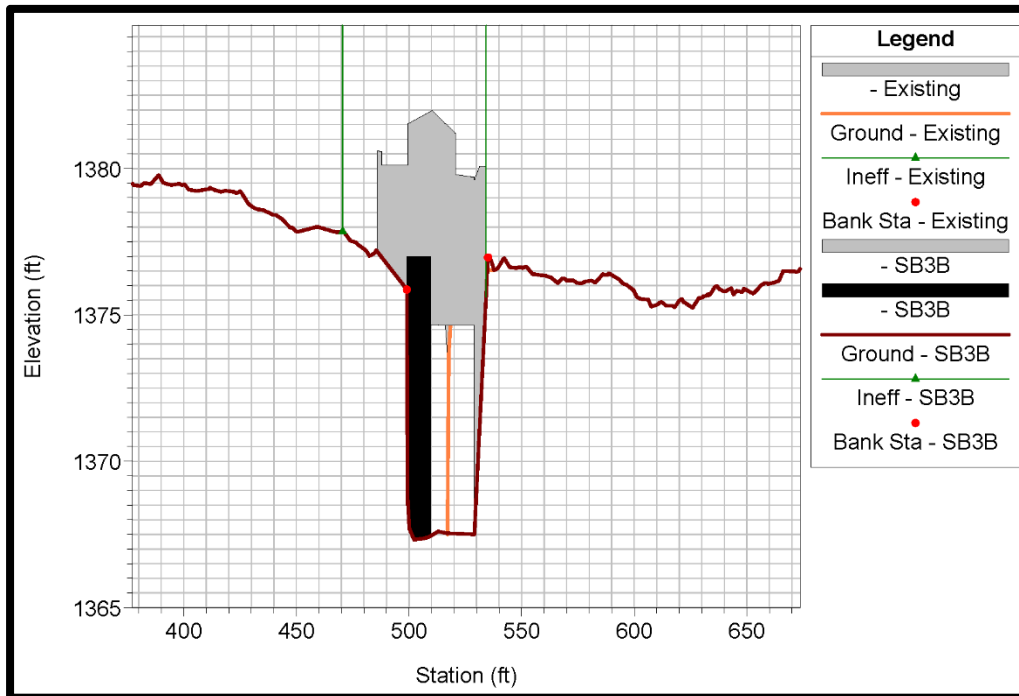
Figure 37: Typical Section of Plan #11

Summary: As discussed in Section 6.2.2 on page 77, the Main Street Bridge is prone to plugging with debris and causing all floods exceeding a 10-year flood elevation to overtop the bridge. This causes water to run downhill and enter the retirement community and surrounding buildings as seen in Appendix A, Figure A-21. This also shuts down Main Street, (State Highway #10) for several hours. To accommodate the anticipated blockage, the proposed structural improvement project will increase the clear span of Main Street Bridge from 17 feet to 30 feet. Flood Mitigation Plan #11 assumes Plan #10 is in place downstream because the channel width downstream needs to match the new clear span of the bridge or it would negate the hydraulic benefits gained by a wider bridge. The obstructed proposed clear span can be seen in Figure 37 and a conceptual sketch of the proposed crossing is shown in Figure 38.

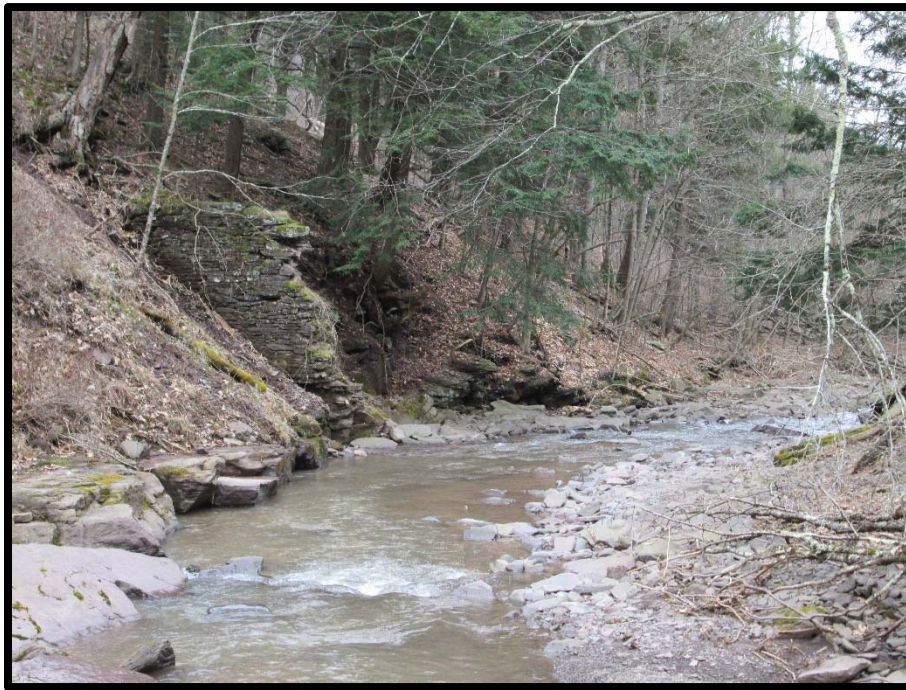
Figure 40: Photo Looking Downstream At Abandoned Dam

Summary: Per Table 42, 22% of the total stream bank length (22,000 total feet) was actively eroding and roughly 13% of that stream bank was found to be an extreme source of flood debris (logs) that would eventually make its way down to the Main Street Bridge. Stream restoration using natural channel design is a design process to restore the stream's processes to match the stream's power to move logs, water and sediment within its geometric dimensions. There are several approaches to mitigating debris sources so it's best to assume a uniform cost per linear foot of eroding bank. Often this cost to implement a natural channel design is a function of the access to the construction site from the nearest public road. If construction access is relatively easy, the cost of construction is estimated at \$125/linear foot of eroding stream bank. If construction access is difficult, then the cost would be closer to \$225/linear foot. Shutting down all or most of the debris sources is a multiyear process and it would be important to help mitigate the transport of trees downstream by intercepting them upstream from the Main Street Bridge. The FC was consulted about the optimal location of a debris catcher and it felt the catcher should not be along the flats upstream of Main Street but located near the downstream abandoned dam which is seen in Figure 40.

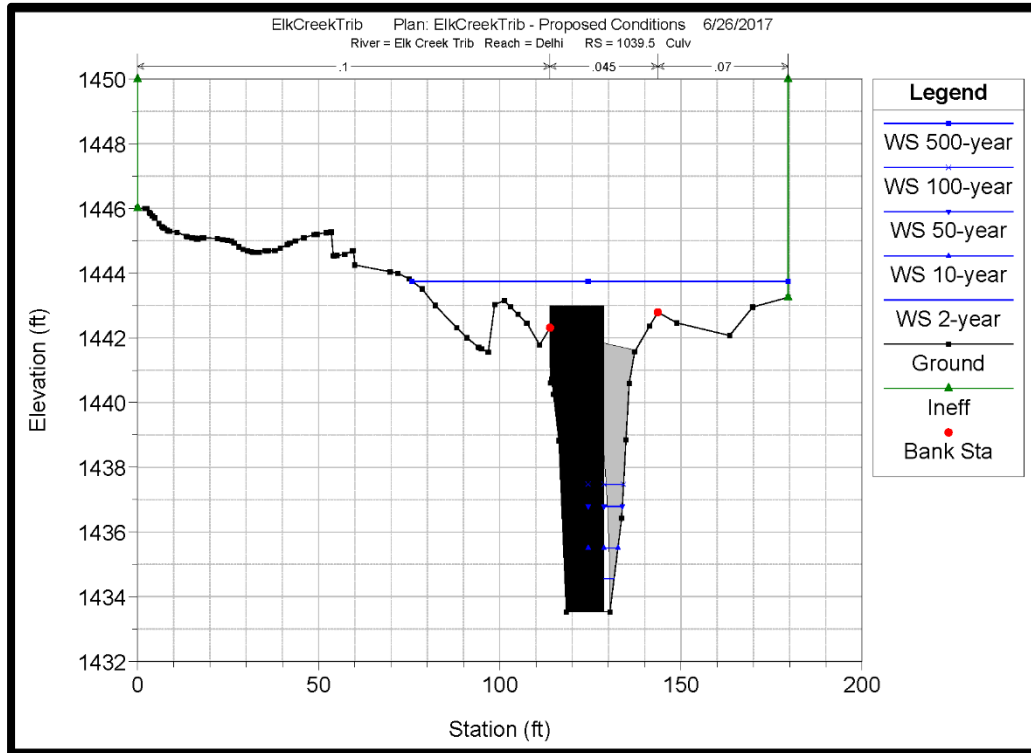
Figure 49: Obstructed Cross Section under Proposed Conditions

Summary: The arch culvert's dimensions were increased to 12' wide with a 7' height span. The culvert alignment, headwall and wing wall dimensions and locations were assumed to be roughly the same. The same size obstruction that was modeled under fully obstructed conditions was placed in the proposed condition model and can be seen in Figure 49.

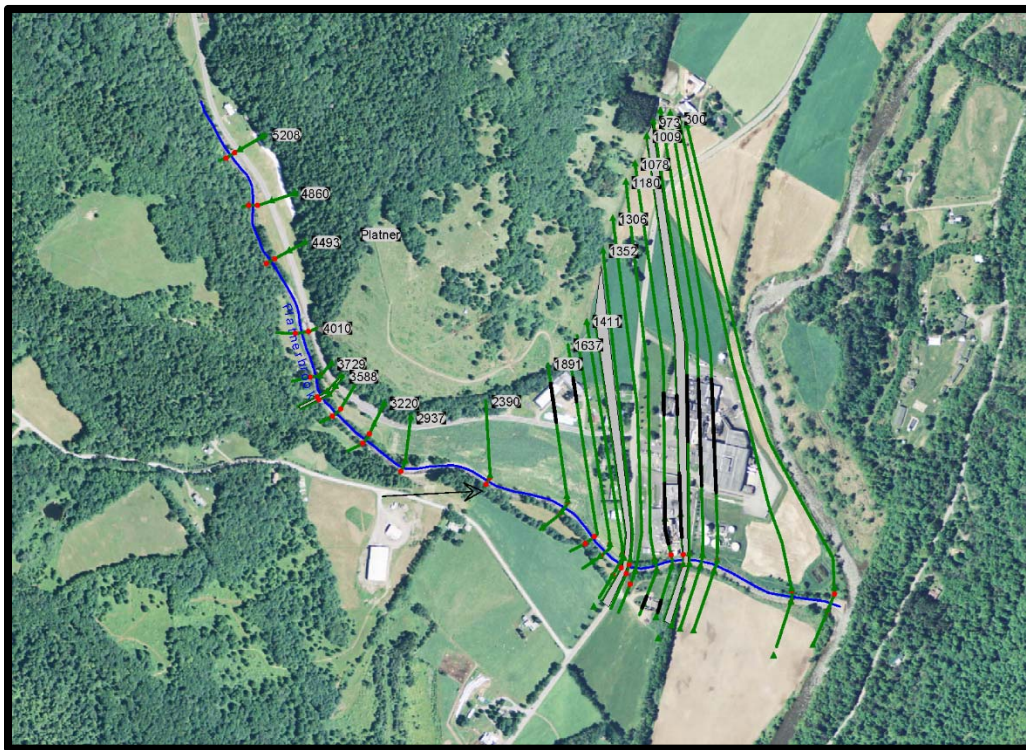
Figure 51: Cross Section Locations in Platner Brook

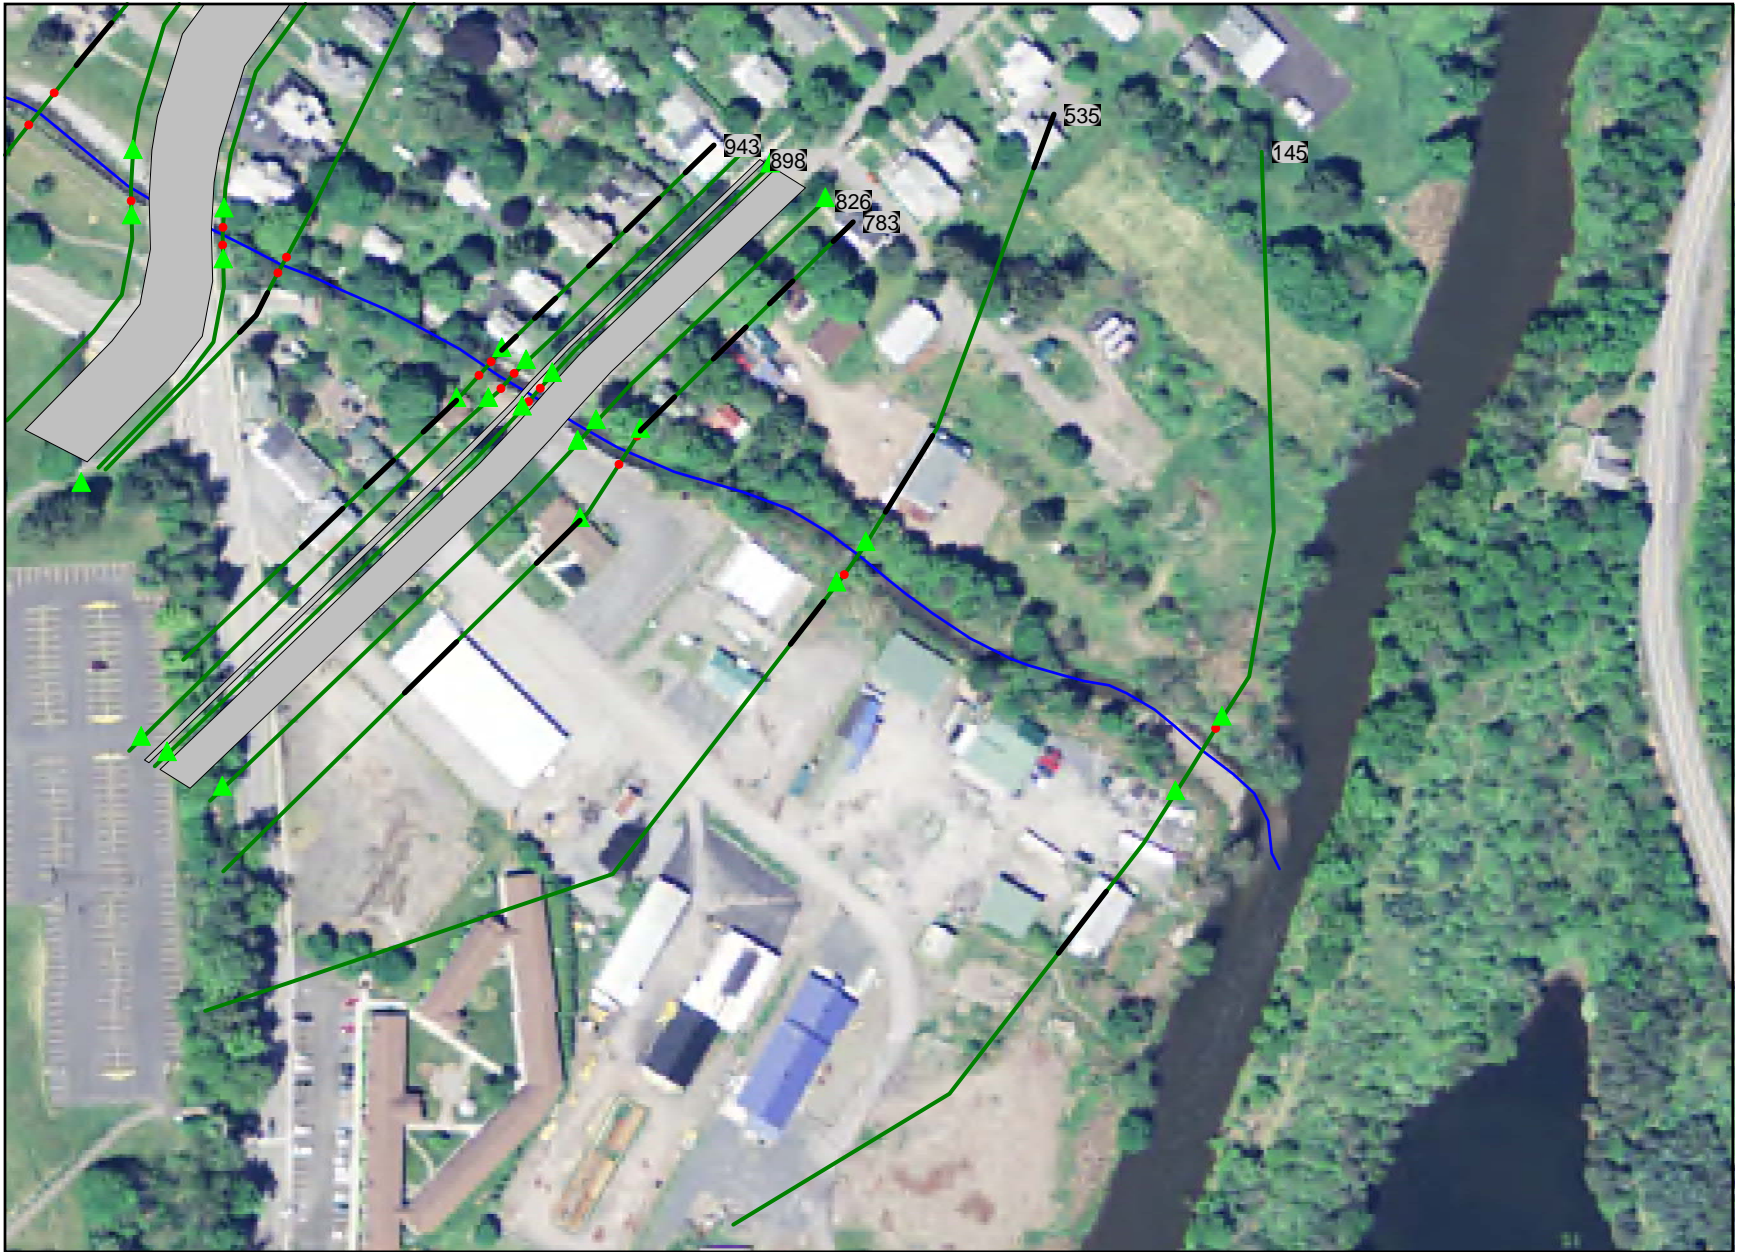
SteeleBrook Plan: 1) Existing 6/25/2017 2) Exist MainSt Obstruct 6/26/2017
