2.7 Riparian Vegetation Issues in Stream Management

Riparian Vegetation of the Manor Kill

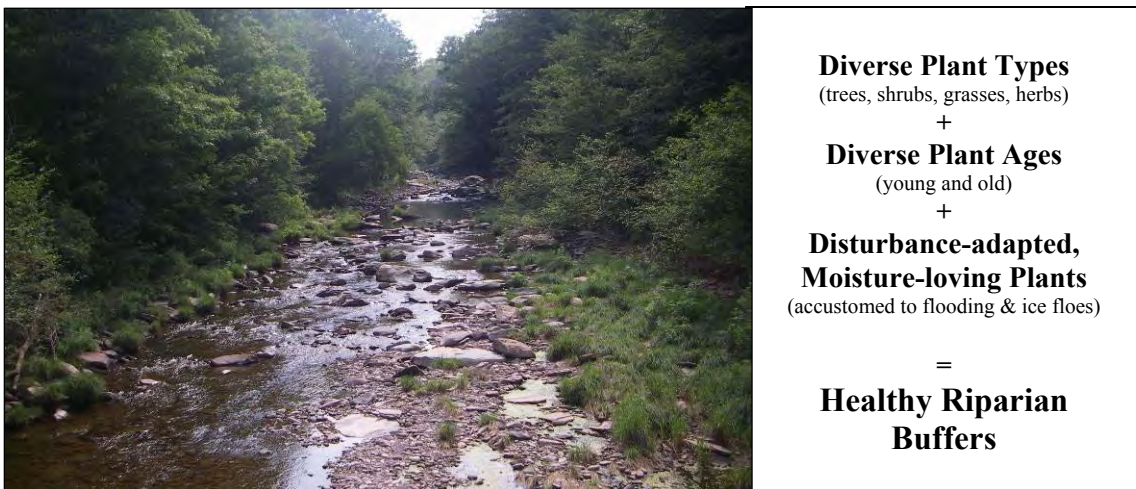
Figure 2.7.2. A healthy riparian community is densely vegetated, has a diverse age structure and is composed of plants that can resist disturbance.

A healthy riparian plant community should be diverse. It should have a wide variety of plants including trees, shrubs, grasses or herbs (Figure 2.7.2). The age of the plants should be varied and there should be sufficient regeneration of new plants to ensure the future of the

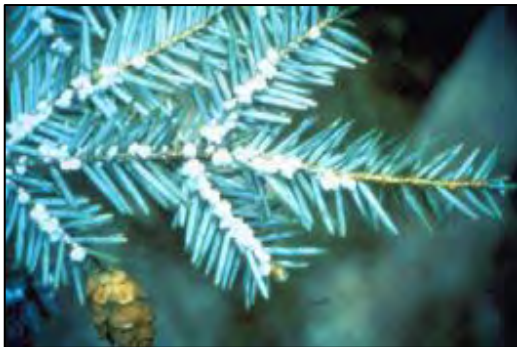
Hemlock woolly adelgid on the underside of a branch.

tsugae) is an insect, which feeds on the sap of hemlocks (*Tsuga spp.*) at the base of the needles causing them to desiccate and the tree to take on a grayish color. Stress caused by this feeding can kill the tree in as little as 4 years or take up to 10 years where conditions enable the tree to tolerate the attack (McClure, 2001). This native insect of

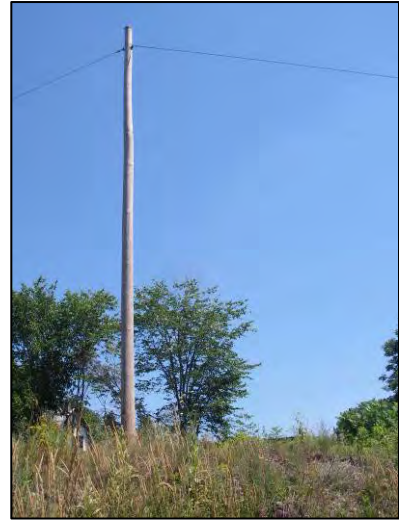
Utility crossing.

Utility lines parallel the roadway and cross the stream at various points requiring the utility company to cut swaths through the riparian vegetation at each crossing, further fragmenting essential beltways for animal movement from streamside to upland areas. Although the road right-of-way and utility line sometimes overlap, at several locations along the stream, the right-of-way crosses through the riparian area separate from the road. This further reduces the vigor of riparian vegetation and prevents the vegetation from achieving the later stages of natural succession, typified by climax species such as sugar maple, beech and hemlock

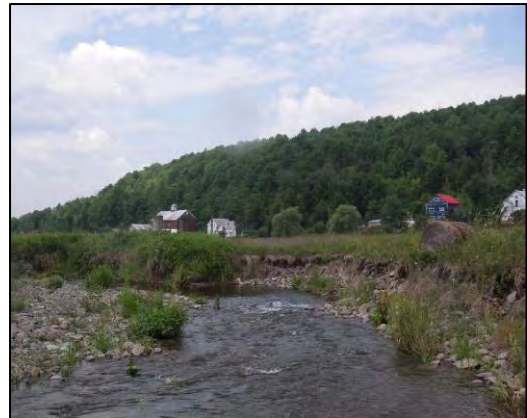
Eroding bank along an agricultural field.

Agricultural land-use is often concentrated along the stream corridors due to the relatively flat, fertile landscape as well as easy stream access for livestock. Often the native riparian trees and shrubs are replaced with herbaceous vegetation including pastures and hayfields; these fields being maintained to the edge of the streambank. Without the dense mat of roots under trees and shrubs to bind the soil together and without the woody material to reduce erosive forces, the rate of streambank erosion may be increased resulting in a loss of valuable topsoil. Additionally livestock, particularly cattle, favor riparian areas and will spend much time by the streambanks and in the water. The result is overgrazing that erodes bank soils. Trampling of riparian land during prolonged access by livestock results in soil compaction and physical damage to vegetation as well as allows for establishment of invasive plants.

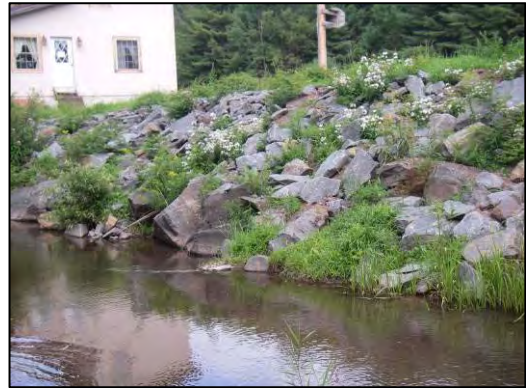
Streamside development and limited riparian vegetation leads to compromised streambanks. This bank has been reinforced with riprap.

results in greater bedload deposition and increases stress on the unprotected bank. Eventually stream alignment may change and begin to cause erosion on the property of downstream landowners. Catskill stream banks require a mix of vegetation such as grasses and herbs that have a shallower rooting depth, shrubs with a medium root depth, and trees with deep roots. Grasses alone are insufficient to maintain bank stability in steeply sloping streams such as the Manor Kill.

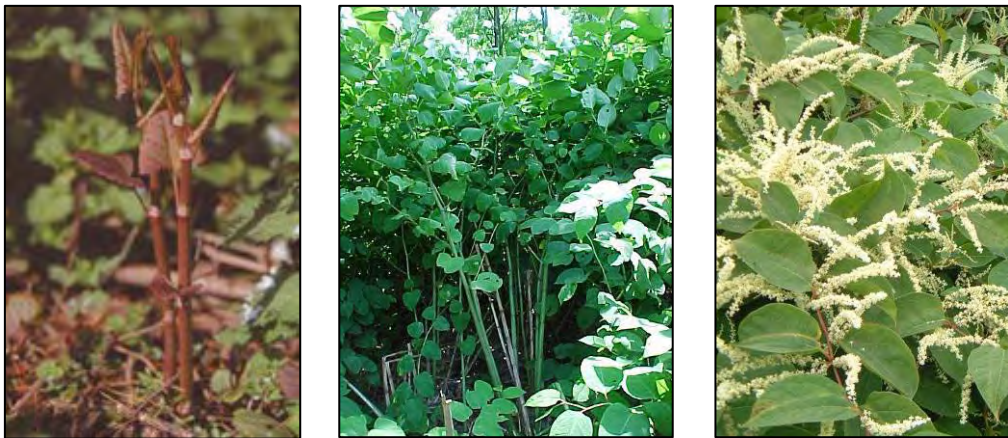
Figure 2.7.4. Stages of Japanese knotweed’s growth throughout the growing season.

Japanese knotweed is quite recognizable throughout the year. The series of photographs in Figure 2.7.4 illustrate different stages of Japanese knotweed’s growth throughout each season. This herbaceous, or non-woody, perennial goes through these

cycles every year. In the spring (generally late April, early May), new red, asparagus-like shoots sprout from last year's crown or from underground roots (*rhizomes*). By July, individual stems may reach 11 feet tall. Many thick, hollow stems are based at a crown.

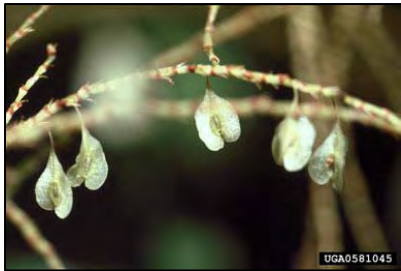
Knotweed seeds.

The numerous flowers turn into buckwheat-like seeds by late September, early October. Although some seeds may create small seedlings (Forman & Kesseli 2003), knotweed spreads more by their *rhizomes*.

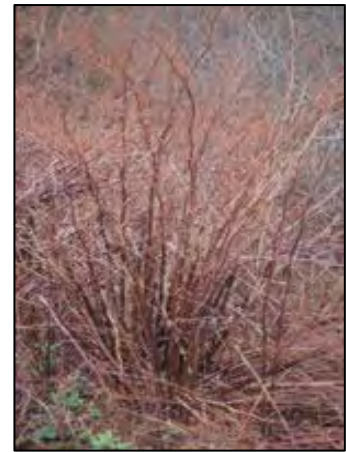
Cold weather halts the growth of knotweed; once frost covers the land, knotweed drops its leaves and turns an auburn hue. These dead stems often remain standing for one or two years and then cover the ground, decaying slowly.

Knotweed following a frost.

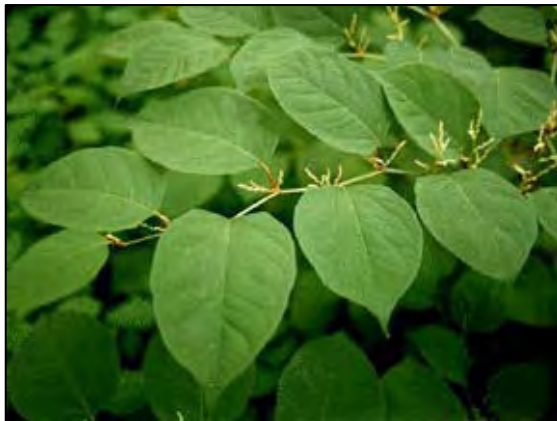
The above ground portion dies back each fall and re-grows to a height of 6-9 feet tall each spring. The canopy of the dense stands of bamboo-like stalks, covered by large heart shaped leaves, blocks out almost all light from reaching the soil, thereby shading out other plants and leaving the soil bare.

Knotweed's leaf pattern.

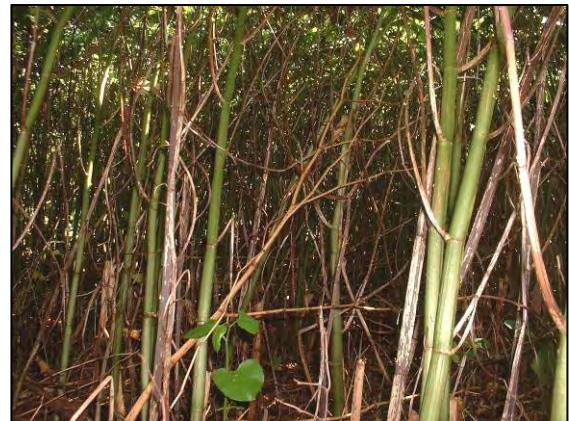
Dense stand of knotweed.

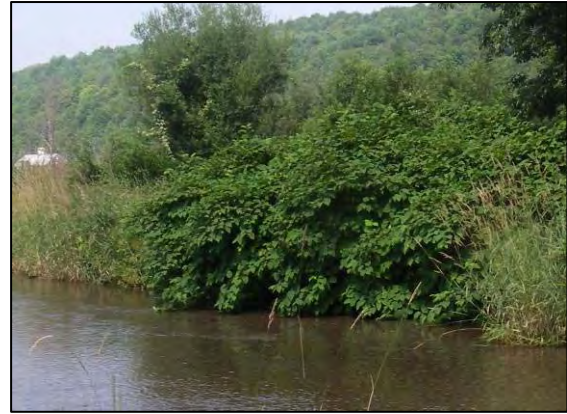
Japanese knotweed colony along the Manor Kill.

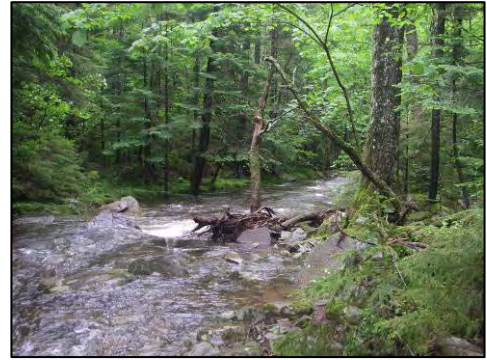
Riparian vegetation (closed mixed), protects stream banks and water quality, and provides habitat and food sources for fish and wildlife.
