Neversink River West Branch

MANAGEMENT UNIT 17

WEST BRANCH MANAGEMENT UNIT 17
BETWEEN STATION 73000 AND STATION 69700

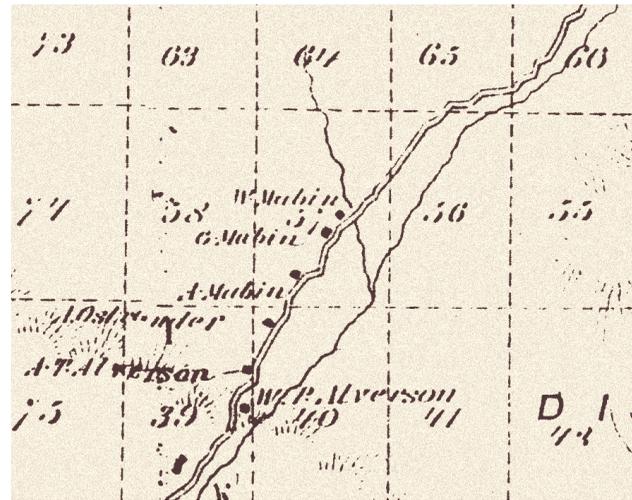
Excerpt from 1875 Beers Map (Figure 2)

The 1875 Beers Atlas of this area indicates that by that time, the stream had been harnessed for manufacturing, primarily saw mills, woodworking shops and tanneries (Figure 2). Raceways were built in the floodplains to divert water to ponds for use as needed. Floodplains were profoundly altered in the process, as these watercourses also became areas of preferential channelized flow when floodwaters inundated the floodplains. When woody debris jams blocked the primary channels, these raceways sometimes eroded out to become major secondary channels, or even took over the full flow to become a new primary watercourse.

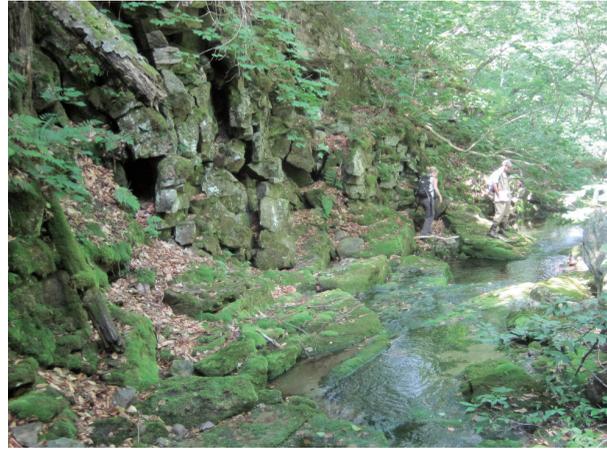
Throughout this management unit the Neversink River is considered a headwater stream as defined by the steep channel slope and confined valley conditions. The main channel is constrained on both banks by boulder and bedrock and the bed grade is controlled by bedrock for the entire extent of river in WBMU17. The dense forest surrounding the stream in this management unit provides a continuous source of large mature trees that can be blown down or washed into the stream during storm events. Several woody debris composed of these downed trees from the steep valley walls were observed forming obstructions in the channel throughout this segment of the river. These woody debris most likely augment the step-pool channel type in this location by providing blockages that lead to pool formation. (B465, A544)

Boulder and bedrock control on valley wall and stream bed (B465)

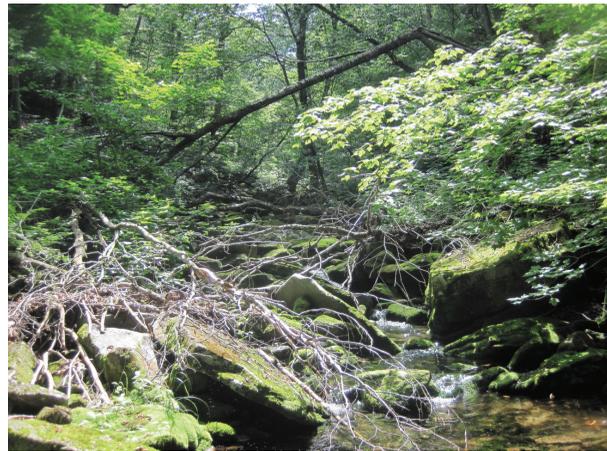
Obstructions in channel (A544)

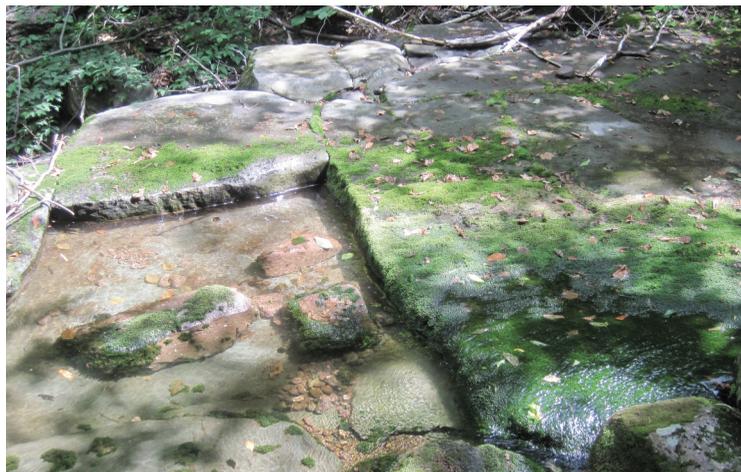
There was finer materials such as coarse gravels observed in some of the pools which are most likely from *colluvium*--sediment transported by gravity from a steep slope—from the steep valley walls and slopes of Slide Mountain. These coarse gravels as well as larger colluvial materials are the sediment supply for the river; they are transported during high flow events and eventually contribute to the alluvial processes in the less confined river valley downstream. (B456, A547)

Coarse gravel in bedrock pool (B456)

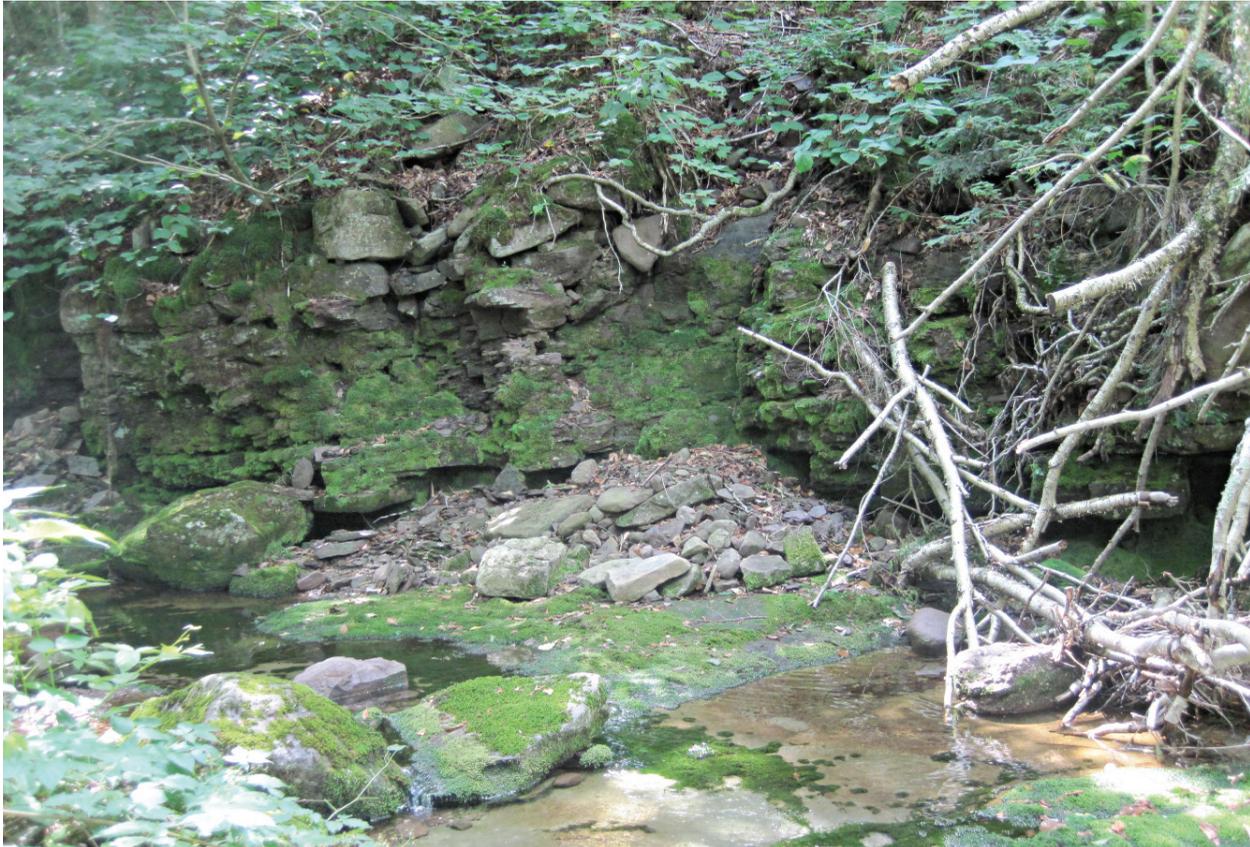
Colluvium (A457)
