# **Conine Stream Restoration Project**

## ***Design and Implementation Report***

*Town of Prattsville, Greene County, New York*

*December, 2007*

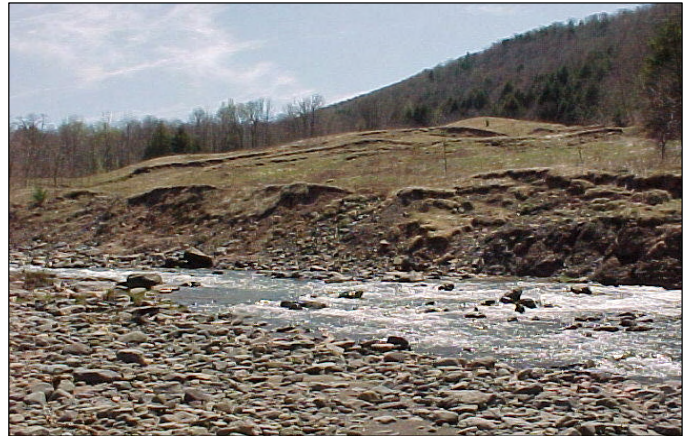
Erosion and failure of upstream high bank in 2001.

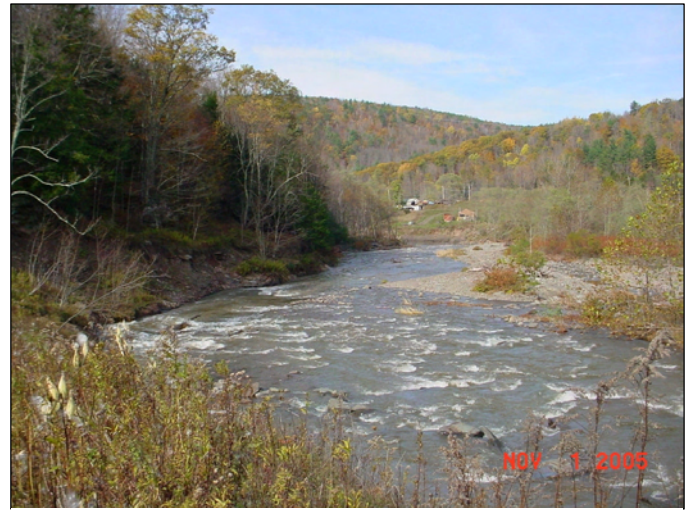
**View looking downstream from upstream bank failure.**

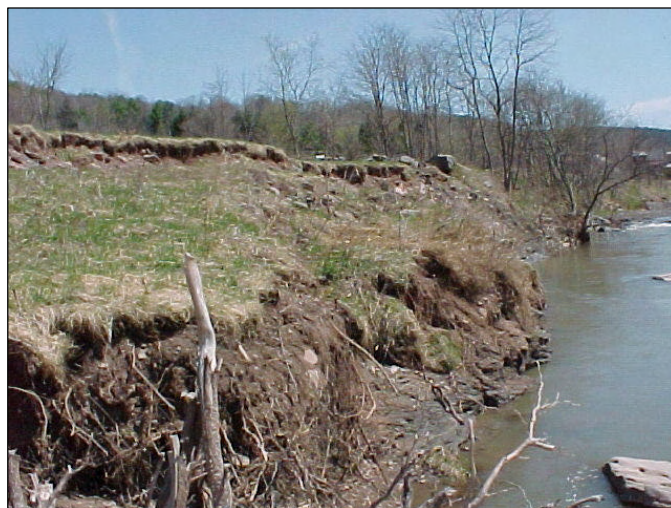
**Image of downstream bank erosion and failure.**

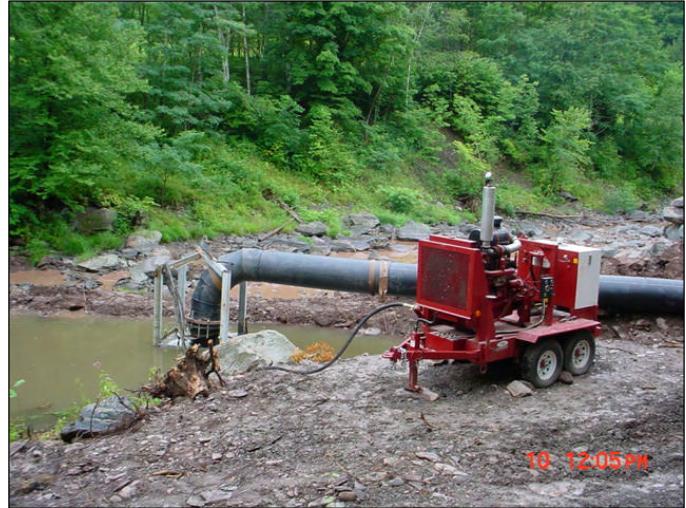
Phase I dewatering pump intake and pipeline.

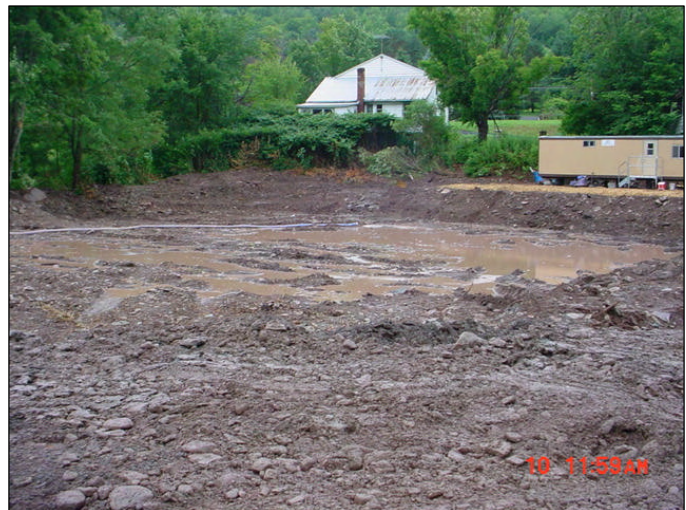
Phase I turbidity control basin.

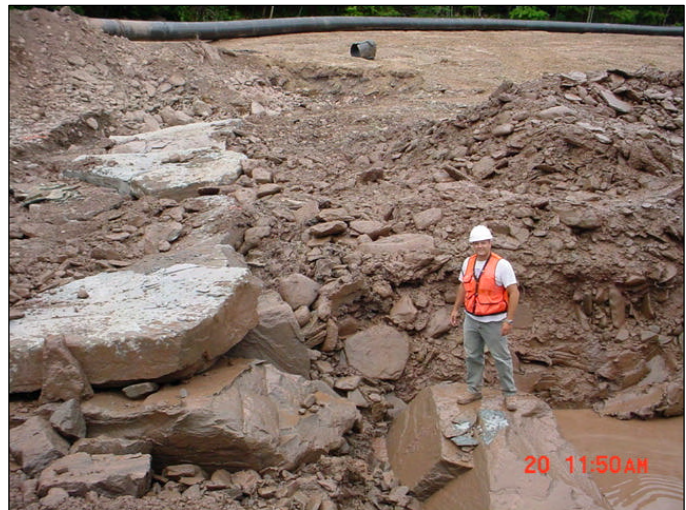
**Excavation and construction of a cross vane sill near the center of project reach.**

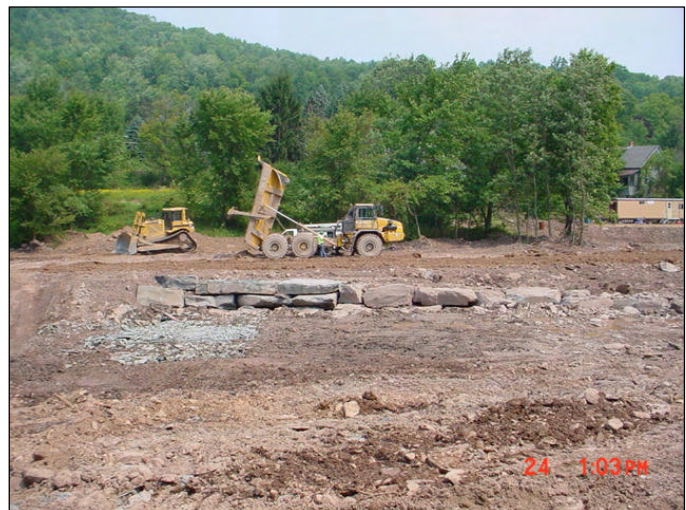
**Completed arm of the downstream cross vane.**

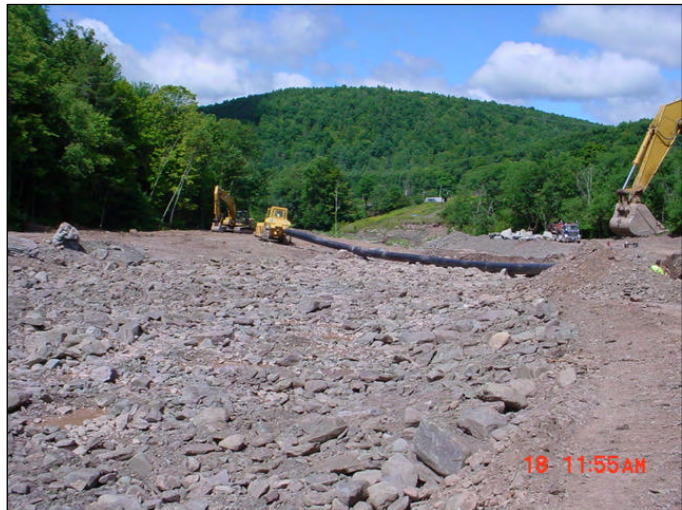
**Section of the constructed riffle displaying salvaged and seeded coarser substrate.**

A constructed riffle was proposed as a component of the channel design. Construction of the riffle required that select coarse material be collected from the existing stream channel and installed to grade in the location of the proposed riffle. The riffle materials were collected and hauled to the riffle location on a time and materials basis according to the equipment and labor rates provided by the contractor as a component of the bidding process. The materials were then installed to the design grades and elevations as a component of Primary Bid Item #3 – Stream Channel Excavation.

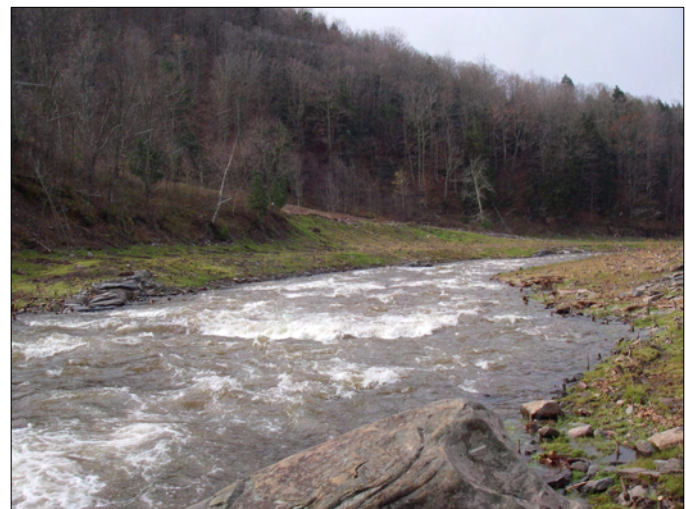
**Upstream cross vane during high flow event.**
