Long Road Stream Restoration Project

Assessment, Design & Implementation Report

Town of Lexington, Greene County, New York

Report Date: February 2010

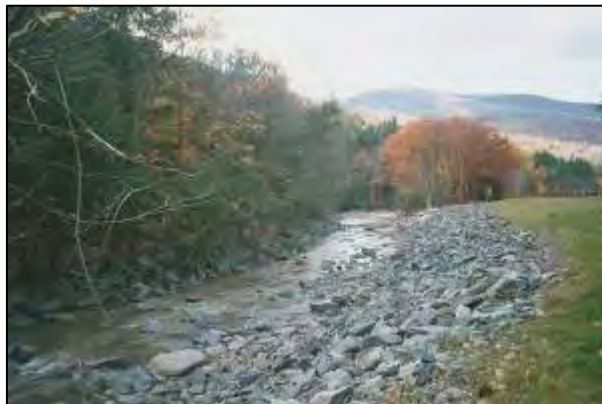
Channel planform in the reach is controlled to a large extent by the road embankment of County Route 6 on the right bank and the valley wall on the left bank.

Planform constrained by infrastructure and landform.

The existing sinuosity of the project reach was 1.09, considered low within Rosgen classification system for natural “F” or “B” stream reaches. The average wavelength was 1,600 feet and measures of radius of curvatures were 337, 954, and 587 feet respectively in a downstream direction. The average meander beltwidth through the reach was 312 feet with a meander width ratio of 4.33.

In general the existing beltwidth was truncated through the lower reach due to impingement of the south valley wall and the road embankment to the north. The condition had caused the reach to be historically prone to bank erosion and failure as the channel had attempted to expand its beltwidth. The imposed restriction of the corridor had caused the channel to incise into the landscape. This had resulted in increased bank heights leading to widespread failure of both the road embankment and the valley wall.

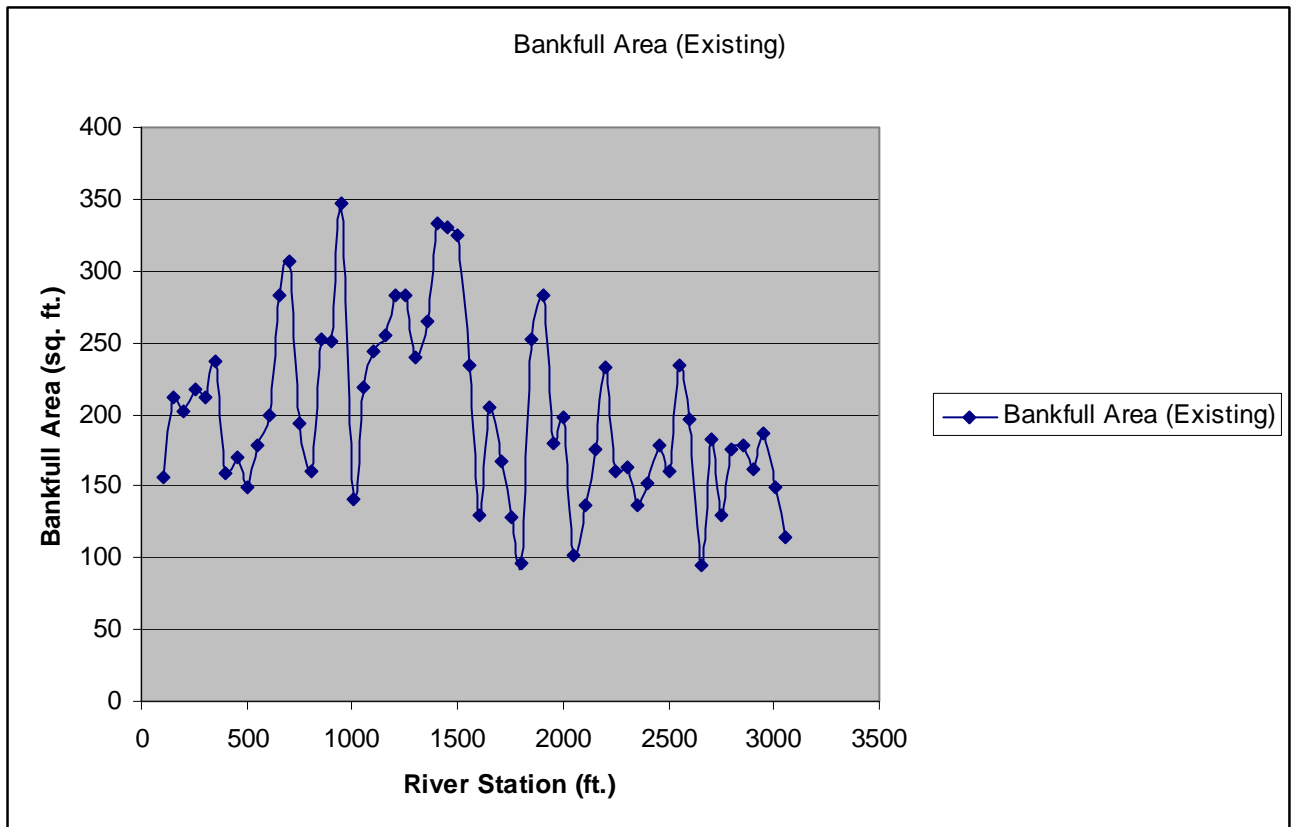
Bankfull flow areas for the reach averaged 201 square feet, and were highly variable, ranging from 95 to 348 feet². Bankfull width averaged 67 feet and hydraulic depth was 3.1 feet. Channel width to depth ratios averaged 25 indicating relatively normal width conditions under this flow condition. It is suspected that these values were heavily influenced by confinement of the channel width, and may result in sediment transport over competence considering the steep slope of the project reach.

Figure 2. Bankfull existing cross sectional area through the project reach.

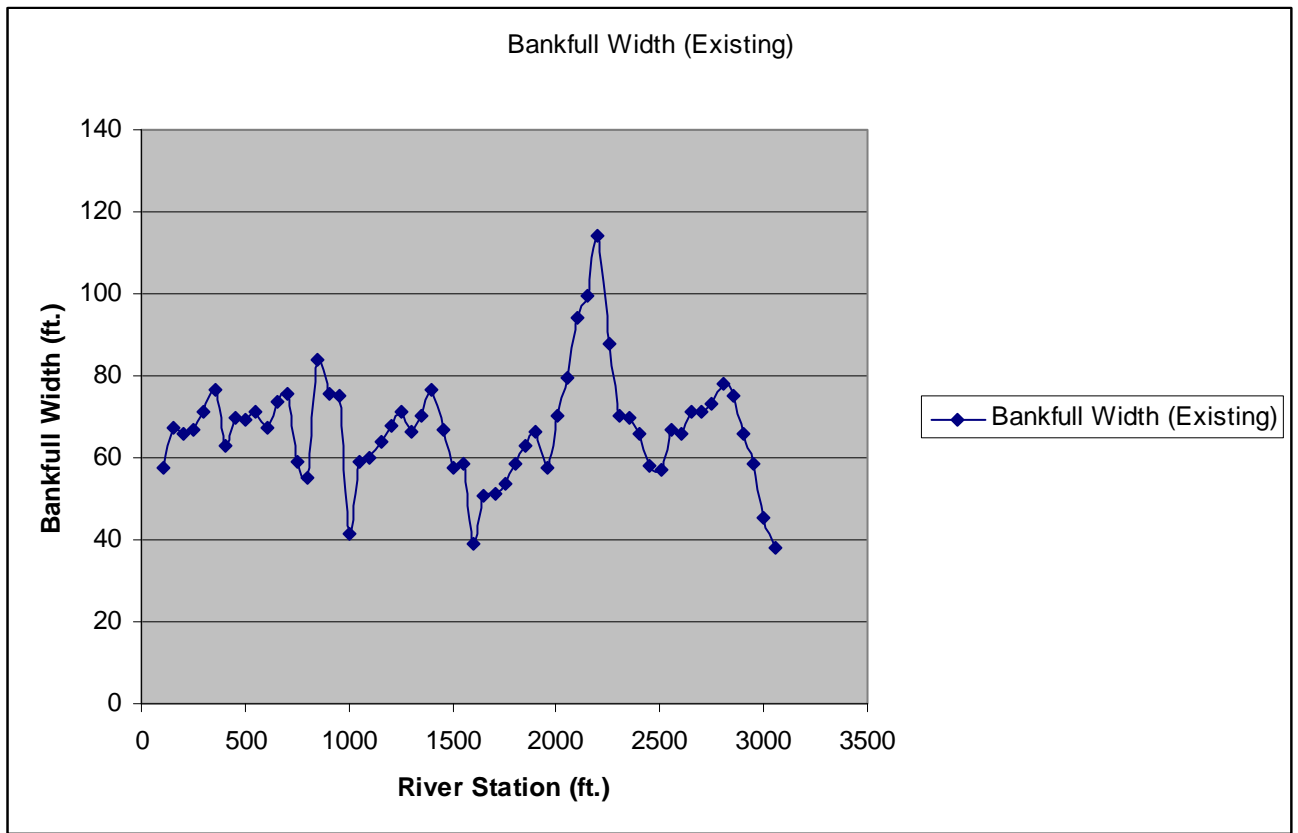
Figure 3. Bankfull channel existing width through the project reach.

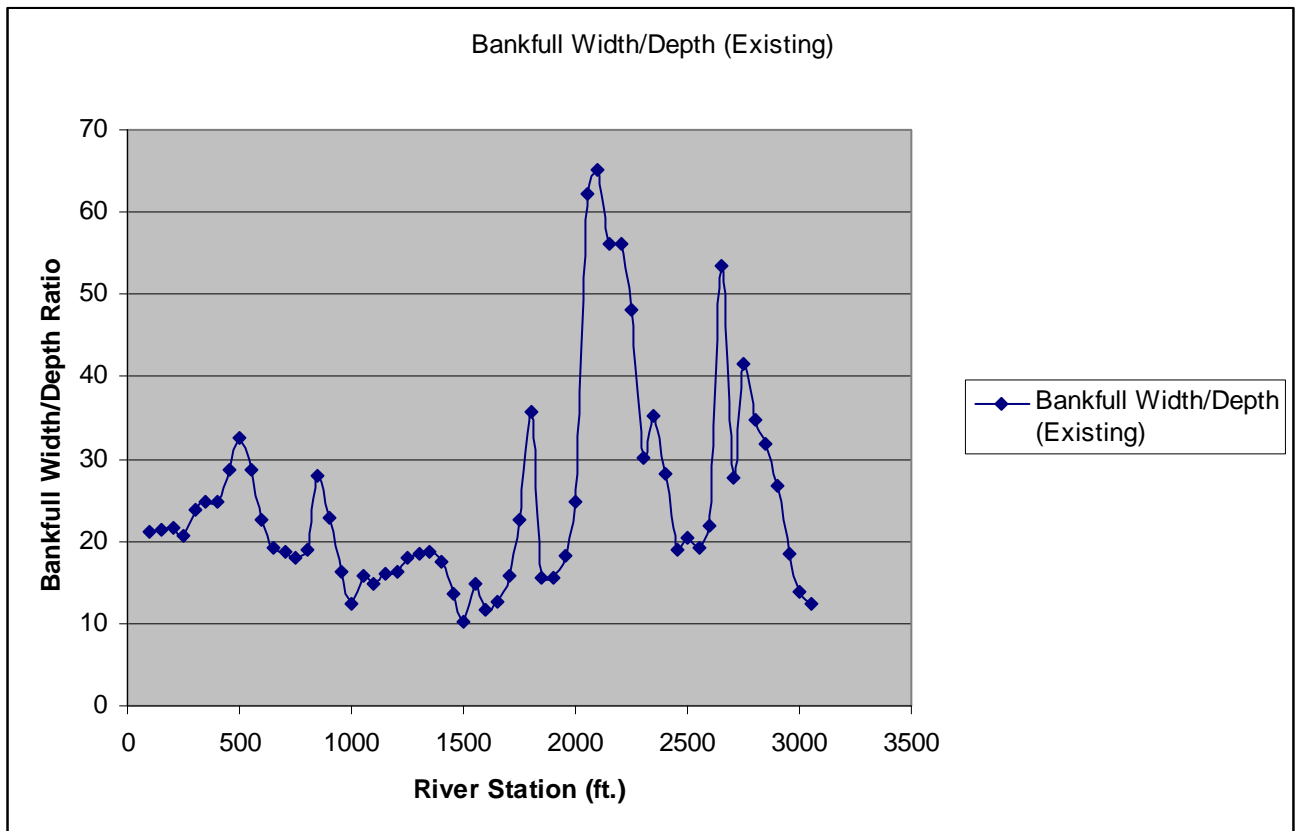
Figure 4. Bankfull channel existing width to depth ratio through the project reach.

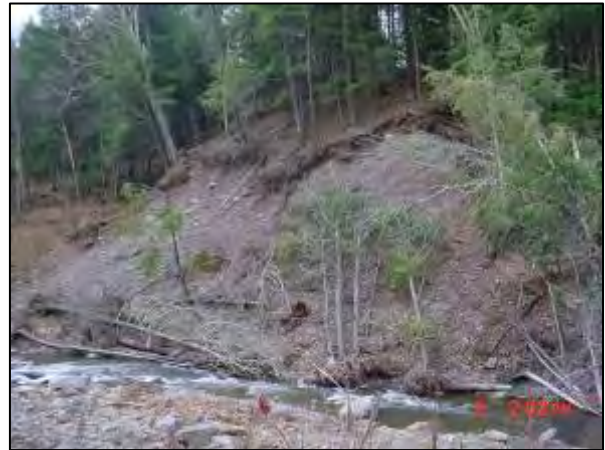
Bank failure can occur in various modes depending on the bank soil properties and the morphology of the stream. Bank failure modes include shallow, planar, rotational and cantilever type failures. The most common type of bank failure results from removal of soil from the channel toe (undermining) and subsequent slope failure.

Erosion and failure of high bank.

Shallow, planar and cantilever failures were all identified within the project reach. These failures were addressed by the installation of stable bank geometry achieved through bank slope and/or height reductions.

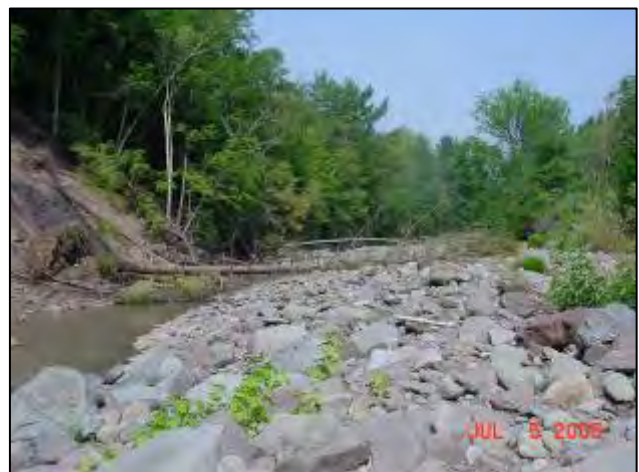
View looking downstream at bank failure and cobble bar.

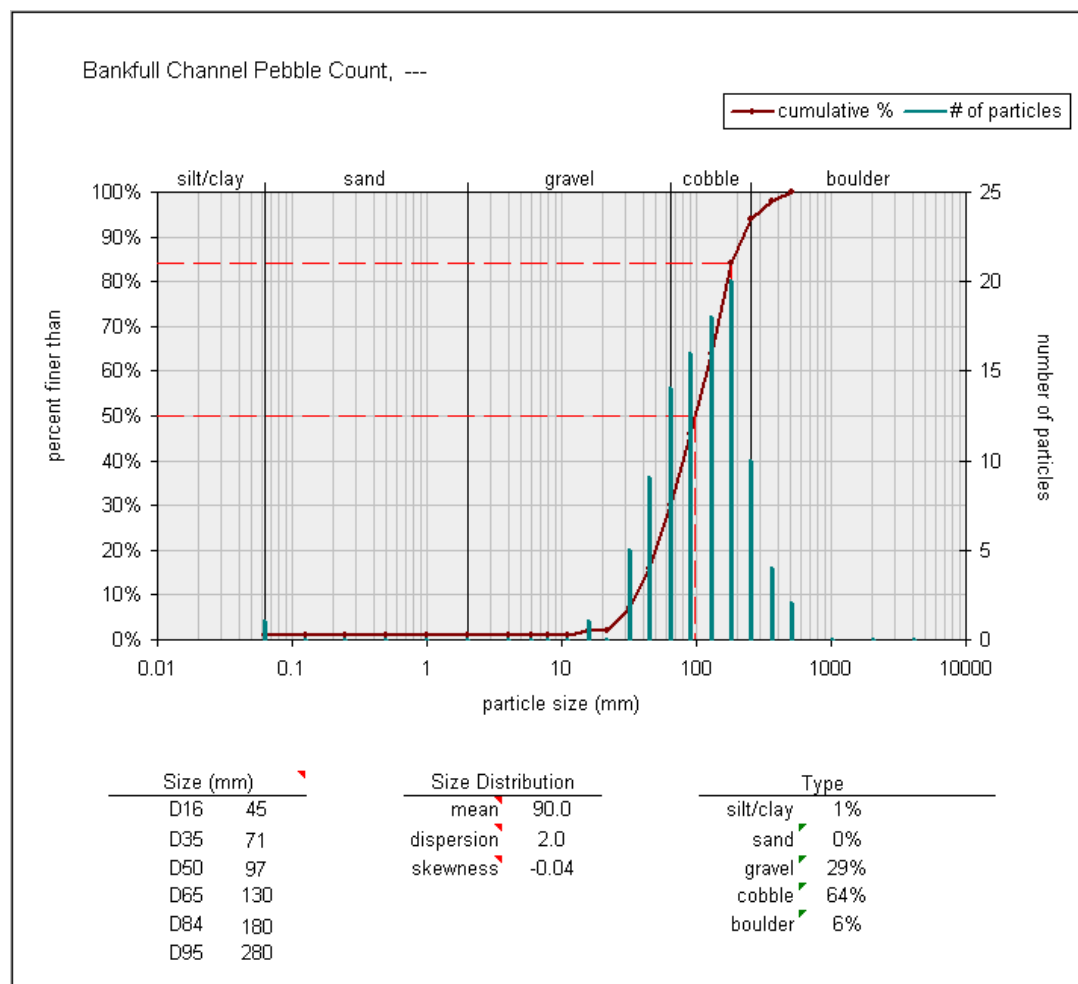
The pebble count distribution in **Figure 5** reveals the predominant material found in the riffle was in the medium cobble size range (D50=97mm) with large portion of the sample in the large cobble class. 6% of materials were boulders and 84% of the sample was estimated to be smaller than 180 mm. The gradation of materials was moderately well sorted containing a large portion of grain sizes in the cobble class (dispersion 2.0). The distribution was considered normal and negatively skewed with a geometric mean of 90 mm and a D50 of 97 mm. Sample materials were generally well rounded and not well imbricated.

Figure 5. Representative bankfull sediment distribution at a riffle section.

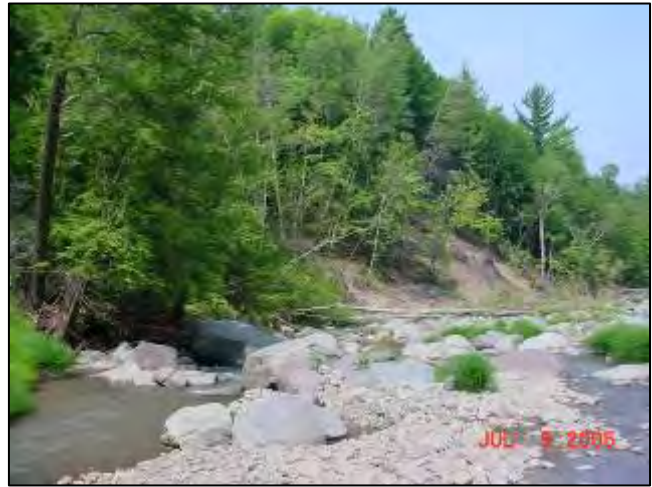
Bank erosion and failure in project reach.

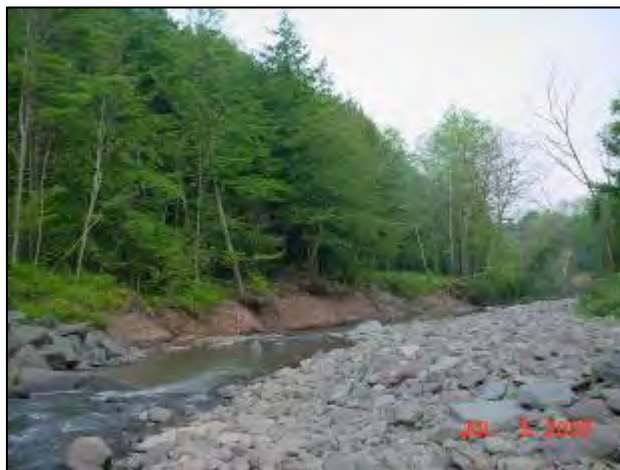
Image of bank erosion and associated cobble bar.

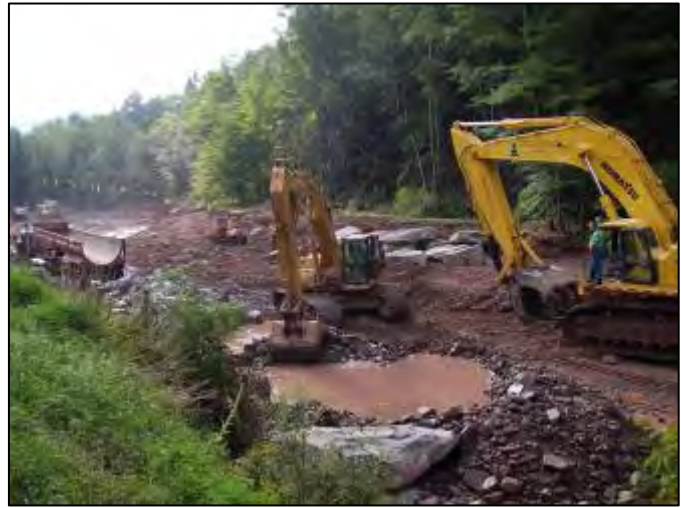
Phase I stream channel excavation.

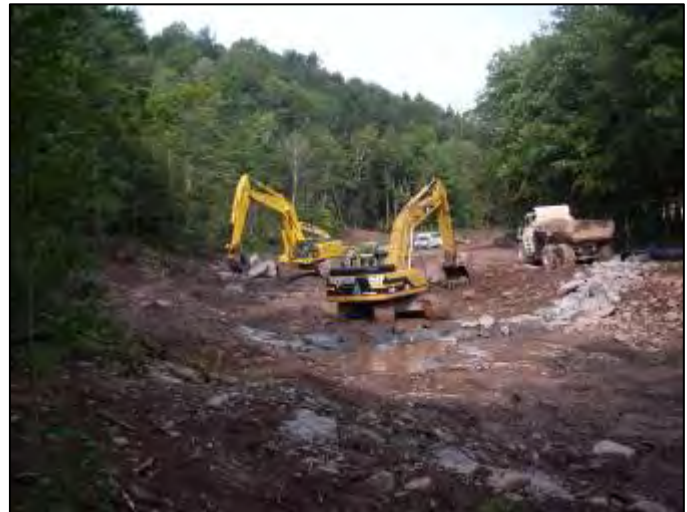
Phase I stream channel excavation.

Stream channel excavation results in disturbance of significant land area. This portion of the project implementation was scheduled in phases to minimize the land area vulnerable to erosion at all times. The phased approach to the excavation work was an effective

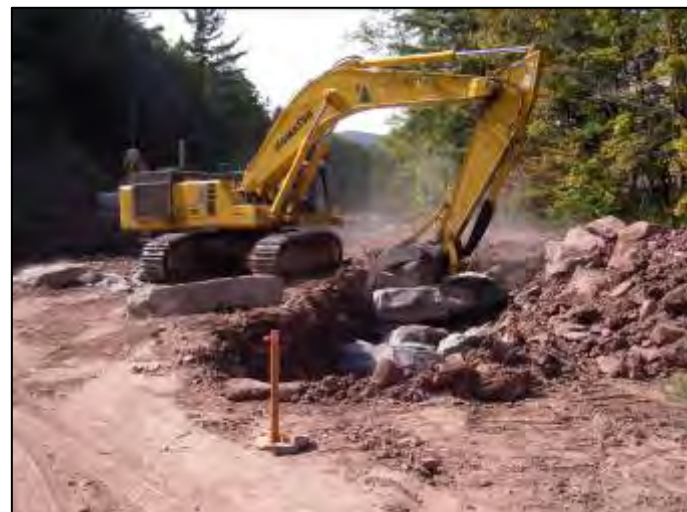
Excavation and construction of a cross vane arm near the center of project reach.

This bid item covered all aspects of in-stream and floodplain stream stabilization rock structures. This item was bid on a unit price basis using rock tonnage as the measure for payment. The unit bid price included all equipment, labor, fuel and other expenses necessary to obtain and install the rock material as specified in the project documents.

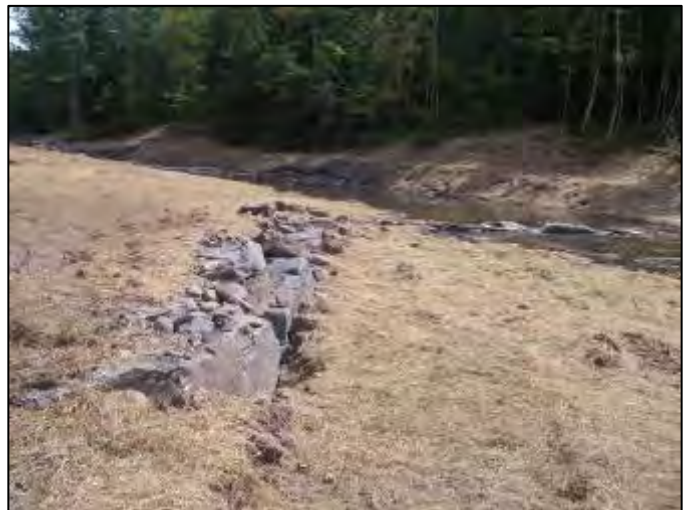
Completed cross vane in upper reach of project.

Monitoring and maintenance decisions for this project should be especially sensitive to evidence of incision into the bed and failure of any of the vertical control measures installed to ensure profile stability in the reach.

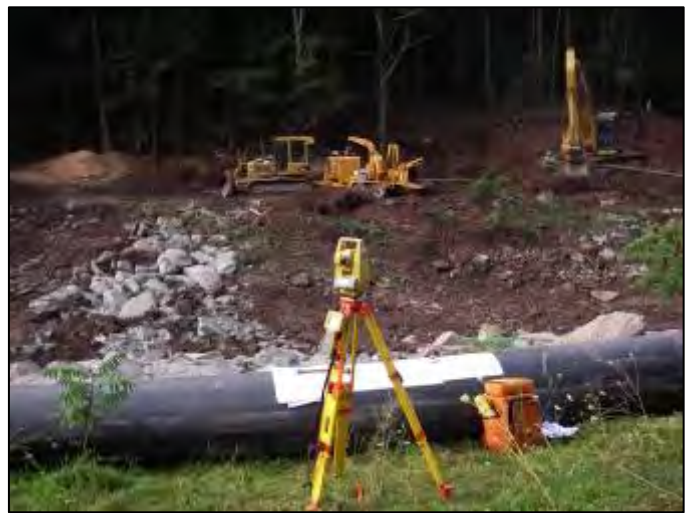
Clearing and grubbing of Phase II.

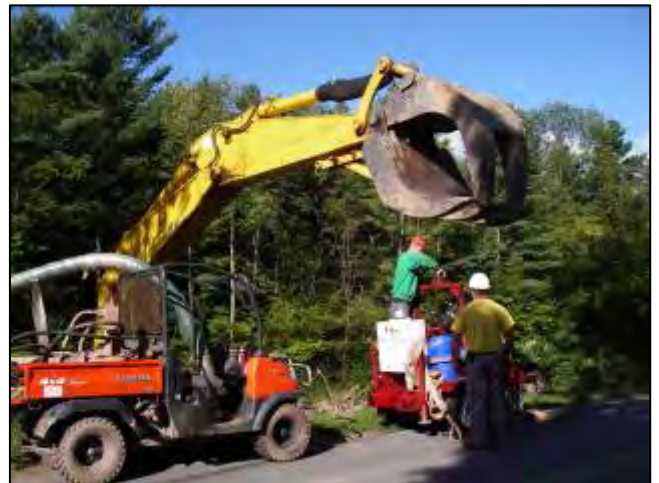
Installation of turbidity control equipment.

Dewatering for the project was provided by GCSWCD. Installation of the provided equipment was completed on a time and materials basis according to the equipment and labor rates provided by the contractor as a component of the bidding process. This included assembly of the dewatering pipeline, installation of the pumping equipment, relocation of the equipment as necessary to complete the project, and removal of the equipment and pipeline upon completion of the project.

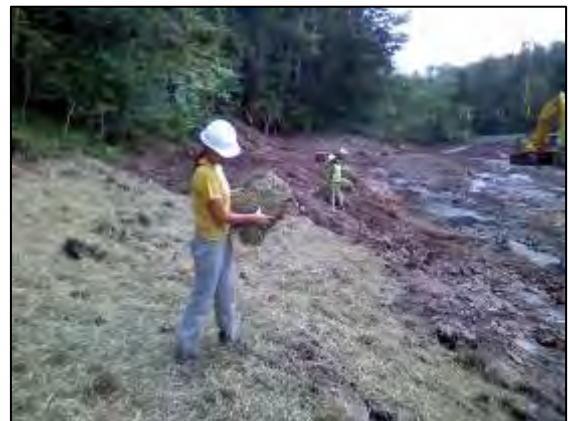
Seeding and Mulching.

All disturbed areas were temporarily stabilized with seed and mulch as soon as possible to minimize soil erosion. On average, disturbed areas were open for less than 14 days total. The sediment control measures ensured that the minimum practicable amount of turbid water discharged from the work area.
