Prattsville Berm Removal Project

6.0 Project Status: Flood Event Inspection (April 22, 2005)

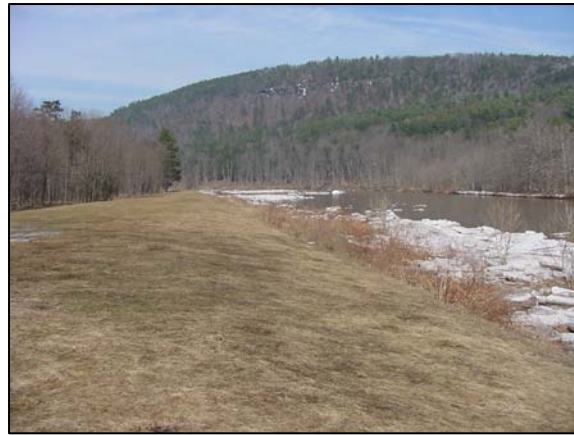
In 1979, a 10ft high gravel berm had been constructed along the left streambank of the Schoharie Creek. This berm restricted flood water from accessing available floodplain beyond the berm and appeared to exacerbate ice jamming on the Schoharie Creek, causing flooding problems within the hamlet of Prattsville. This berm had caused stream channel to be uncharacteristically entrenched. A high channel width to depth ratio in the reach promoted deposition in the channel. Deposition can promote lodging and adhesion of ice to the bed and formation of ice jams. The top of the berm was at an elevation higher than the road and homes on the east side of the stream causing flood water to encroach on the adjacent homes and roadway before flowing onto its natural floodplain on the east side of the creek.

*Prattsville flood remediation project
pre-construction*

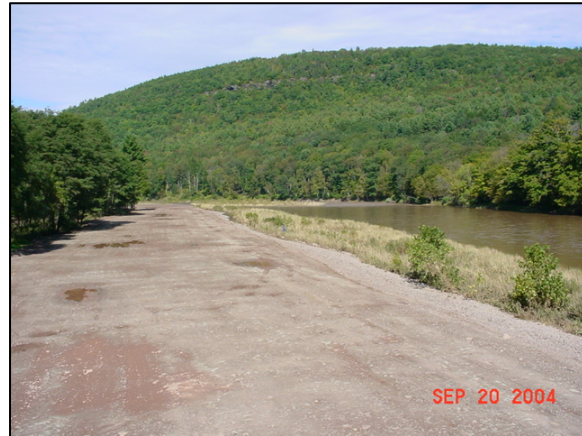
In 2004, GCSWCD and the Prattsville Highway Department completed the project by re-grading the berm to match the elevation of the existing floodplain, in order to allow flood water to access the natural floodplain. The natural floodplain can also act as an ice storage area during large seasonal flow events and provide a release for flood water in the event of a localized ice jam. Construction encompassed approximately 2,200 feet of streambank along the western floodplain of the Schoharie Creek

*Prattsville flood remediation project
post construction*

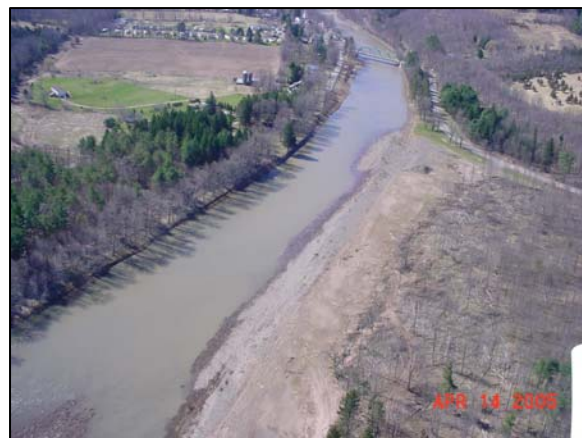
*Prattsville flood remediation project
post-flood*

Flood flow crested the left streambank and former berm area to a stage several feet above the floodplain elevation. Extensive amounts of debris and large woody material were deposited throughout the floodplain. Numerous tree tops, which remained from the recent logging operation, were intermixed with the flood debris and remain piled throughout the floodplain.

Small isolated areas containing rill type erosion were noted along the top surface of the former berm area. The rill erosion was present only in limited areas where grass had not completely established. In larger sections of the former berm area, a thin layer of sand was deposited.

The streambank experienced minor scour as a result of the flood flow. It is presumed that the bank erosion would have been partially if not entirely mitigated if the vegetation had been able to establish prior to the increased stresses caused by the flood event.

The existing defined floodway, which bisects the access road, had significantly deeper flows which resulted in the deposition of coarse gravel and cobble near the entrance to the project. There were no signs of erosion or scour present in the floodway upstream of downstream from the access road.

- As-built surveys have not been completed for the project site. The as-built survey should be completed to document the post construction site topography, as a basis of comparison to the design, as well as for use in future floodplain modeling.

- Thought should be given to establishing monitoring cross sections at the site to document the stability and dimension of the stream channel.
- Repair to the project site should include reseeding and mulching all exposed areas as well as areas where vegetative establishment has been poor.

- The gravel stockpile should be removed from the project area. Upon removal, the area should be graded as outlined in the project design, seeded and mulched.

- The treetops remaining from the floodplain logging should be removed from the floodplain so as not to exacerbate debris buildup or cause the accumulation of ice. Thought should be given to grinding or chipping the slash material as well as selected woody debris deposited by the flooding.

- Large quantities of Japanese knotweed stems are present in the flood debris. Additionally, active established colonies are located along the downstream section of floodplain. The ability of knotweed to grow or become established from previously cut stems is unknown. The potential re-growth from the cut and dry knotweed should be researched and incorporated into any strategy for reuse of the woody flood debris to prevent the transport and establishment to other areas.

- It is not recommended that former flood channels be connected between the floodplain and stream channel. Excavation of such channels through the former berm area will result in increased velocity and stress within the flood channel requiring the potential need for increased stabilization. It is presumed that these channels would provide an insignificant reduction in flood stage. If required, existing floodplain modeling could be used to determine the impact of constructed channel on the floodwater surface as well as determine the stress in the bypass channels and resultant required stabilization.
