## Reach 1c (County Route 56 Bridge below L.MacGlashen to Peck Road Bridge)

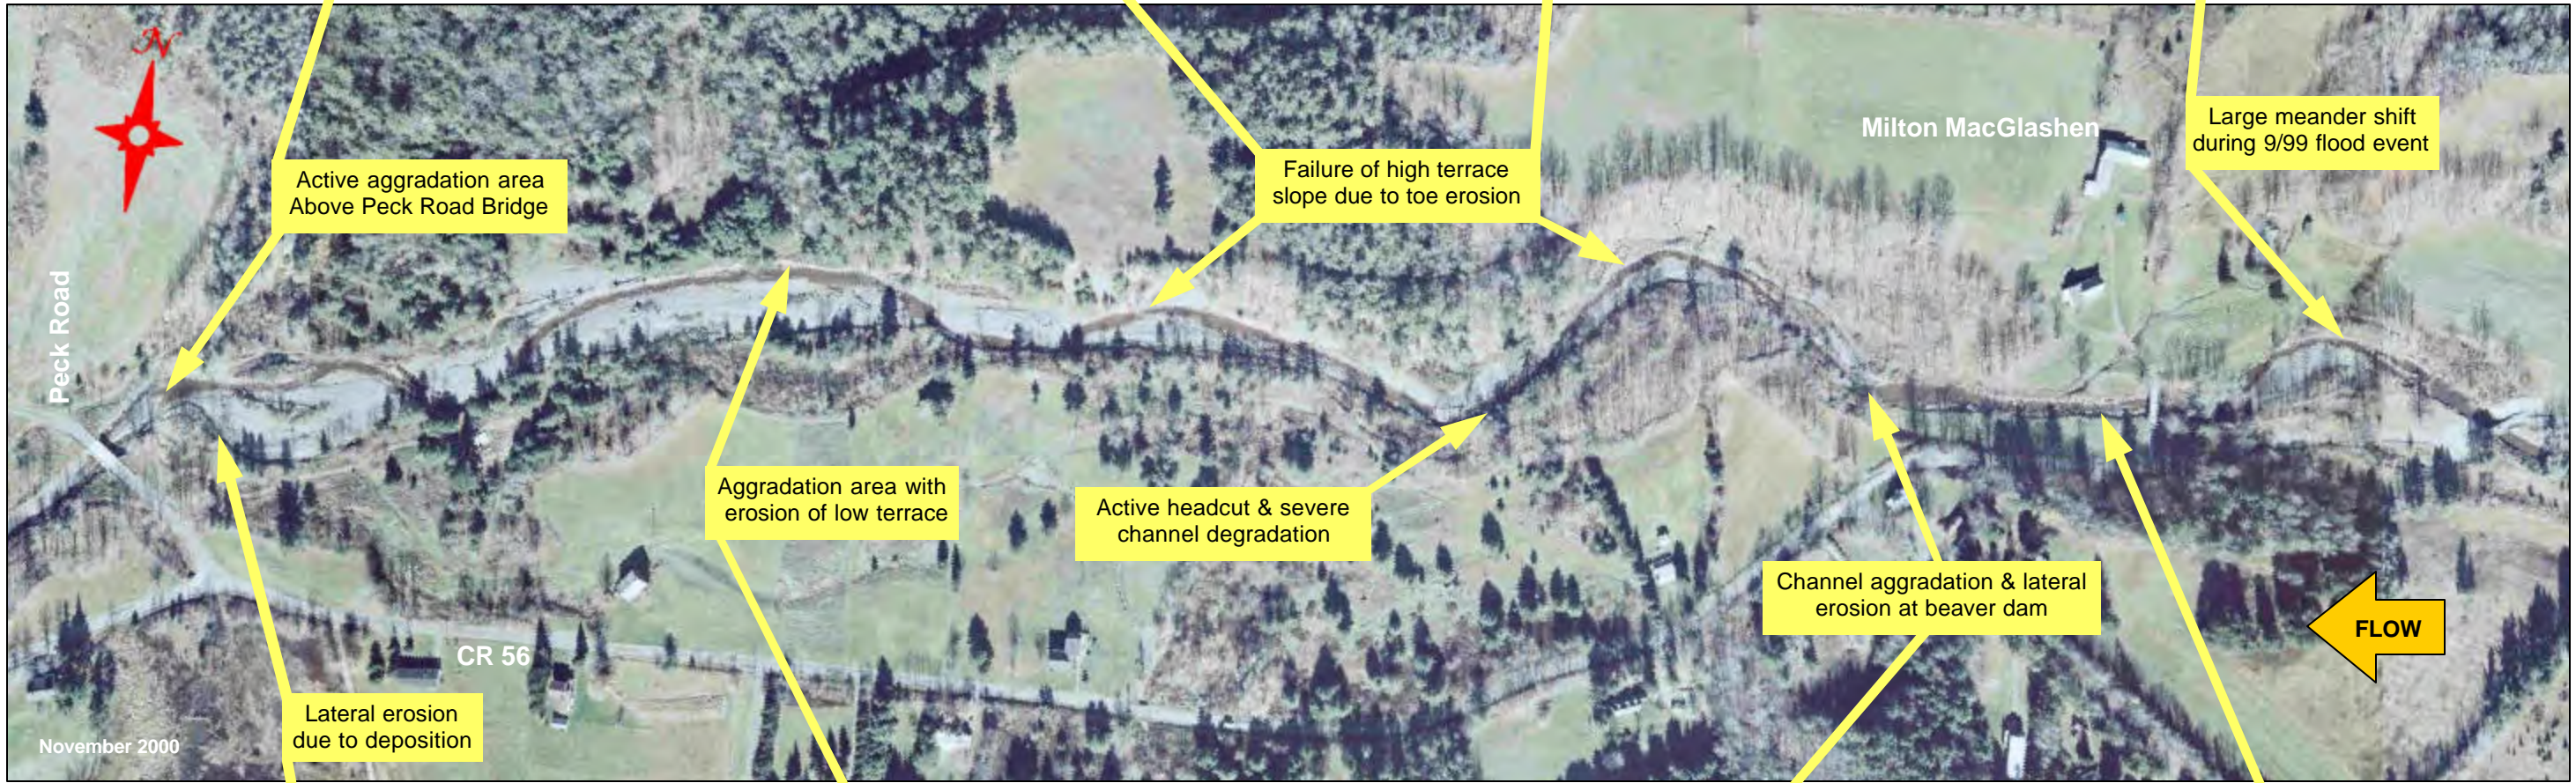
D

The condition of the riparian area in the segment was highly variable. At the head of the segment, much of the riparian area was characterized by open fields, with narrow strips of wooded riparian vegetation (**Figure VI-10, photo A,D,H**). In the lower extent of the reach, the stream was bordered by denser, woody vegetation, however extreme boundary shear stress from channel aggradation and over-widening has resulted in the trees being undercut and lost. While the high terraces in the segment support vegetation at the top of the terrace, and once were stabilized by forest cover, the unstable faces of the terrace are too steep to support bank stabilizing vegetation. The portion of the streambank that is exposed to the erosional forces of the stream is predominantly unprotected by vegetation.
