## D. Chestnut Creek Management Unit 4

### 1. Summary Description

## Chestnut Creek Stream Management Plan

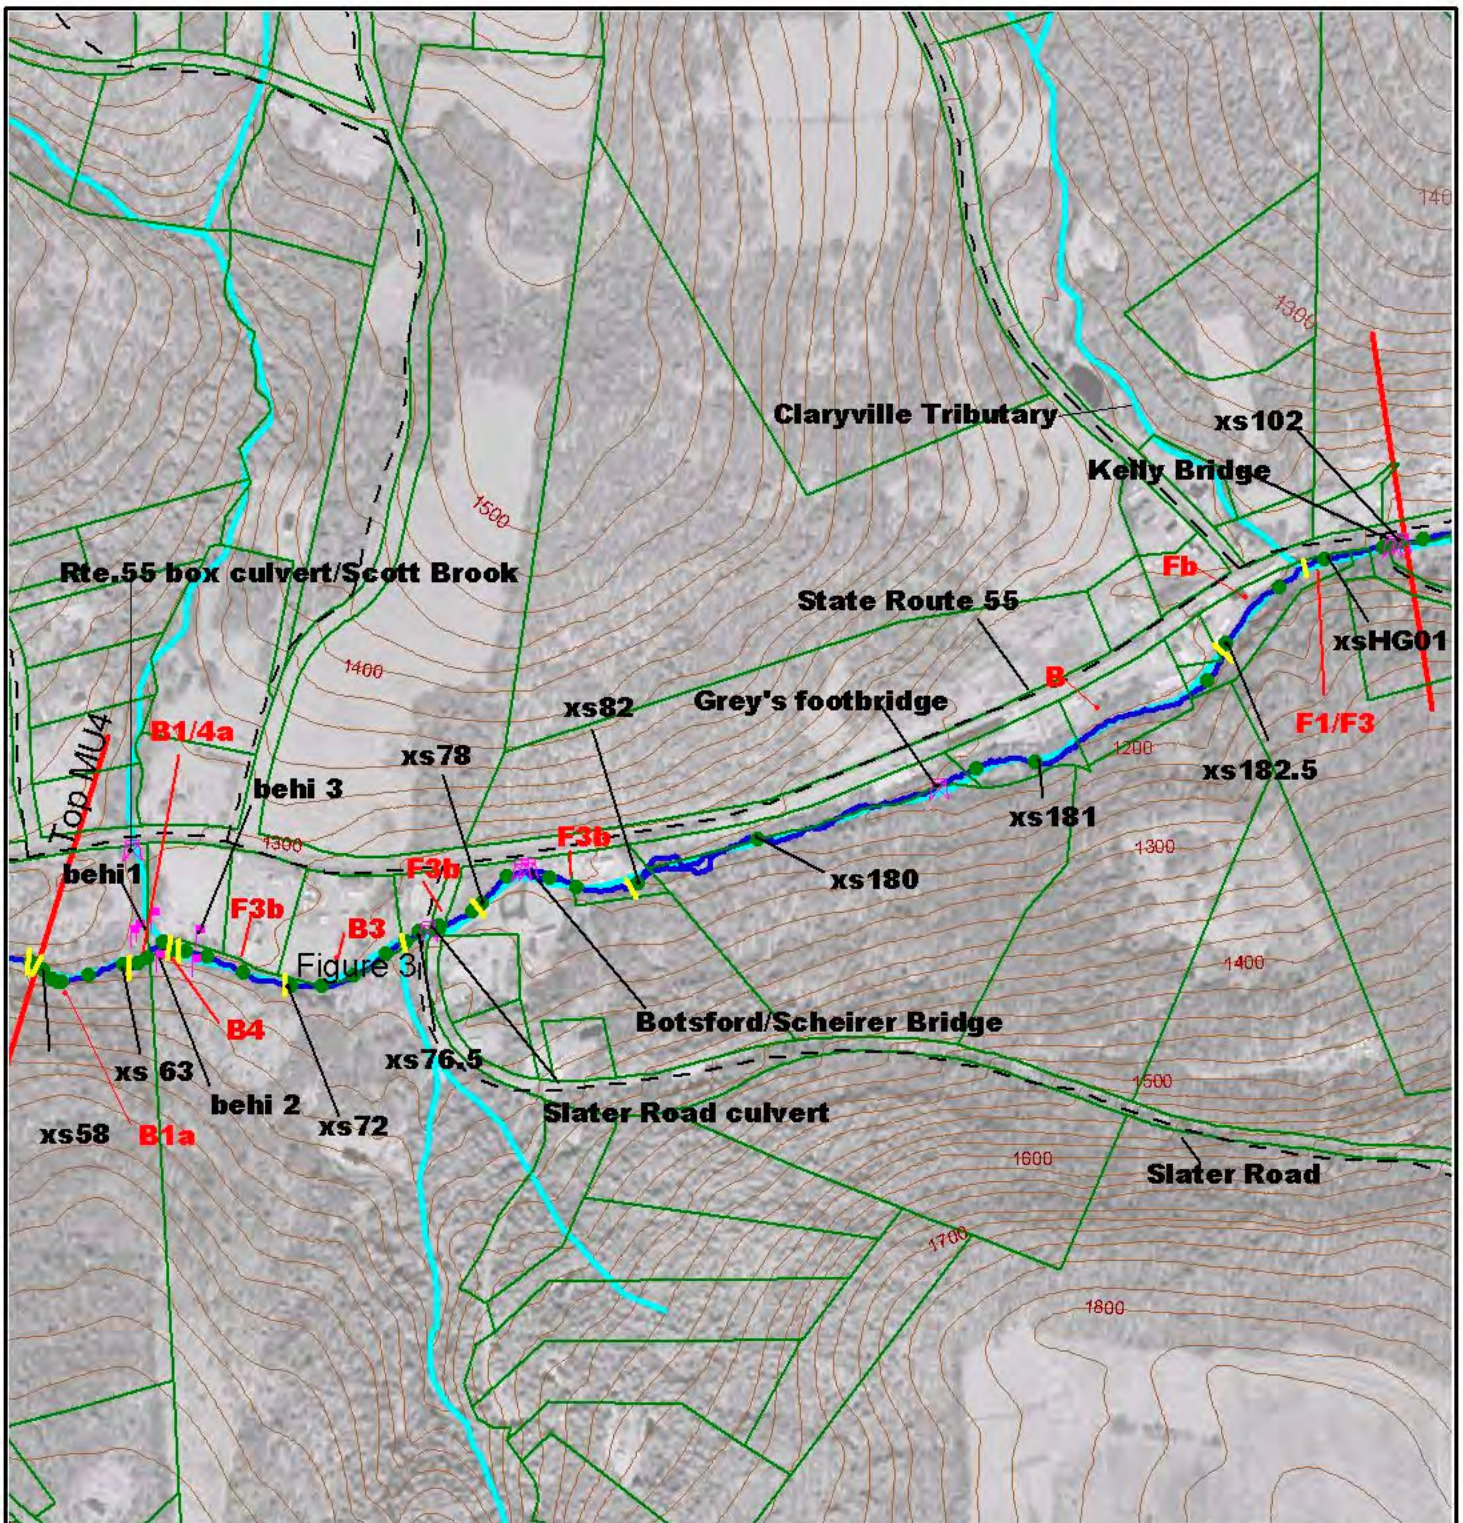
**Figure 2. Chestnut Creek MU4 Stream Types and Cross Sections**

The largest portion (62%) of this unit includes moderately *entrenched* channel B-types. With a low width to depth ratio (i.e., 11 – 16) and mature vegetation on the banks these types of channels tend to be very stable and are generally effective at moving sediment transported from upstream reaches (MU4 Stream Type & Cross Section map, Figure 2).

quickly to downstream reaches where they can contribute to channel instability and flooding. The *morphological* data collected along the reaches is summarized in Table 1 and illustrated in Figure 2.
