East Kill Management Unit 4

Town of Jewett – Station 62465 to Scribner Hollow Road Bridge (Station 51119)

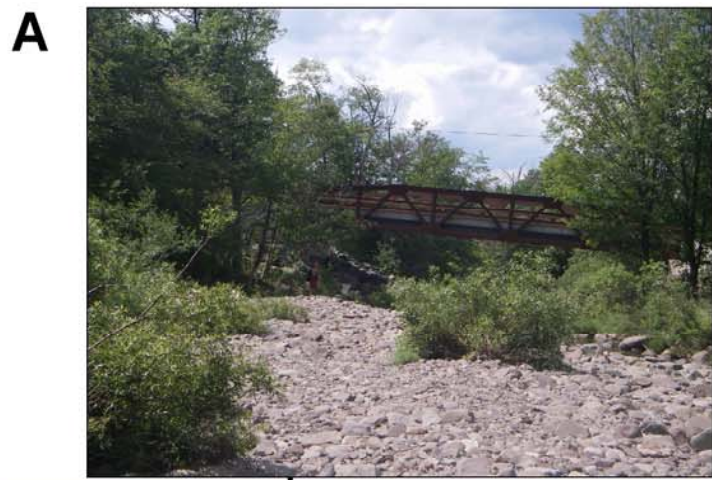
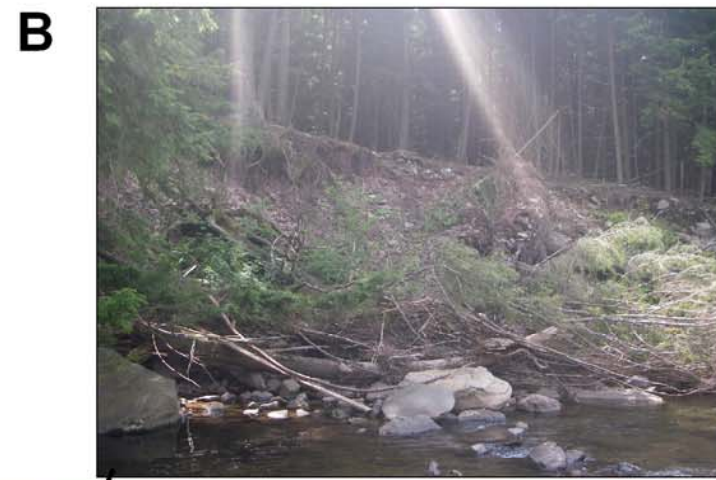
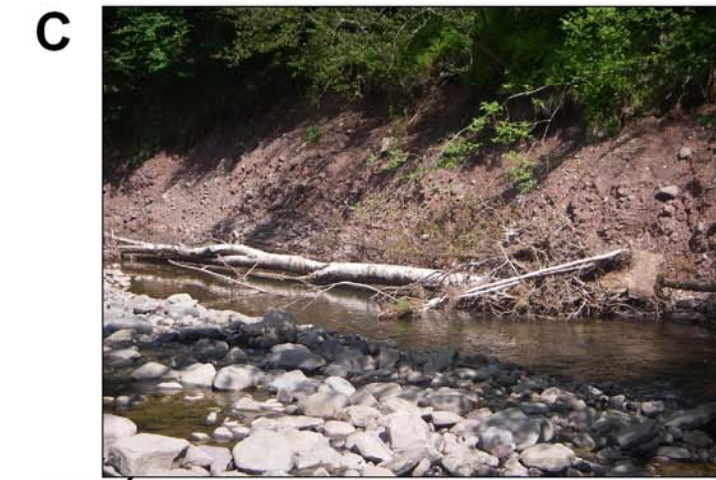
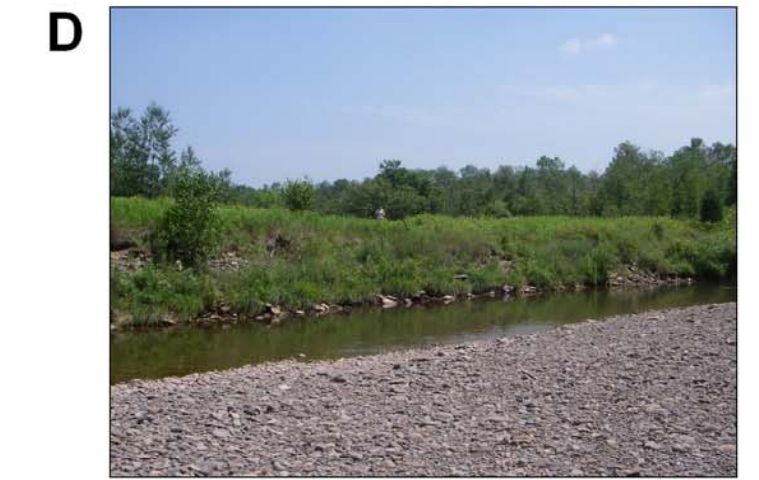
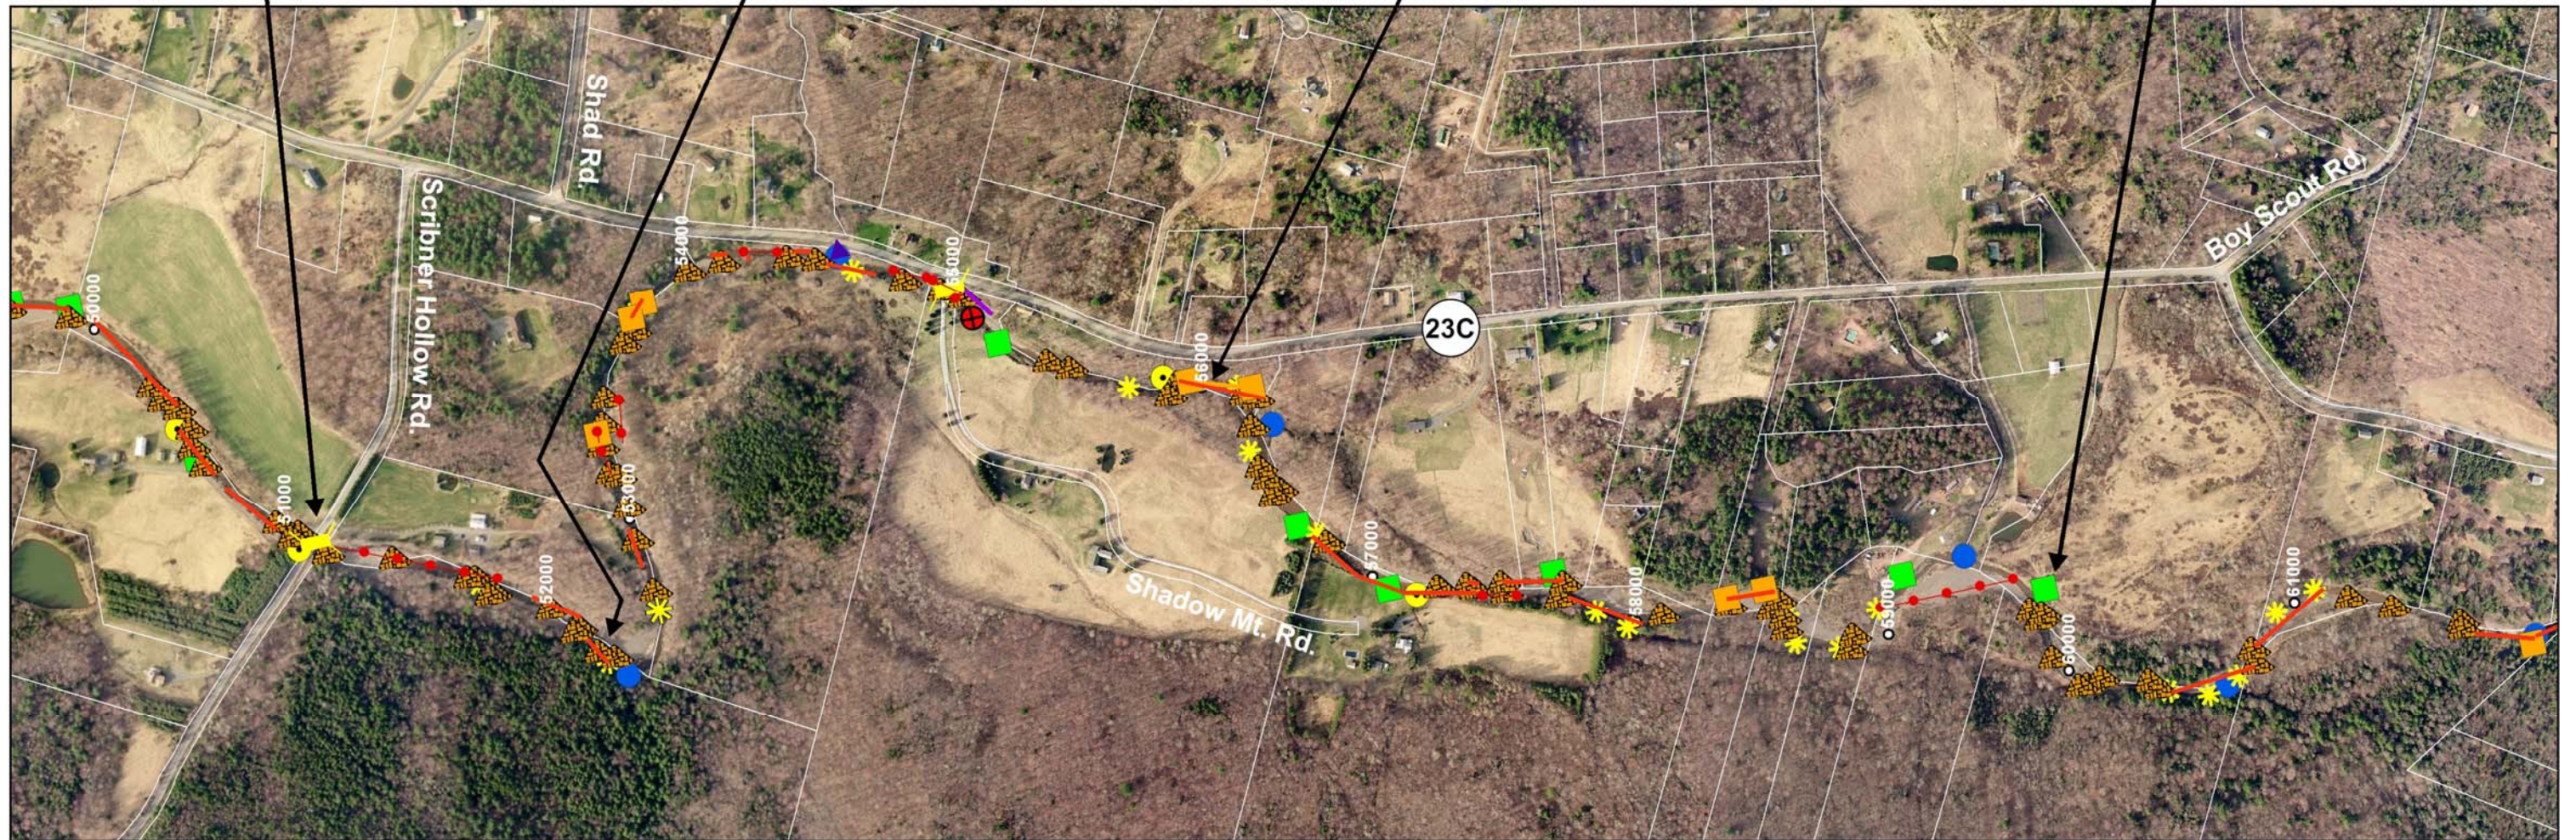
Figure 4.4.1 Management Unit 4 - 2006 aerial photography with stream feature inventory

The 2006 stream feature inventory revealed that 17.4% (3,946 ft.) of the stream banks exhibited signs of active erosion along the 22,693 ft. of total channel length in the unit (Figure 4.4.1). *Revetment* has been installed on 8.8% (1,998 ft.) of the stream banks. One berm, along 0.5% of the stream banks (120 ft.), was identified in this management unit at the time of the stream feature inventory.

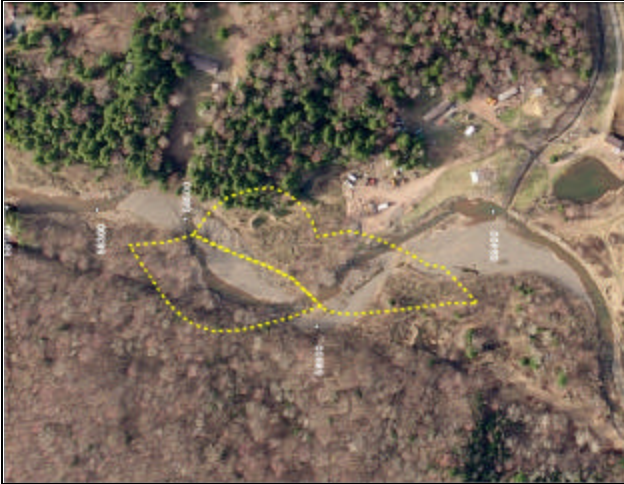
*Wetland boundary approximately delineated by NWI
Stations 49346 - 58386*

on the inside of a meander bend. The tributary that entered from the right bank likely contributed to the excessive aggradation along this stretch of stream. Starting at the downstream end of this point bar, there were two federal wetlands adjacent to each other (Stations 59346 – 58386). The first wetland was 1.8 acres and classified as R3USA, the second one was 1.2 acres and classified as PEM1A (see Section 2.6 for detailed wetland type

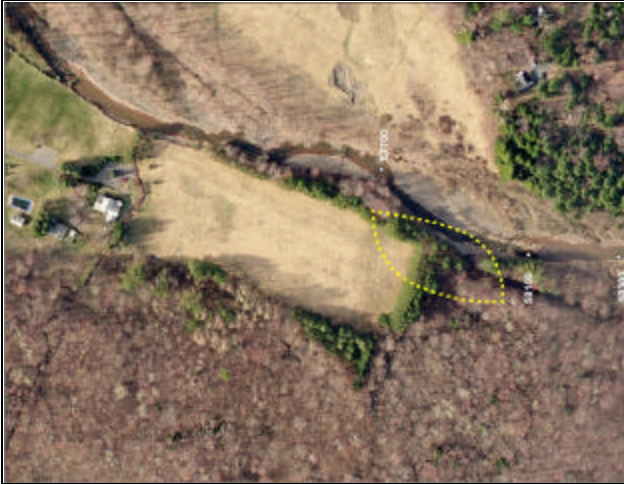
*Wetland boundary approximately delineated by NWI
Stations 58068 - 57721*

Continuing downstream, along the left bank, there was a 0.8 acre federally designated riverine wetland (Stations 58068 – 57721), classified as R3USA (see Section 2.6 for detailed wetland type descriptions). Conditions along this bank were unstable, there was approximately 2,261 ft² of erosion (Stations 58020 – 57737), and two woody debris accumulations along this bank that appeared to contribute to scour at this site.

There was a thin line of trees and shrubs along the top of the eroding stream bank, which provided limited stability or protection from stream flows. Beyond the narrow riparian buffer there was mown lawn. Recommendations for this site include augmentation of existing buffer with the planting of additional native trees and shrubs along the streambank and the upland area. Buffer width should be increased by the greatest amount agreeable to the landowners. Increasing the buffer width to at least 100 feet will increase the buffer functionality by slowing stormwater runoff, filtering pollutants, and protecting the stream from the impacts of nearby land uses. Through the eroding bank, a flood chute (Station 57913) entered from the left with a three foot drop into a scour hole. The location of the channel divergence was not observed at the time of the assessment. Flow exiting the flood chute during high flows likely contributes to, or exacerbates, the erosion along this bank. Due to the influence that the riverine wetland and flood chute have on the stream bank, prior to proceeding with any vegetative plantings, these conditions should be given careful consideration when identifying the appropriate species and locations for plantings.

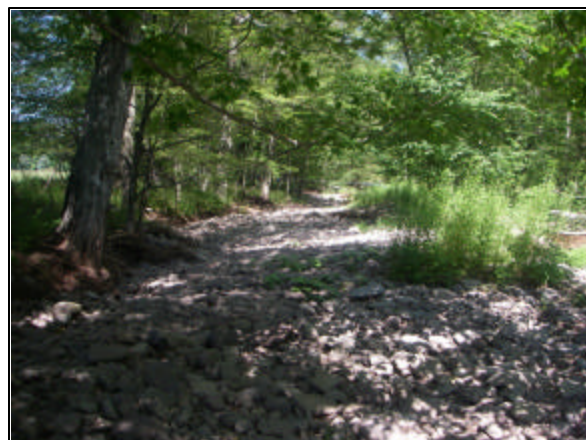
Flood chute at Station 56370

Excessive sediment deposition (Stations 56600 -55000) continued for approximately 1,600 feet, until the stream flowed under the Shadow Mountain Road Bridge, with multiple side and point bars along the left and right channel bed. There were also multiple woody debris obstructions through this stretch of stream. As the stream meandered to the right, there was a channel divergence on the left bank where a flood chute (Station 56370) split off from the main channel. The flood chute continued for approximately 389 feet until its convergence with the main channel (Station 55842). At the confluence of the flood chute with the East Kill, there was excessive sediment deposition, which was contributing to the aggradational conditions along this reach of the stream.

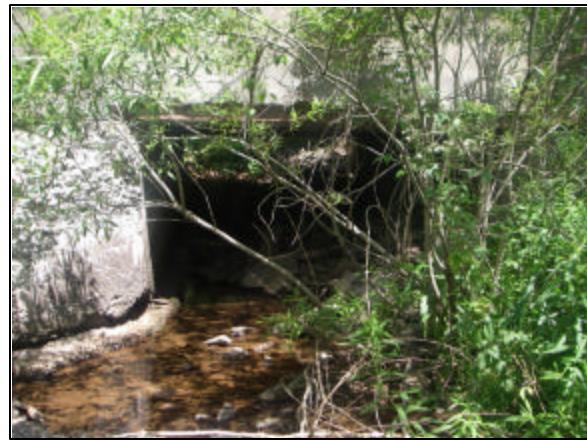
*Tributary flow through culvert at Station 55459
photo orientation – looking at*

On the right stream bank, there was a root wad among woody debris that had accumulated beside the bank, just before a small unnamed tributary flowed through a culvert (Station 55459) under State Route 23C. Just downstream of the tributary there was some minor scour causing an undercut bank (Stations 54476 – 54452) on the right for approximately 62 feet. Opposite the erosion, there was a point bar along the left bed of the stream, with large boulders and sedges.

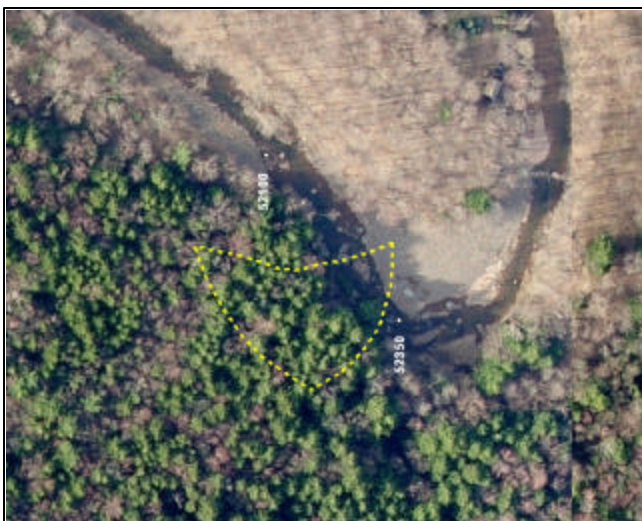
*Wetland boundary approximately delineated by NWI
Stations 52329 - 52121*

Just downstream from the tributary, there was a 0.5 acre federally designated wetland (Stations 52329 - 52121). The riverine wetland was classified as R3USA (see Section 2.6 for detailed wetland type descriptions). Along this section of stream excessive sediment had

deposited, forming a transverse bar, and woody debris had accumulated along the eroding left stream bank.

The left bank was located on the outside of a meander bend, where stream velocity is greatest during high flows, and the thalweg flowed up against the bank, compromising bank stability and resulting in a mass failure (Stations 52289 – 52178, Figure 4.4.1 Inset B).

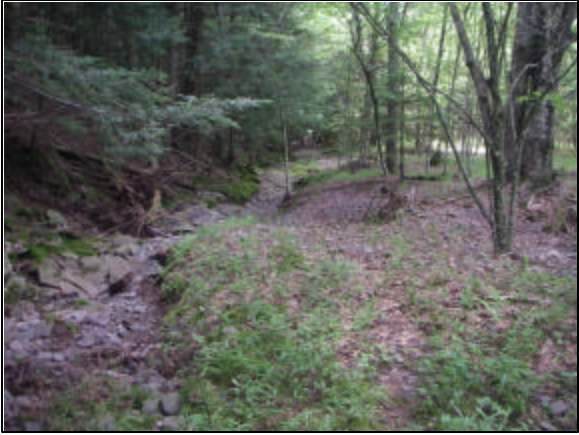
Flood chute at Stations 52086 - 51334

Downstream of the mass failure, excessive sediment deposition continued to the Scribner Hollow Road Bridge including side, center and transverse bars, as well as full channel aggradation. Along the left bank, there was a channel divergence (Station 52086) where a flood chute split off from the main channel. This secondary channel received intermittent flows during periods of high water and flowed through a forested floodplain for approximately 730 feet until it converged (Station 51334) with the East Kill.
