Schoharie Creek Management Unit 4

Town of Hunter - Station 138610 to Station 124311

Schoharie Creek Management Unit 4 Stream Feature Inventory

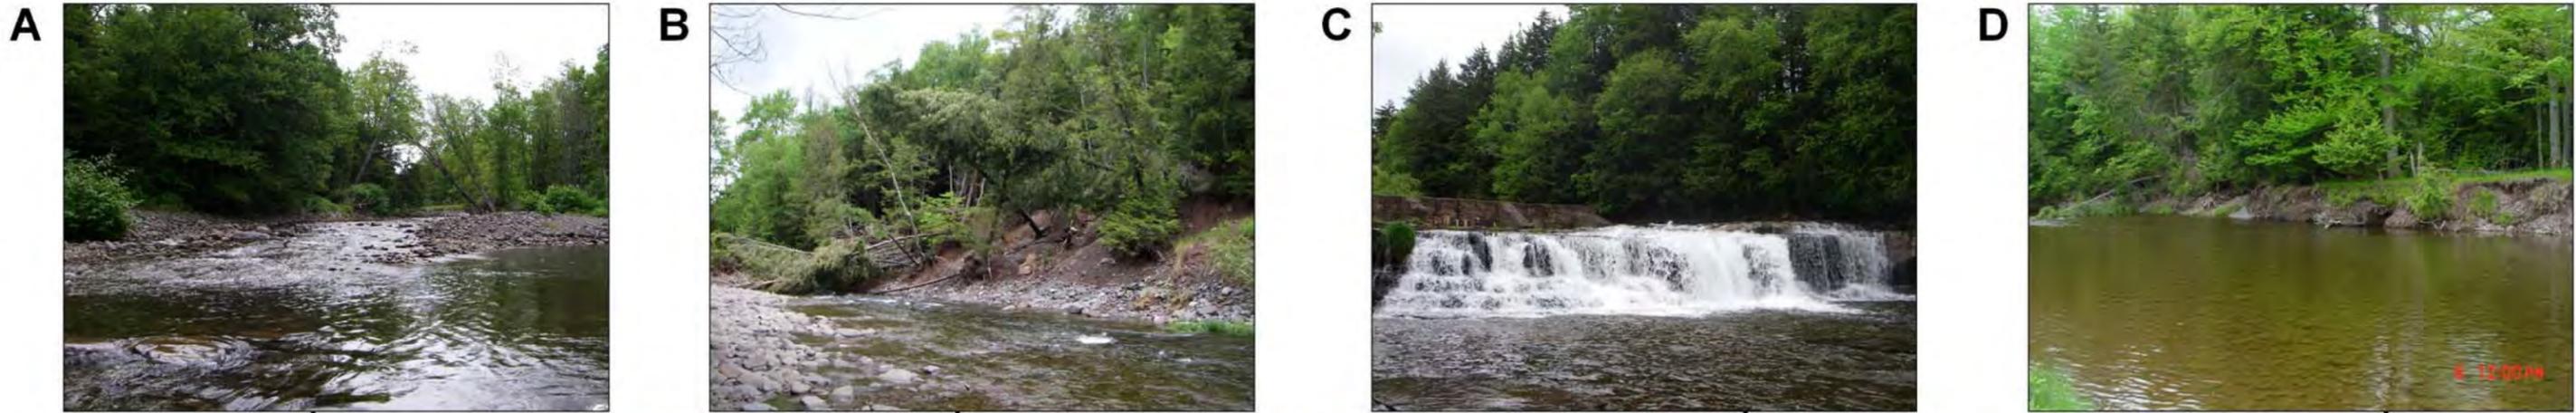
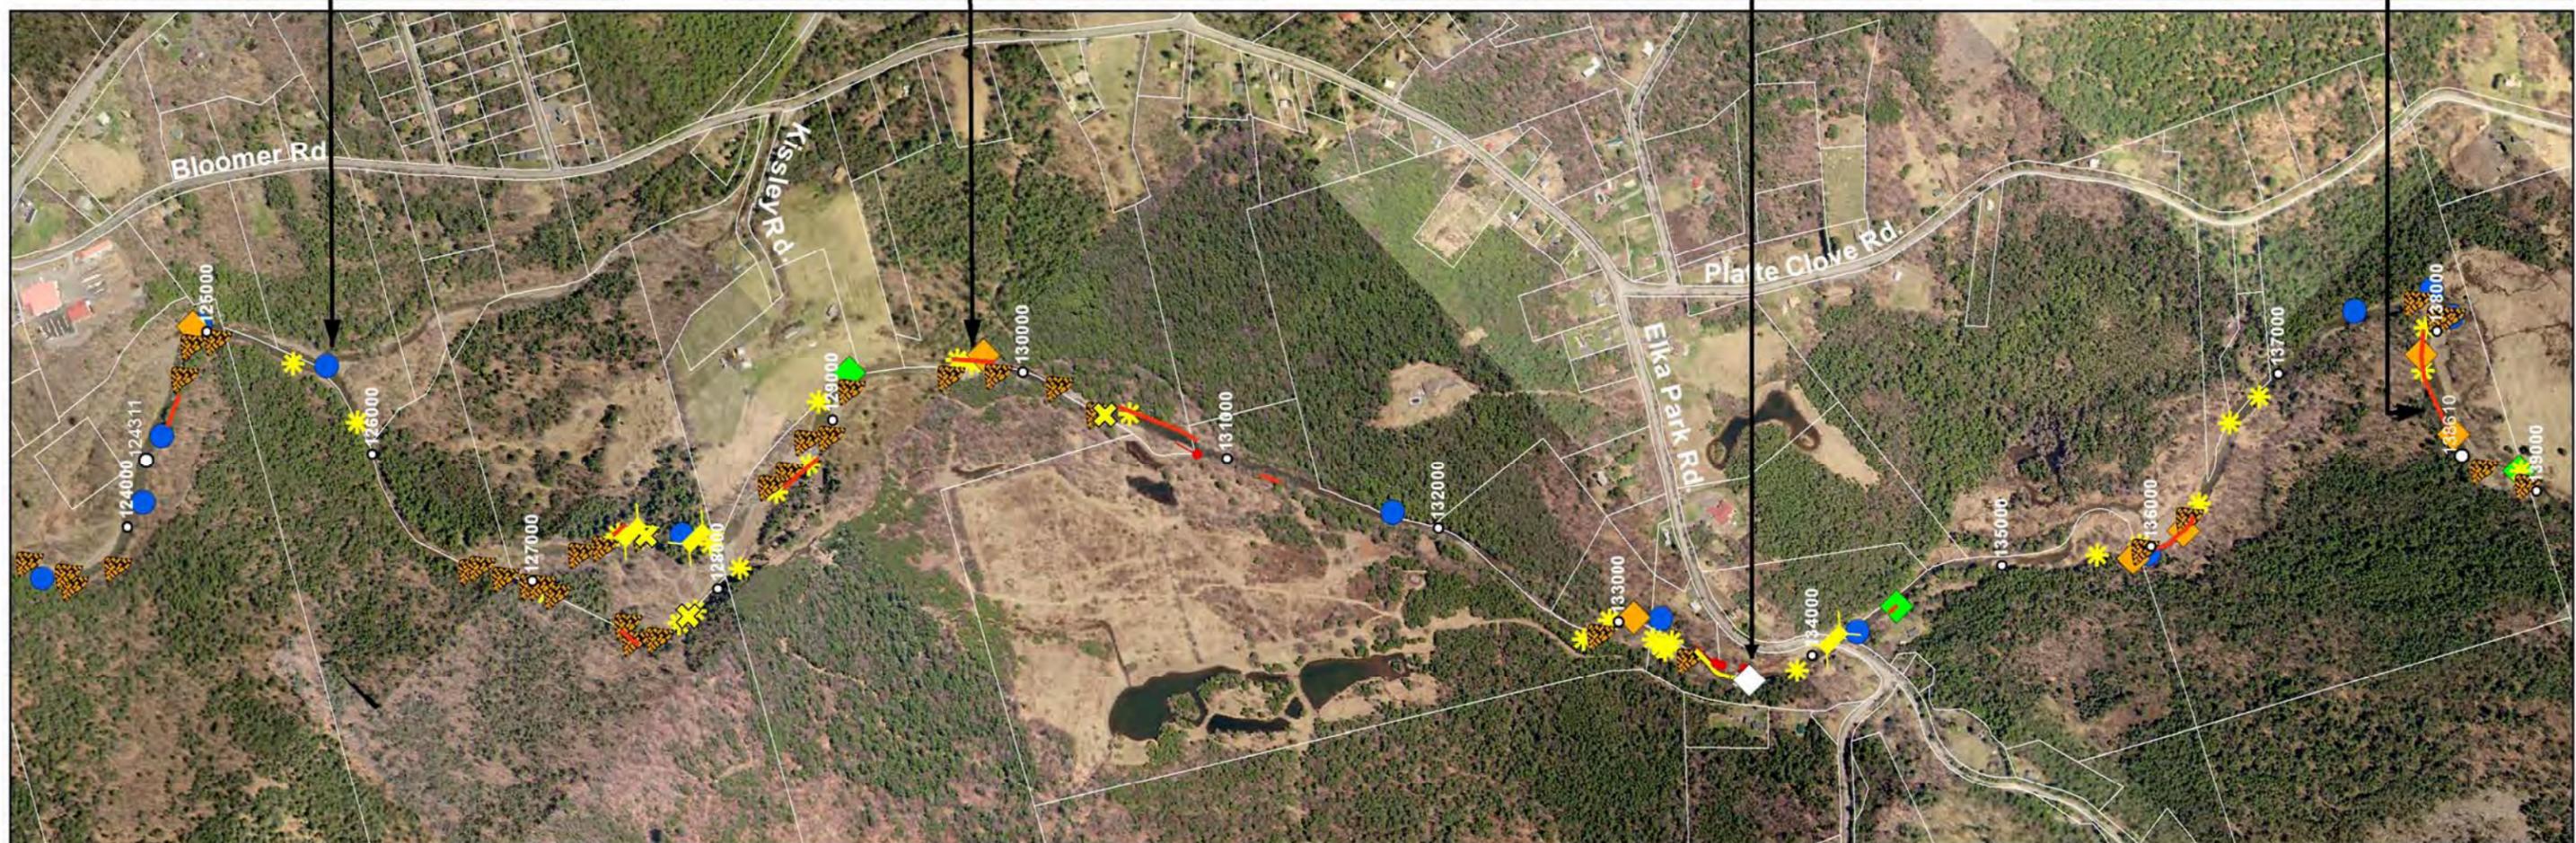
Figure 4.4.1 Management Unit 4 - 2006 aerial photography with stream feature inventory

The 2006 stream feature inventory revealed that 7.1% (2,029 ft.) of the streambanks exhibited signs of active erosion along 28,598 ft. of total channel length (Fig. 4.4.1). The surface area of active erosion totaled approximately 19,343 ft². *Revetment* had been

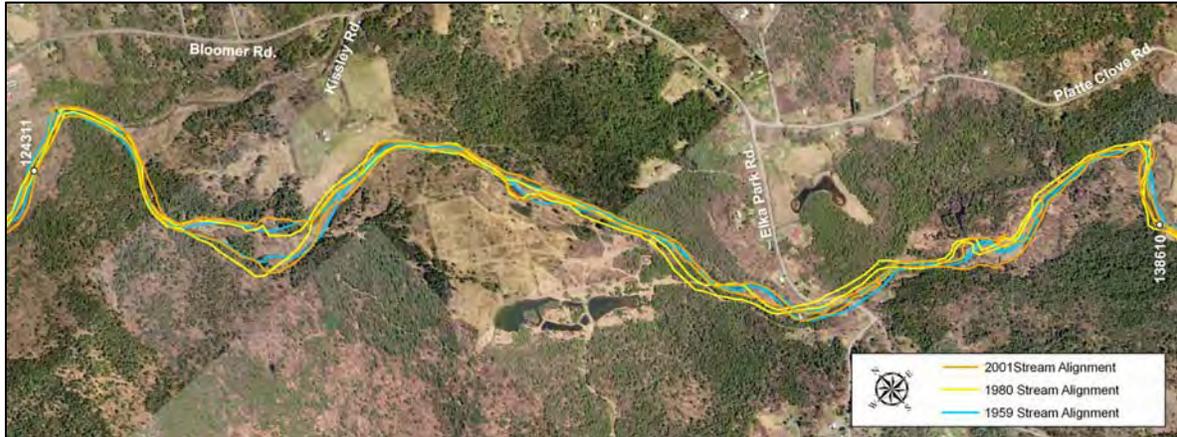
As seen from the historical stream channel alignments (below), the channel alignment has not changed significantly since 1959.

Historic stream channel alignments overlaid with 2006 aerial photograph

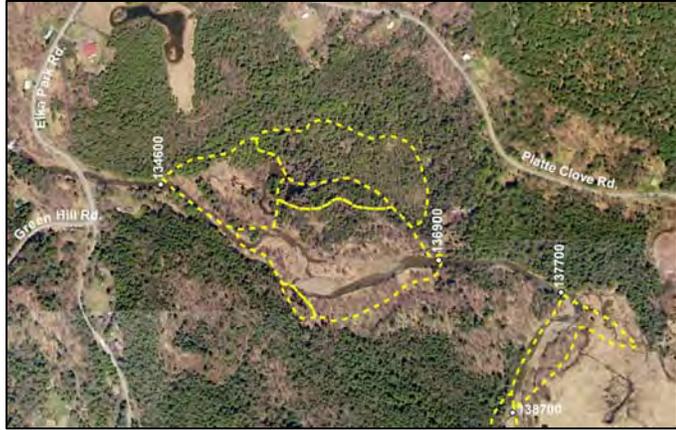
The beginning of this management unit was dominated by two large palustrine wetlands (Station 138700 - 137700 and 136900 - 134600). Wetlands are important features in the landscape that provide numerous beneficial functions including protecting and improving water quality, providing fish and wildlife habitats, storing

Wetland (Station 138700 - 137700 and 136900 - 134600)
Approximate wetland boundary delineated by NWI

floodwaters, and maintaining surface water flow during dry periods. The first palustrine wetland was approximately 3.6 acres with forested vegetation (Station 138700 – 137700) (PFO1A); and the larger 28.6 acre wetland downstream had a mixture of forested and shrub-scrub vegetation (Station 136900 – 134600) (PFO1A, PFO4E, PSS1A, PSS1Eb) (see Section 2.6 for detailed wetland type descriptions).

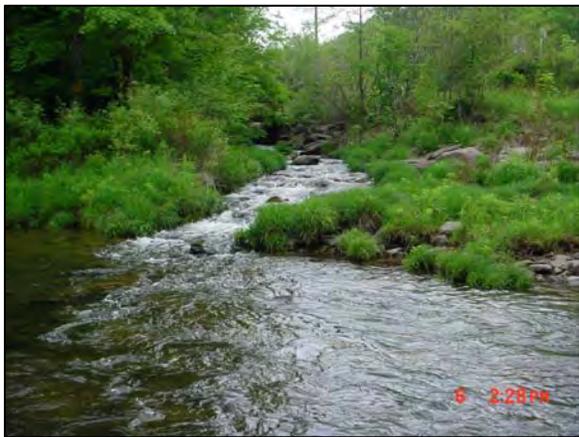
Cook Brook tributary confluence at Station 134200

Downstream, Cook Brook *tributary* entered the Schoharie Creek from the left streambank (Station 134200). This tributary drains the slopes of Plateau and Spruce Top Mountains. The New York State Department of Environmental Conservation classifies streams and rivers based on their “best use” (NYSDEC, 1994). The headwaters of this tributary was classified C(ts) by the NYS DEC, indicating that the

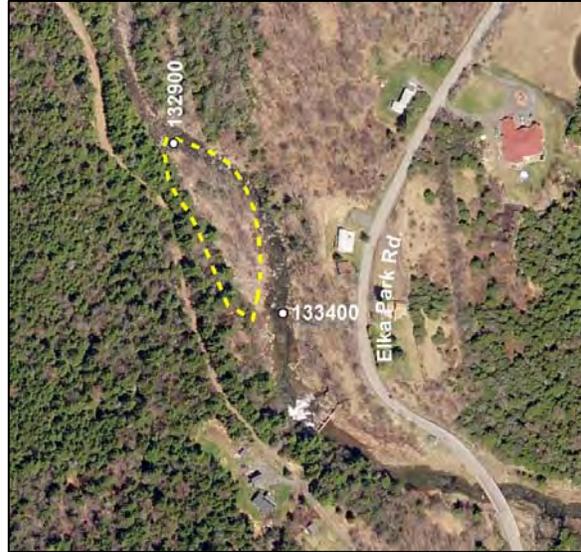
Wetland (Station 133400-132900)

Downstream of the dam, the stream channel was fairly straight, confined by the valley form, and the streambanks appeared stable. There was a 1 acre palustrine wetland with shrub-shrub vegetation along the left streambank (Station 133400-132900) (PSS1A). Woody debris had accumulated in this area but did not seem to have caused any detrimental effects. The right streambank had experienced scour during high flow events, resulting in a 30ft long segment of exposed glacial lake silt/clay (Station 133100).

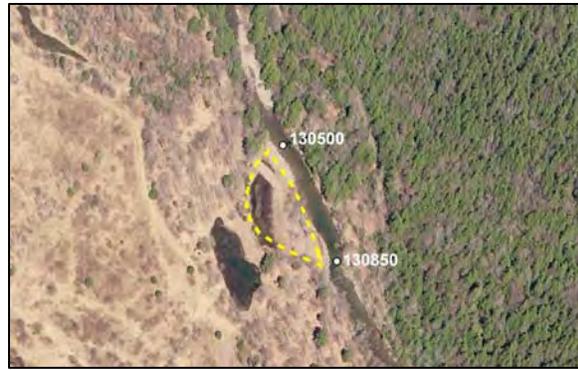
Beyond this rip-rap was another small palustrine wetland located on the left streambank (Station 130850-130500). This wetland encompassed approximately 0.7 acres with shrub-scrub vegetation (PSS1A). On the opposite bank from this rip-rap, the right streambank (Station 130850) was experiencing erosion along 388ft, exposing an area of 2230ft². This failure had begun to undermine several mature trees at the top of the bank.

Wetland (Station 130850-130500)
Approximate wetland boundary delineated by NWI

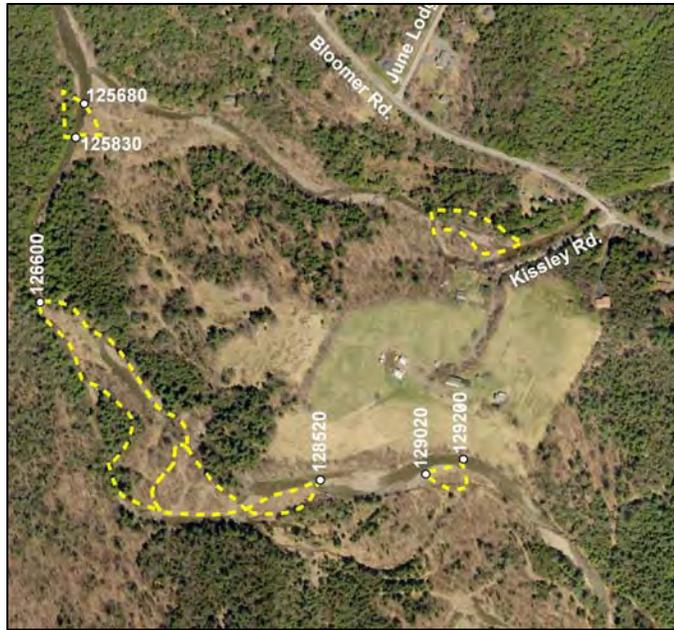
The large wetland between Station 128520 and 126600 was comprised of two wetland types. The upstream half, approximately 2 acres, was classified as riverine upper perennial with an unconsolidated shore (R3USA), while the lower 4 acre wetland was palustrine with forested vegetation (PFO1A). Another small riverine upper perennial wetland with an unconsolidated shore, approximately 0.5 acres in size, was located between Stations 125830-125680 (R3USA).

Wetland boundaries approximately delineated by NWI (Stations 129200-129020, 128520-126600, 125830-125680)

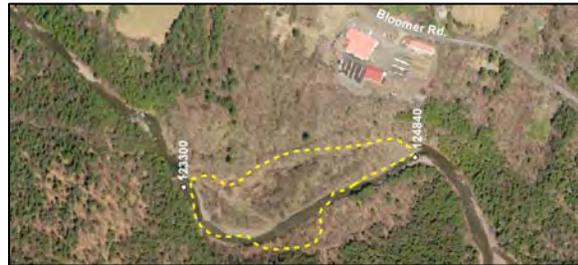
At the end of this management unit, a large palustrine wetland began and extended into the next unit (Station 124840-123300). This wetland was classified as palustrine with forested vegetation (PFO1A).

Wetland boundary approximately delineated by NWI (Stations 124840-123300)

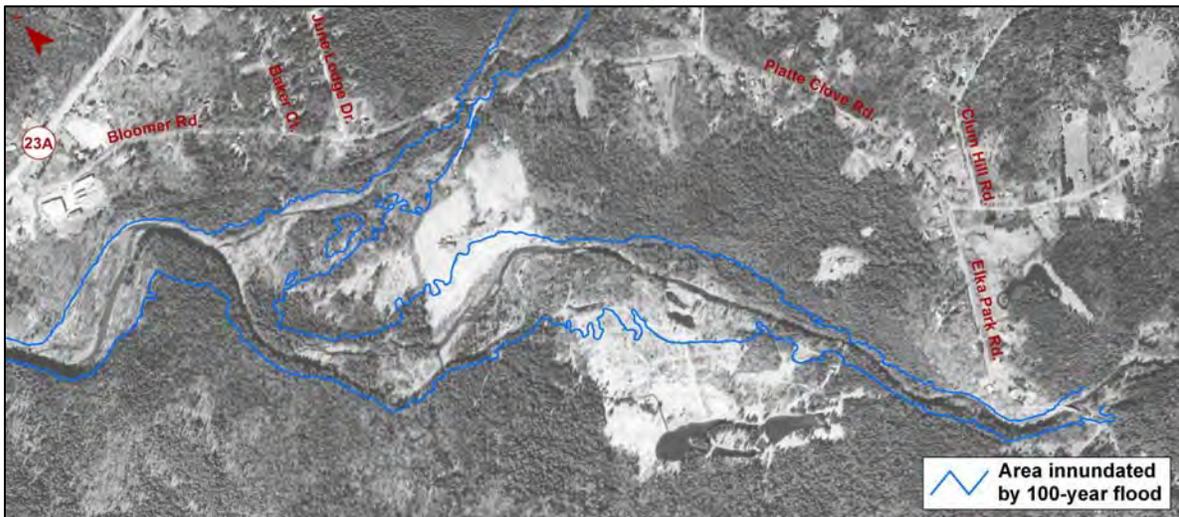
Floodplain maps are not available for the entire management unit (below). The FIRM maps for the Schoharie Creek begin at Elka Park Road and continue downstream to the Schoharie Reservoir. It is recommended that a hydraulic analysis be completed to create floodway and floodplain maps from Elka Park Road upstream to Prediger Road. In 2006, existing structures in this unit appeared to be situated out of the estimated 100-year floodplain. The 100-year floodplain is that area predicted to be inundated by floods of a magnitude that is expected to occur once in any 100-year period, on the basis of a statistical analysis of local flood record. Most communities regulate the type of development that can occur in areas subject to these flood risks.

100-year floodplain boundary map beginning at Elka Park Rd. bridge
