Schoharie Creek Management Unit 5

Town of Hunter - Station 124311 to Klein Ave. (Station 108605)

2006 Stream Feature Statistics

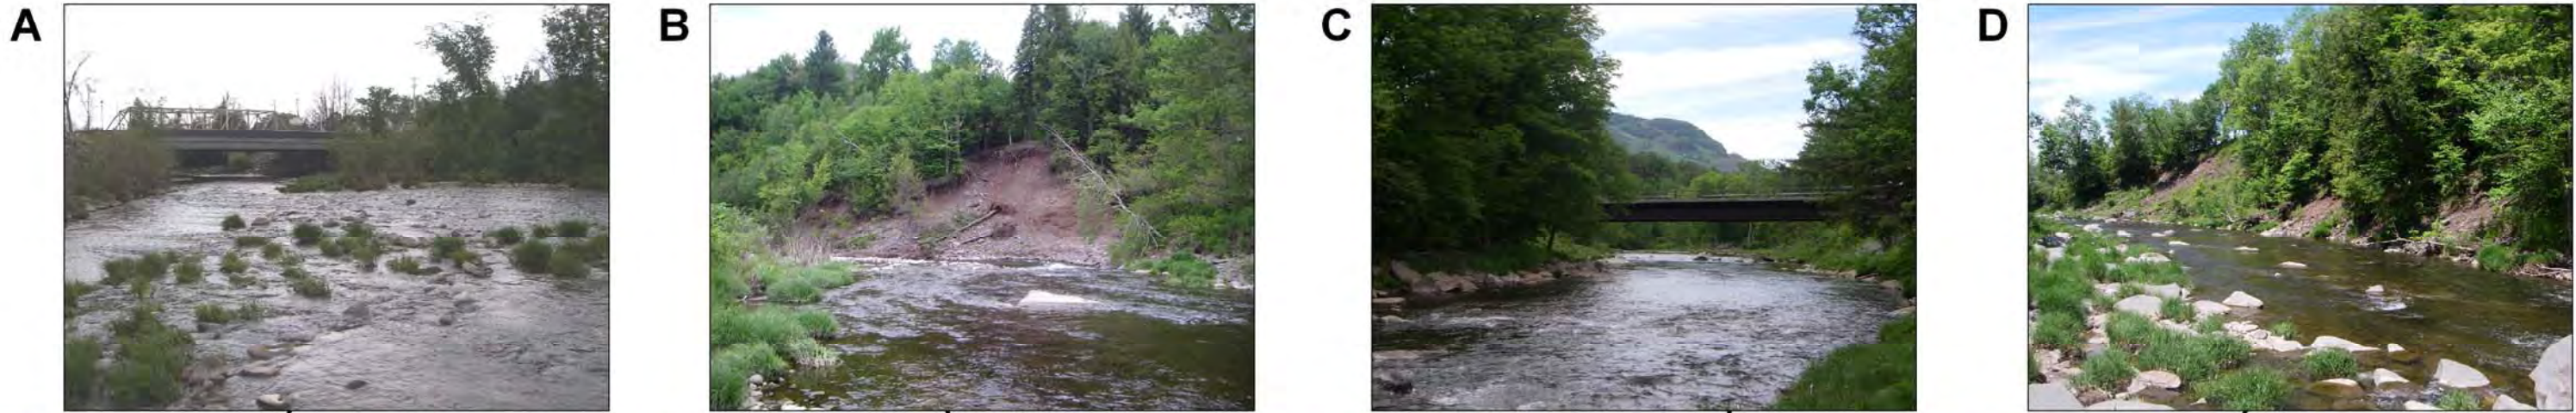
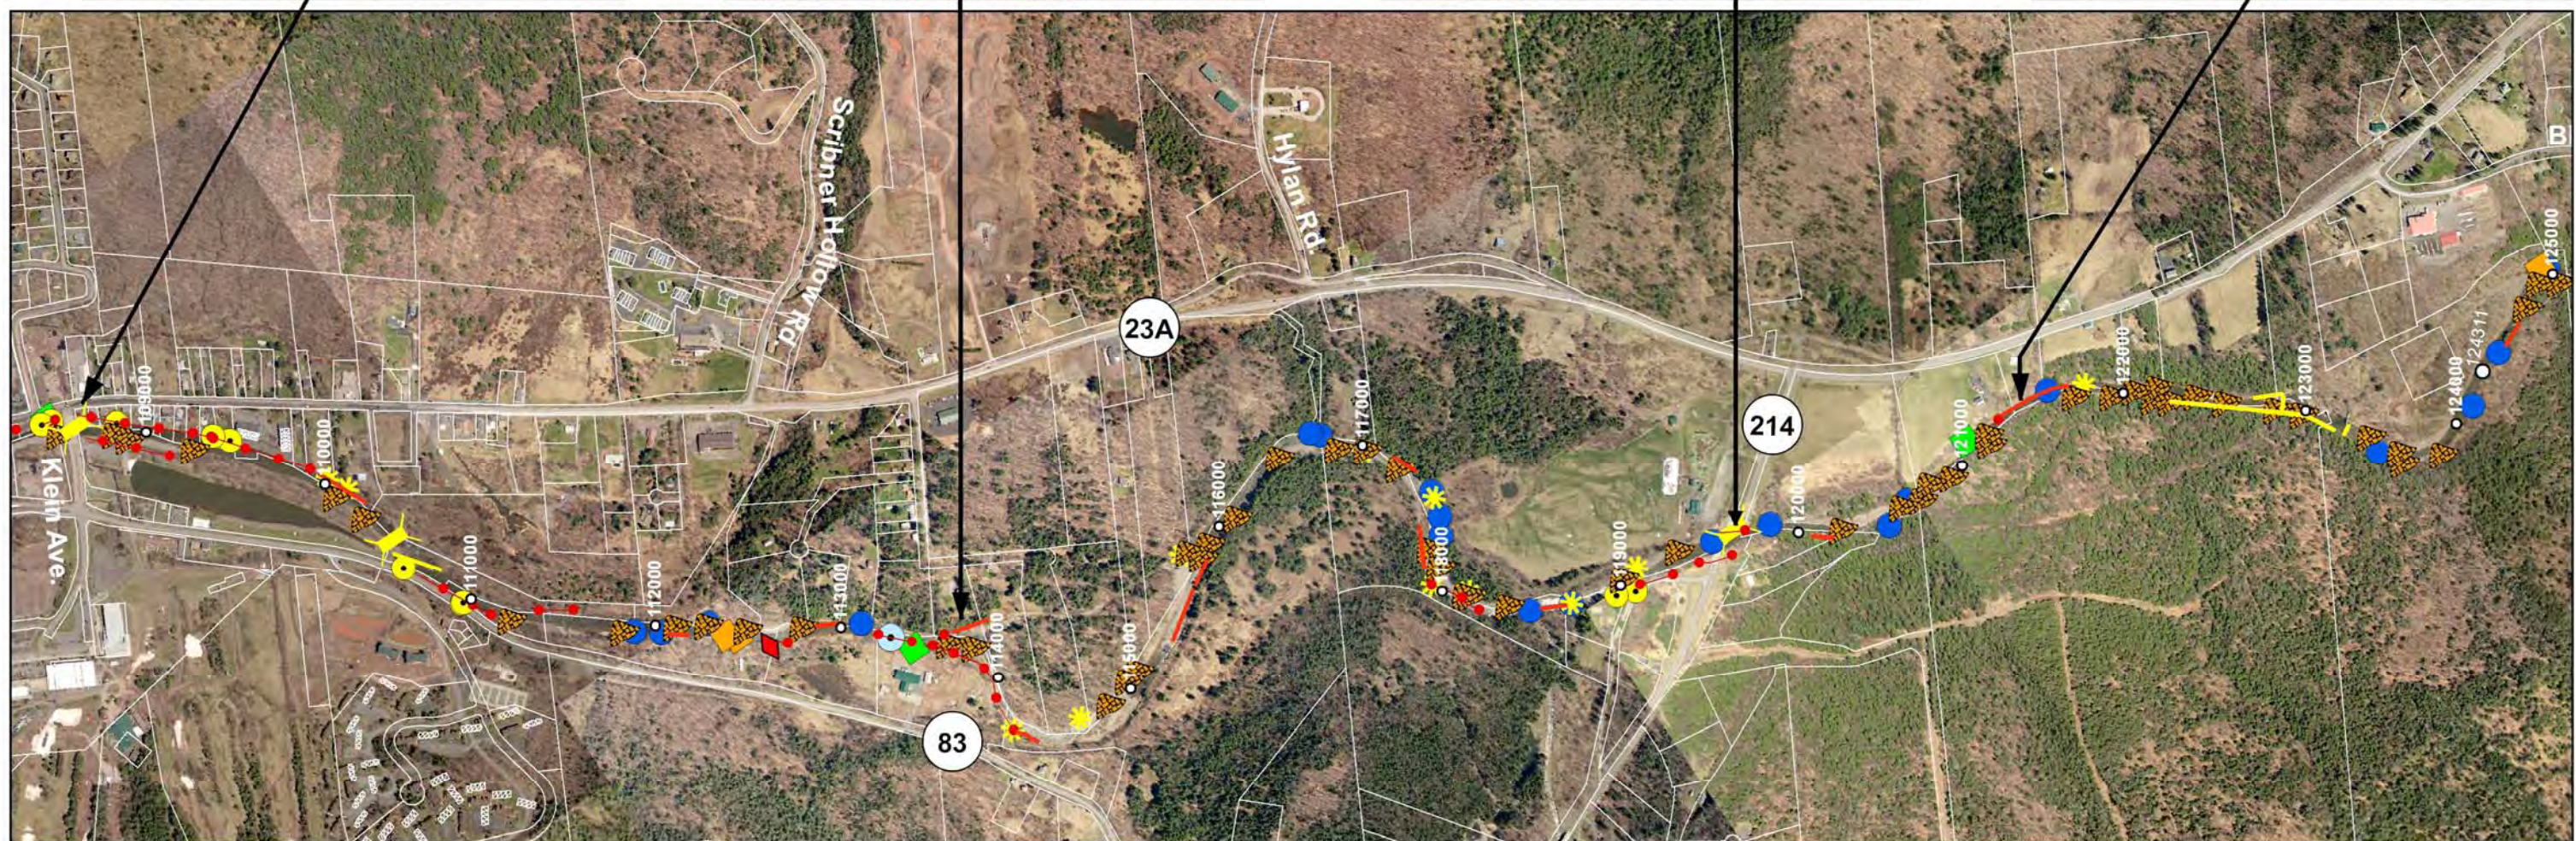
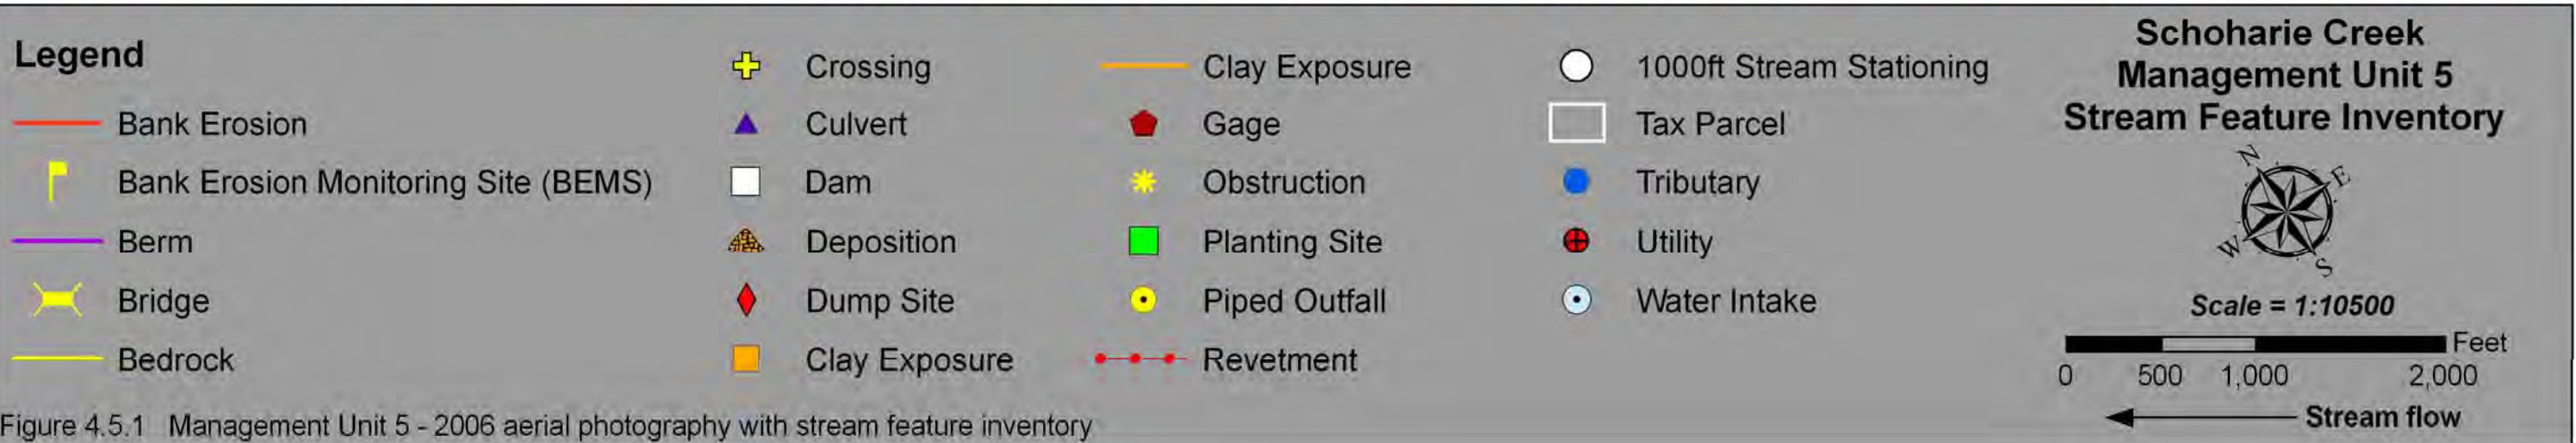
Figure 4.5.1 Management Unit 5 - 2006 aerial photography with stream feature inventory

The 2006 stream feature inventory revealed that 7.1% (2,029 ft) of the streambanks exhibited signs of active erosion along 28,598 ft of total channel length (Fig. 4.5.1). The total surface area of active erosion totaled approximately 19,343 ft². *Revetment* had been

installed on 1% (285 ft.) of the streambanks. No *berms* were identified in this management unit at the time of the stream feature inventory.

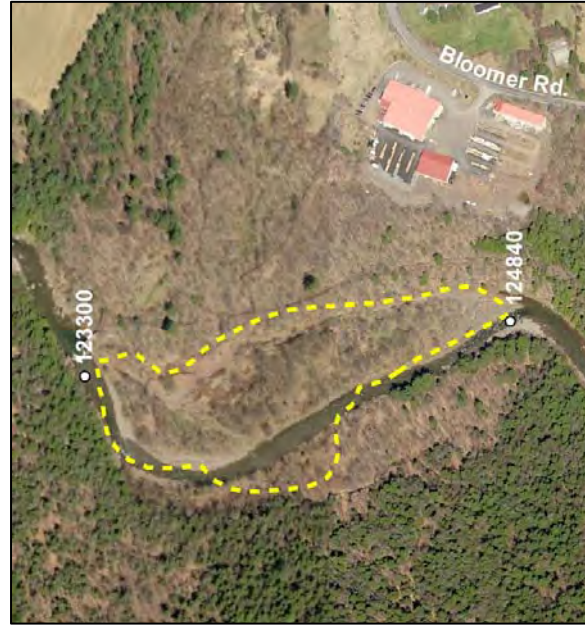
Wetland boundary approximately delineated by NWI (Stations 124840-123300)

As the start of the management unit there was a large 8 acre palustrine wetland (Station 124840-123300). Wetlands are important features in the landscape that provide numerous beneficial functions including protecting and improving water quality, providing fish and wildlife habitats, storing floodwaters, and maintaining surface water flow during dry periods. This wetland was classified as palustrine, forested broad-leaved deciduous, temporarily flooded (PFO1A) (see Section 2.6 for detailed wetland type descriptions).

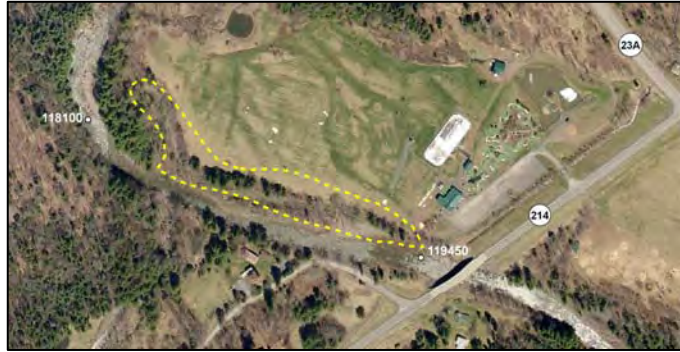
Wetland boundary approximately delineated by NWI (Stations 119450-118100)

Along the right streambank, there was a 3.5 acre palustrine wetland with scrub-shrub vegetation (Station 119450-118100) (PSS1C). Rip-rap had been installed on the left streambank (Station 119300). This rip-rap was in good functioning and structural condition, but interplanting with native shrub and sedge species would help strengthen the revetment, while enhancing aquatic habitat.

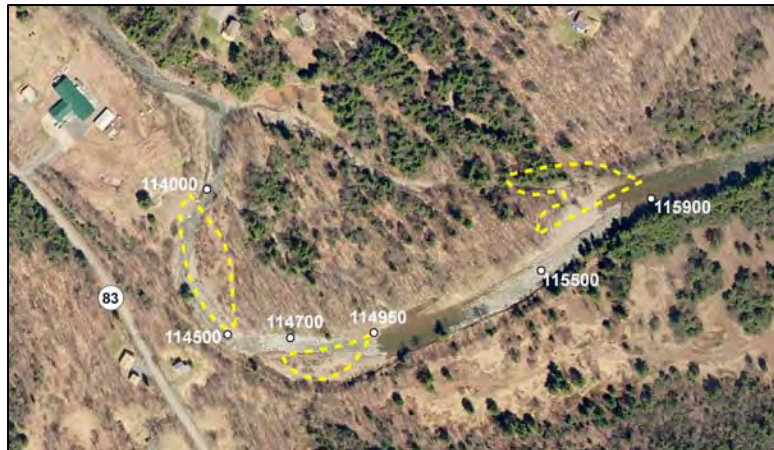
*Wetland boundary approximately delineated by NWI
(Stations beginning at 115900 & 114950 & 114500)*

prior to 1959 (Station 115800). A 0.9 acre wetland classified as riverine lower perennial with an unconsolidated shore, signifying it is contained in the natural channel and characterized by a low gradient and slow water velocity, was located on this

flood chute (Station 115900-115500) (R2USC). On the left streambank at station 115800 the streambank was experiencing minor toe scour along 303ft, resulting in an erosion area of approximately 884 ft². This erosion site was a good candidate for remediation using vegetative toe and bank protection, but may self recover with time. At the next meander bend there were two wetlands. A small 0.4 acre wetland classified as riverine lower perennial (Station 114950-114700) (R2USC) and a 0.9 acre palustrine wetland dominated by scrub-shrub vegetation (Station 114500-114000) (PSS1A).

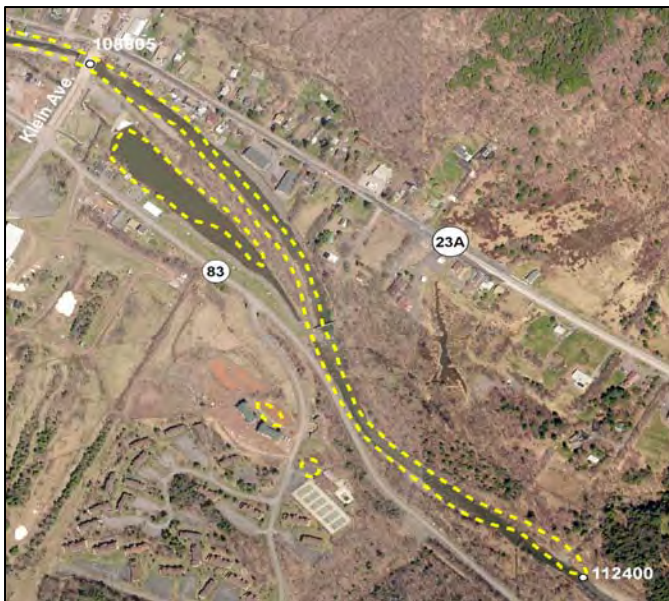
Wetland boundary approximately delineated by NWI (Station 112400-108605)

channel, classified as riverine lower perennial, stretched from here to the end of this management unit (Station 112400-108605) (R2UBH).

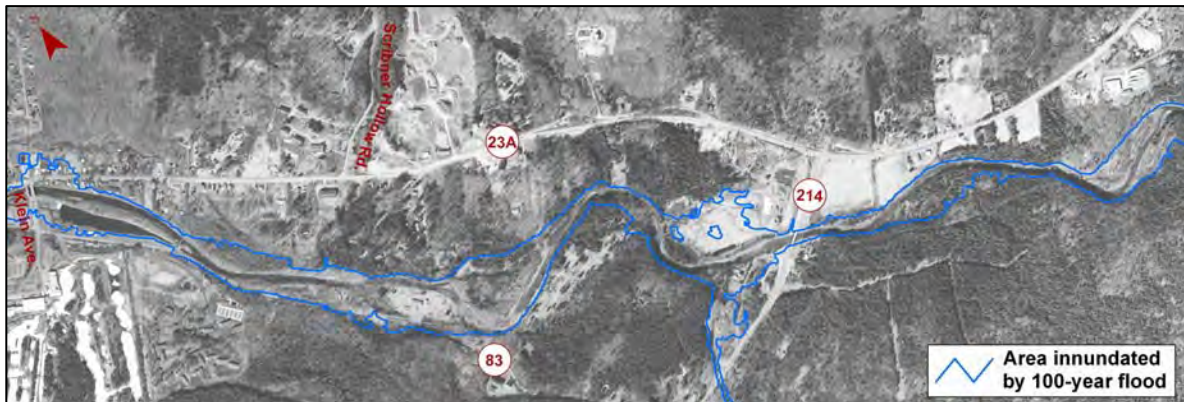
100-year floodplain boundary map

According to the 2006 floodplain maps (above), twenty-four existing structures in this unit appeared to be situated within the estimated 100-year floodplain. The 100-year floodplain is that area predicted to be inundated by floods of a magnitude that is expected to occur once in any 100-year period, on the basis of a statistical analysis of local flood record.
