Schoharie Creek Management Unit 6

Town of Hunter – Klein Ave. (Station 108605) to Bridge St. (Station 104521)

Stream Channel and Floodplain Current Conditions (2006)

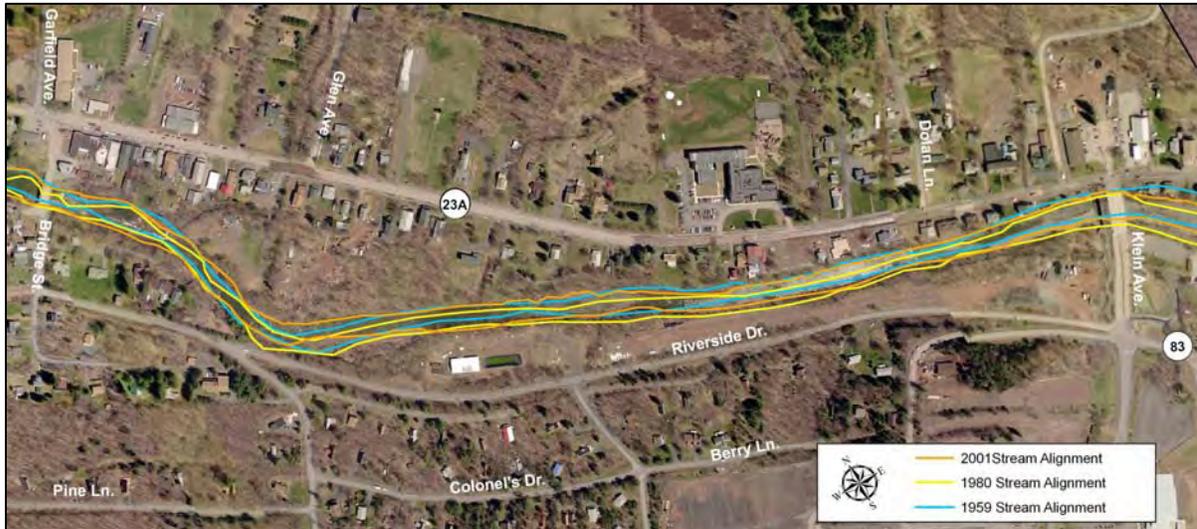
As seen from the historical stream alignments (below), the *planform* of the channel has remained fairly stable since 1959.

Historic stream channel alignments overlaid with 2006 aerial photograph

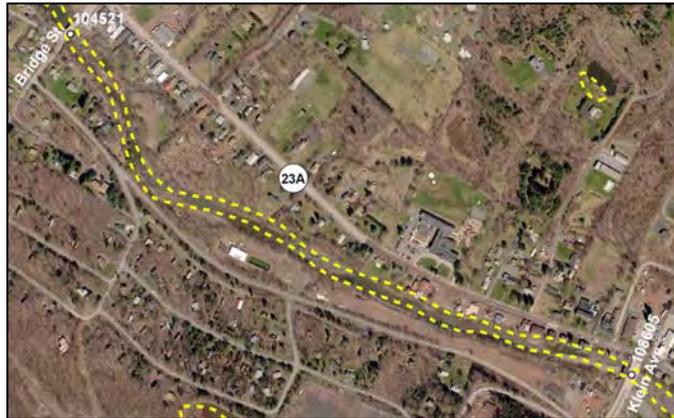
The entire stream channel within this management unit was designated as a wetland. This wetland was approximately 7 acres in size and classified as riverine lower perennial, signifying it is contained in the natural channel and characterized by a low gradient and slow water velocity (R2UBH, Station 108605-104521) (see Section 2.6 for detailed wetland type descriptions).

Wetland boundary approximately delineated by NWI (Station 108605-104521)

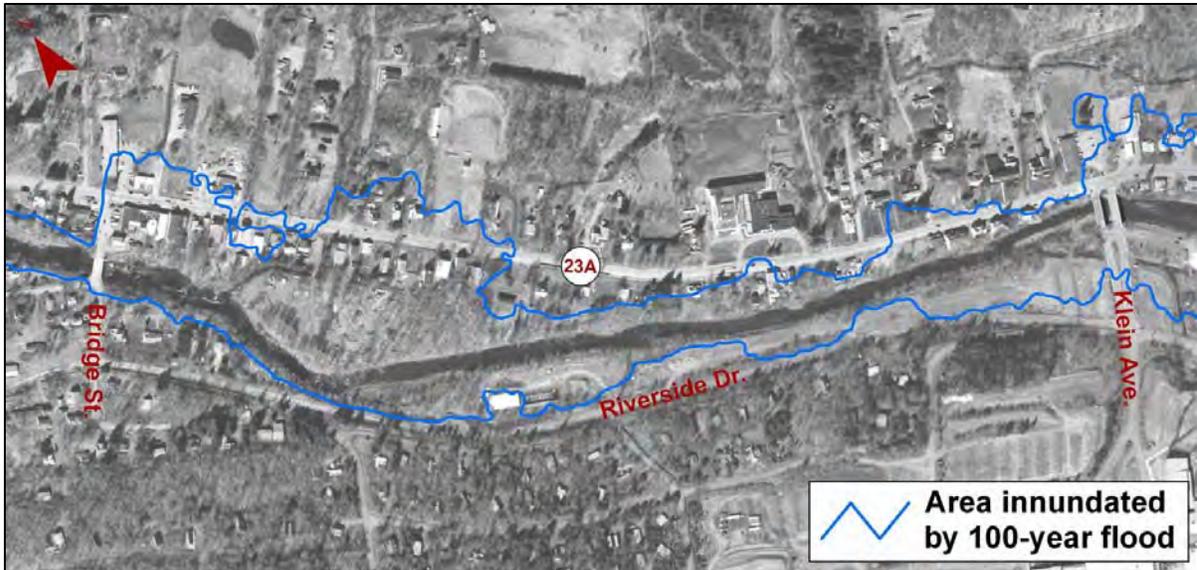
According to the current floodplain maps (below), thirty-six existing structures in this unit appeared to be situated within the estimated 100-year floodplain. The 100-year floodplain is that area predicted to be inundated by floods of a magnitude that is expected to occur once in any 100-year period, on the basis of a statistical analysis of local flood records. Most communities regulate the type of development that can occur in areas subject to these flood risks.

100-year floodplain boundary map
