# Schoharie Creek Management Unit 9

Town of Jewett – Carr Road Bridge (Station 83957) to County Route 17 (Station 70652)

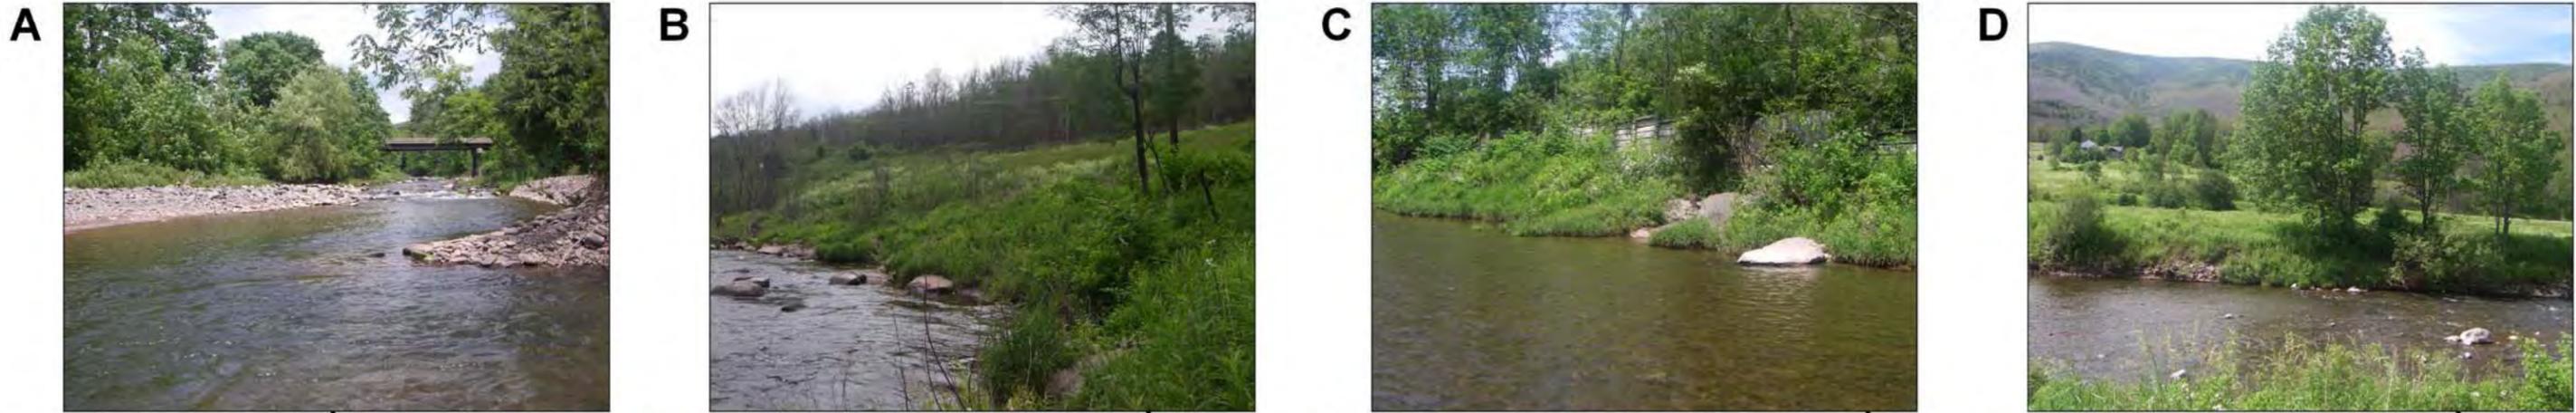
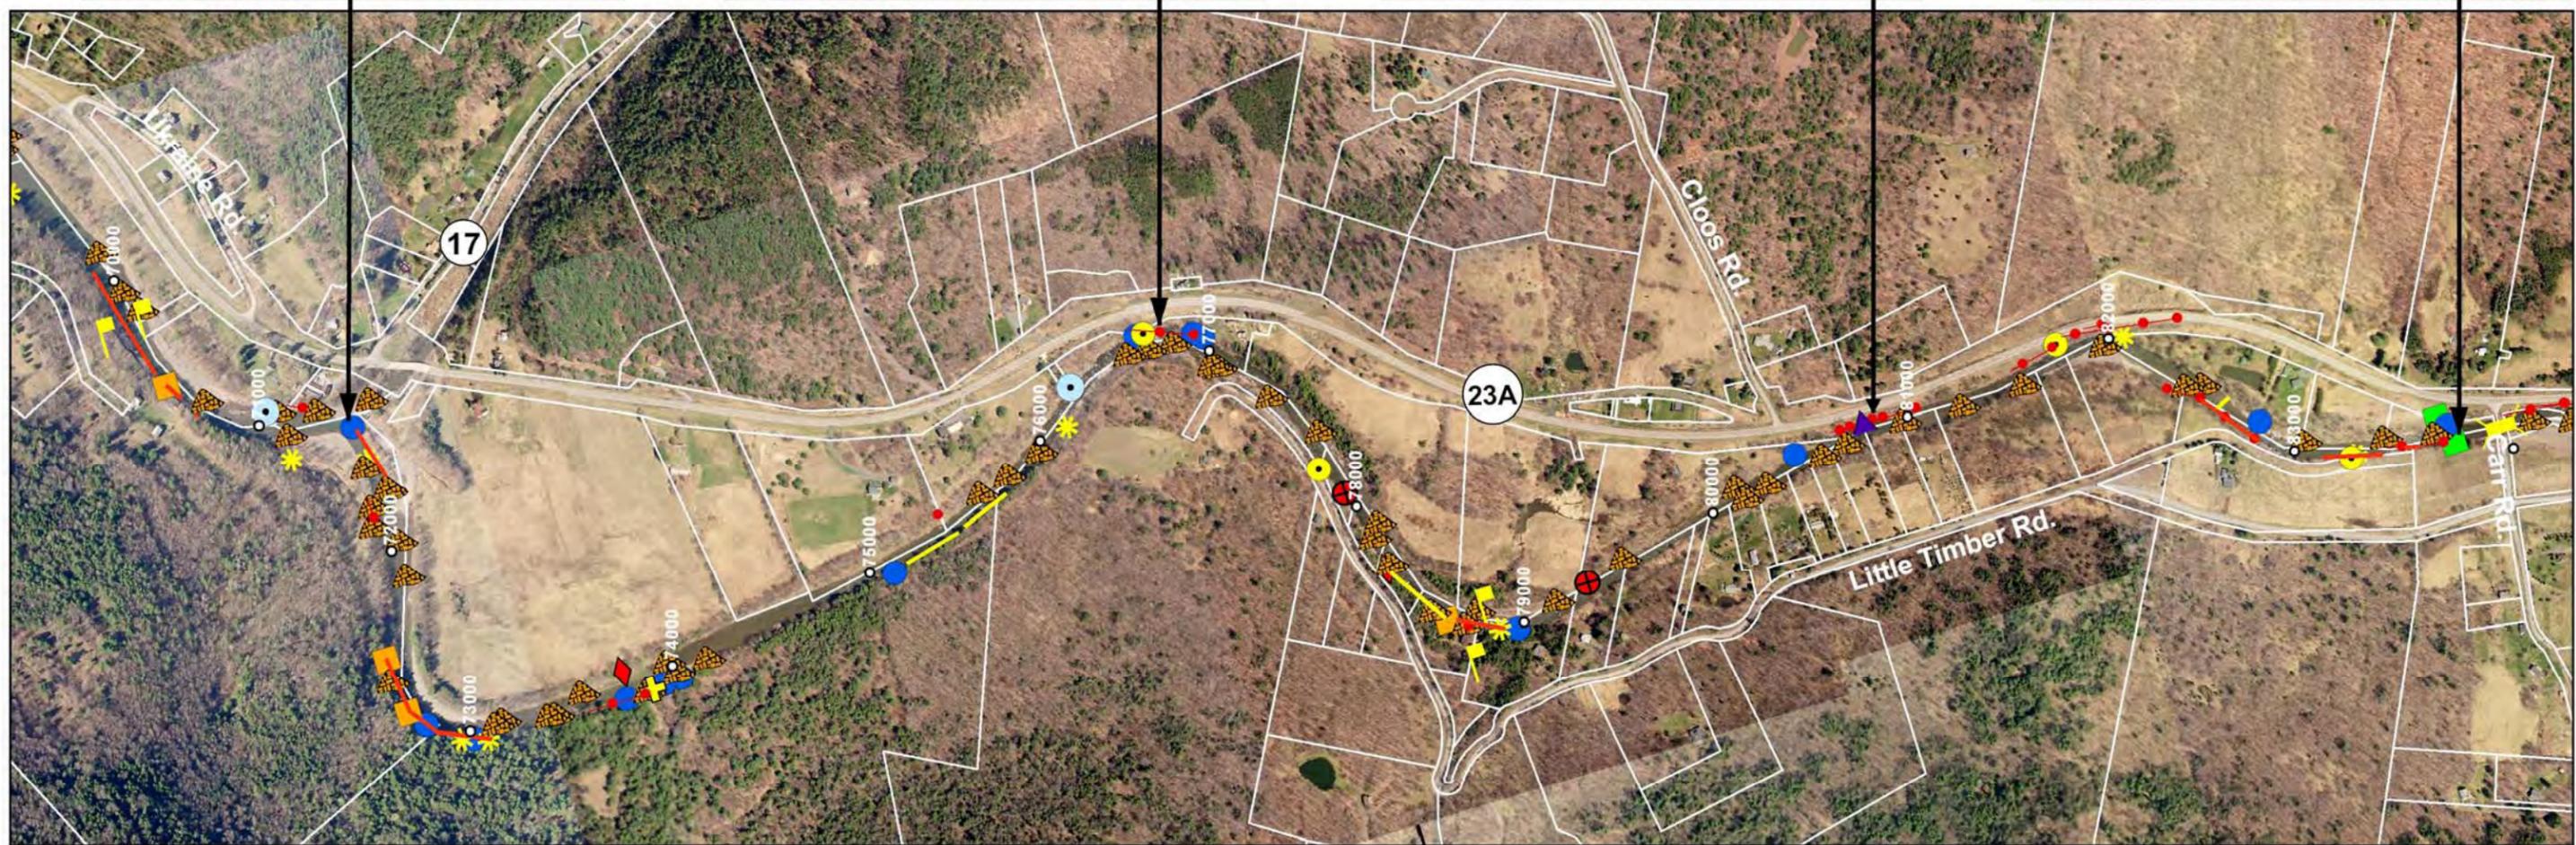
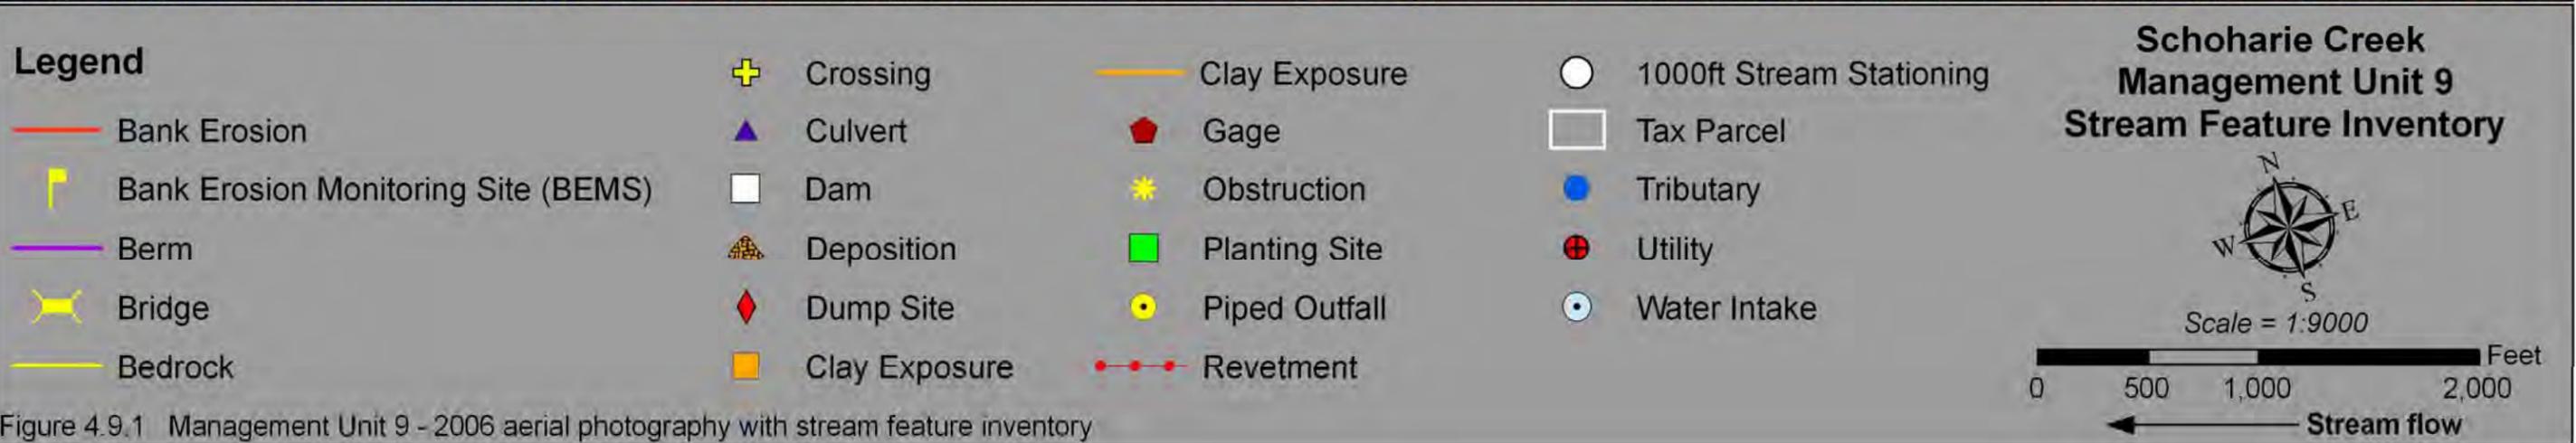
Figure 4.9.1 Management Unit 9 - 2006 aerial photography with stream feature inventory

The 2006 stream feature inventory revealed that 7% (1,861 ft) of the streambanks exhibited signs of active erosion along the 26,610 ft of total channel length in the unit (Fig. 4.9.1). The total surface area of active erosion totaled approximately 70,973 ft<sup>2</sup>. *Revetment* had been installed on 10% (2,691 ft) of the streambanks. No *berms* were identified in this management unit at the time of the stream feature inventory.

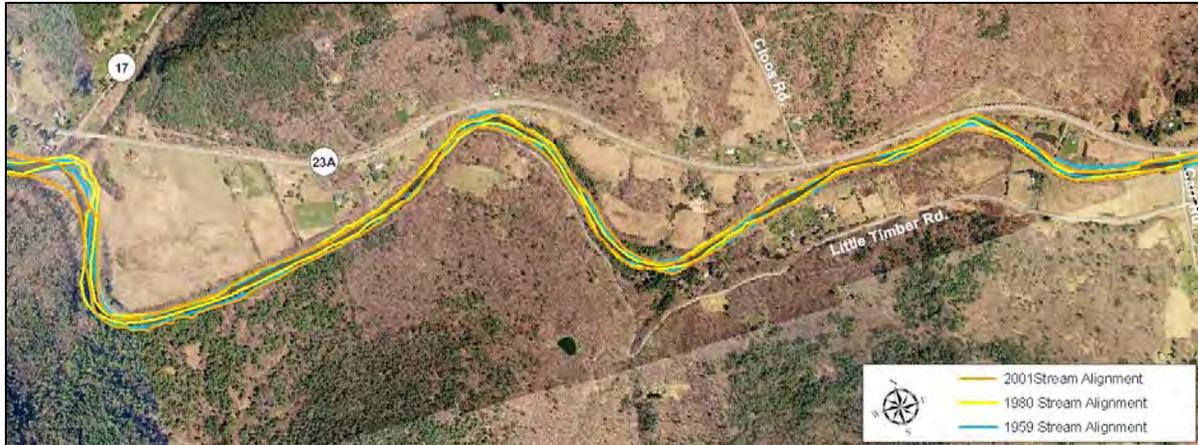
As seen from the historical stream alignments (below), the *planform* of the channel has remained fairly stable since 1959.

*Historic stream channel alignments overlaid with 2006 aerial photograph*

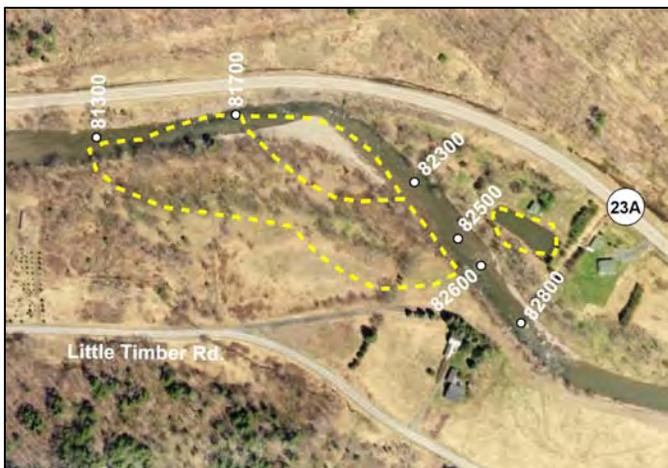
*Wetlands (Station 82800-82500 & 82600-81300 & 82300-81700) Approximate wetland boundary delineated by NWI*

There were three wetlands in this vicinity. On the right streambank was a 0.4 acre impounded palustrine wetland (PUBFh, Station 82800-82500). On the left streambank was a large 4.7 acres palustrine forested wetland (PFO1A, Station 82600-81300) along with a 1.4 acre riverine lower perennial wetland (R2USA, Station 82300-81700) (see Section 2.6 for detailed wetland type descriptions).

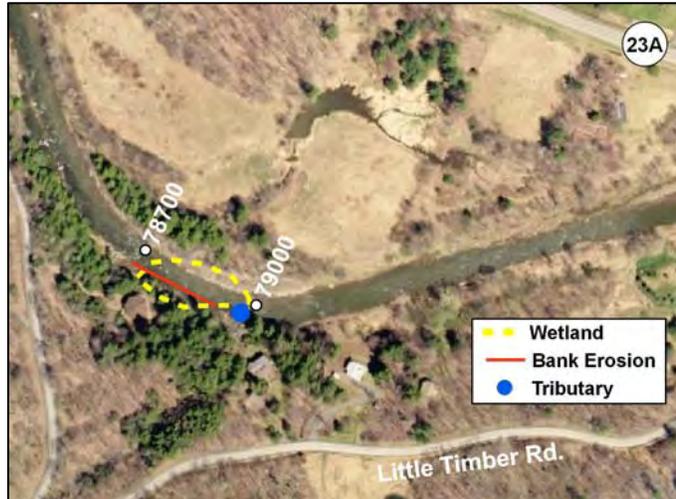
As the stream *meandered* downstream a 0.5 acre riverine, upper perennial, seasonally flooded wetland was located within the stream channel (R2USC, Station 79000-78700). Near the upstream end of this wetland an unnamed tributary entered the Schoharie Creek from the left streambank (Station 78965). This tributary drained the steep slopes of Evergreen Mountain, before it reached the flatter topography of the valley floor where it entered the Schoharie Creek. As a result of this stream slope change, the tributary lost its ability to transport sediment gathered from the mountain slopes, and began to deposit sediment at its mouth and into the more gently sloped Schoharie Creek. This is a common feature of confluence areas, which often contain extensive sediment bars, function as important sediment storage areas, and are typically among the most dynamic and changeable areas in the stream system. This tributary was classified C by the NYSDEC (NYSDEC, 1994).

Wetland (Station 79000-78700)  
Approximate wetland boundary delineated by NWI

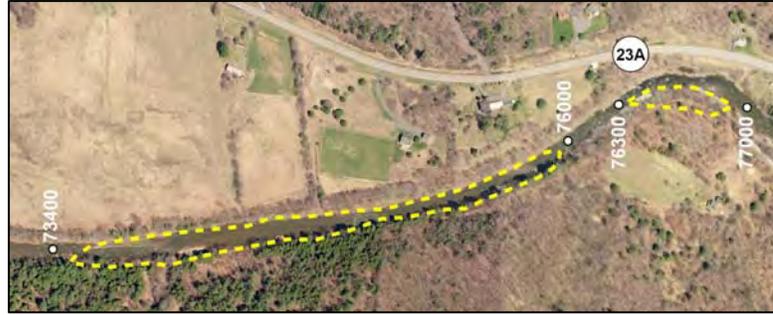
There was a 0.9 acre riverine, upper perennial, seasonally flooded wetland located along the left streambank (R2USC, Station 77000-76300). A larger 5.4 acre riverine, upper perennial, permanently flood wetland was located within the stream channel downstream (R2UBH, Station 76000-73400).

Wetland (Station 7700-76300 & 76000-73400)  
Approximate wetland boundary delineated by NWI

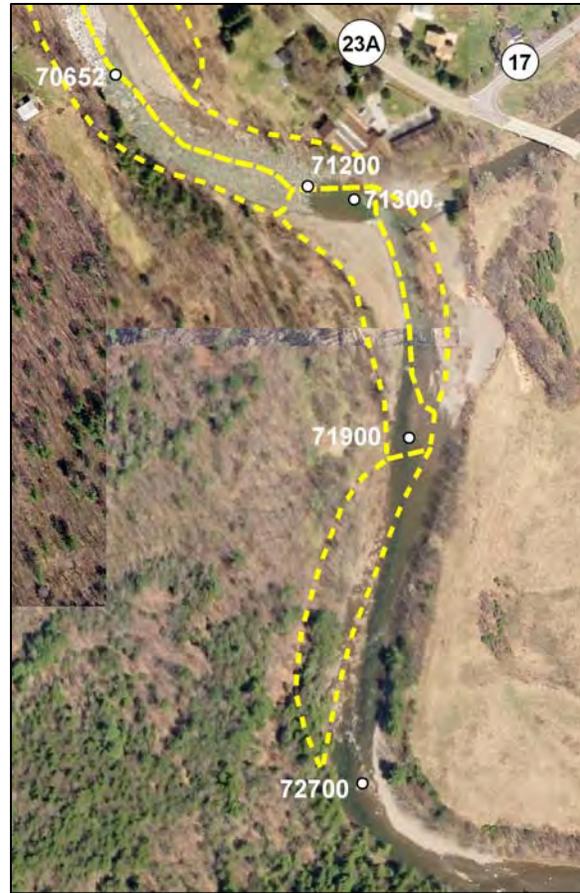
The downstream end of this management unit was dominated by wetlands including four riverine, upper perennial wetlands, totaling 5 acres (R2USC, Station 72700-71900) (R2USC, Station 71900-71300) (R2USC, R2UBH, Station 71200-70652). A 1.7 acre palustrine, forested wetland was located along the left streambank (PFO1A, Station 71900-71200).

*Wetlands at downstream end of management unit  
Approximate wetland boundary delineated by NWI*

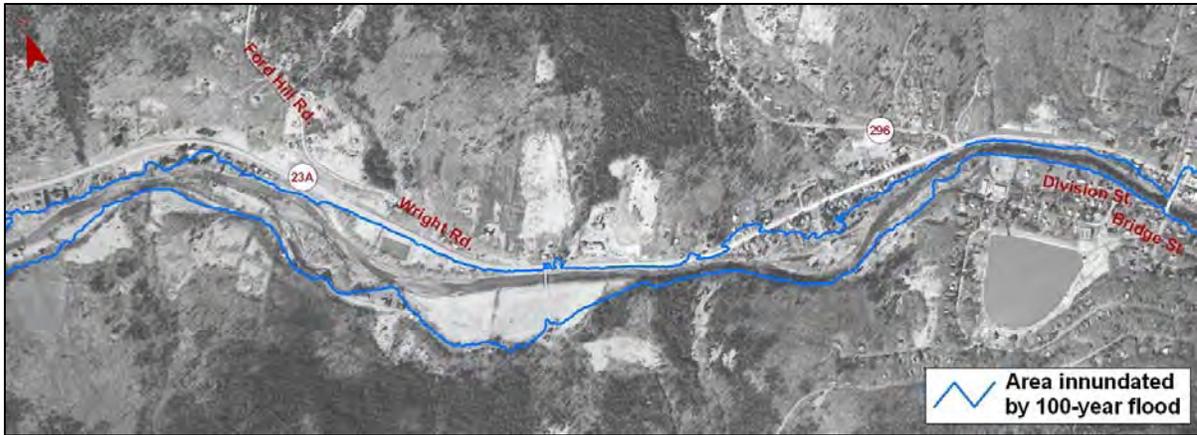
According to the current floodplain maps (below), fourteen existing structures in this unit appeared to be situated within the estimated 100-year floodplain. The 100-year floodplain is that area predicted to be inundated by floods of a magnitude that is expected to occur once in any 100-year period, on the basis of a statistical analysis of local flood record. Most communities regulate the type of development that can occur in areas subject to these flood risks.

*100-year floodplain boundary map*
