# Schoharie Creek Management Unit 10

Towns of Jewett and Lexington – County Route 17 (Station 70652) to  
Bush Road Bridge (Station 63446)

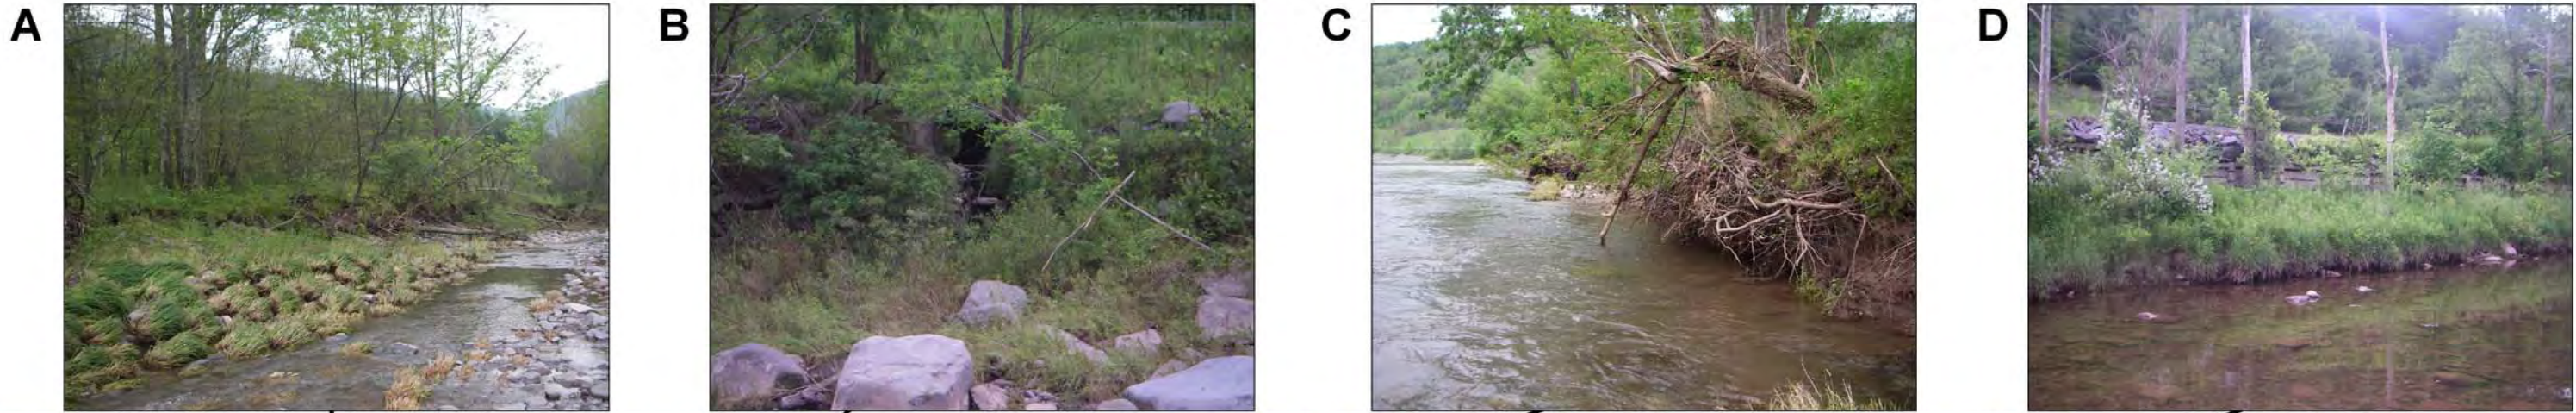
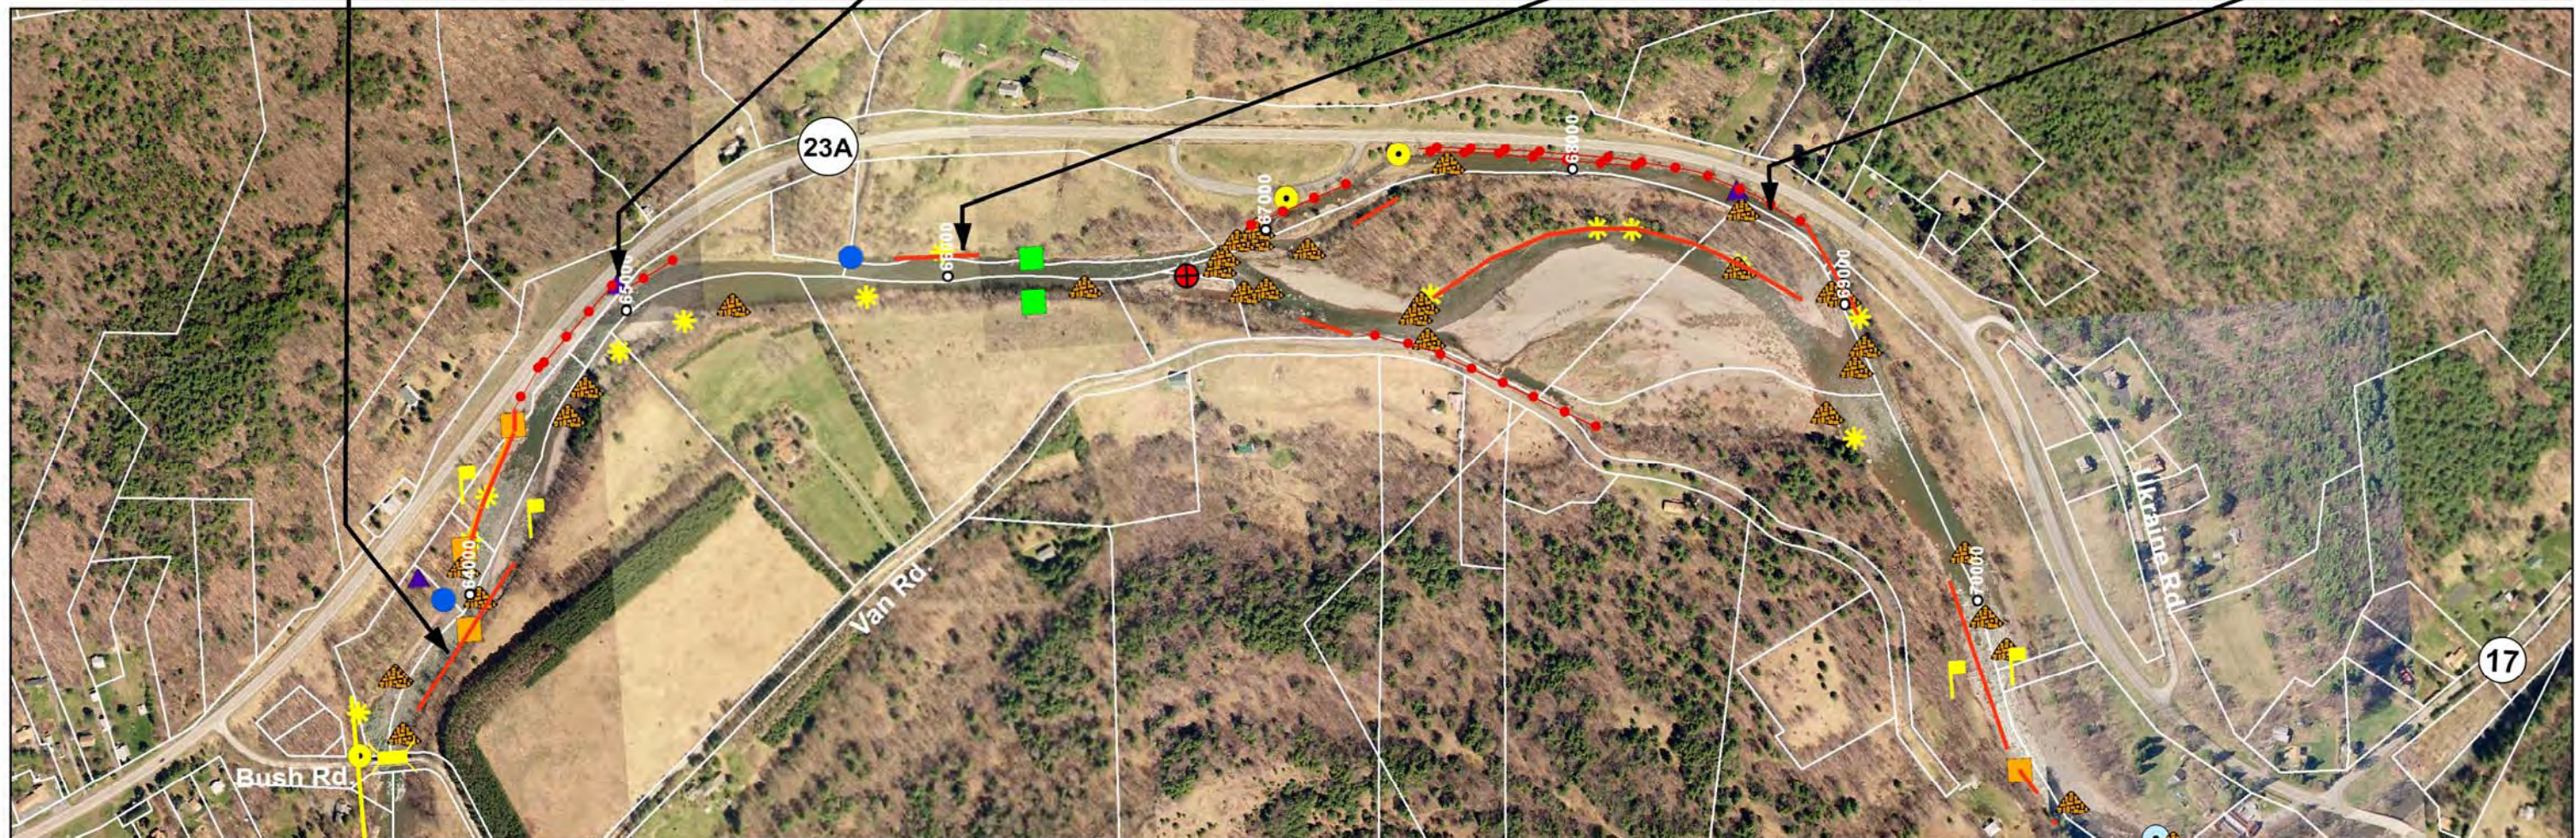
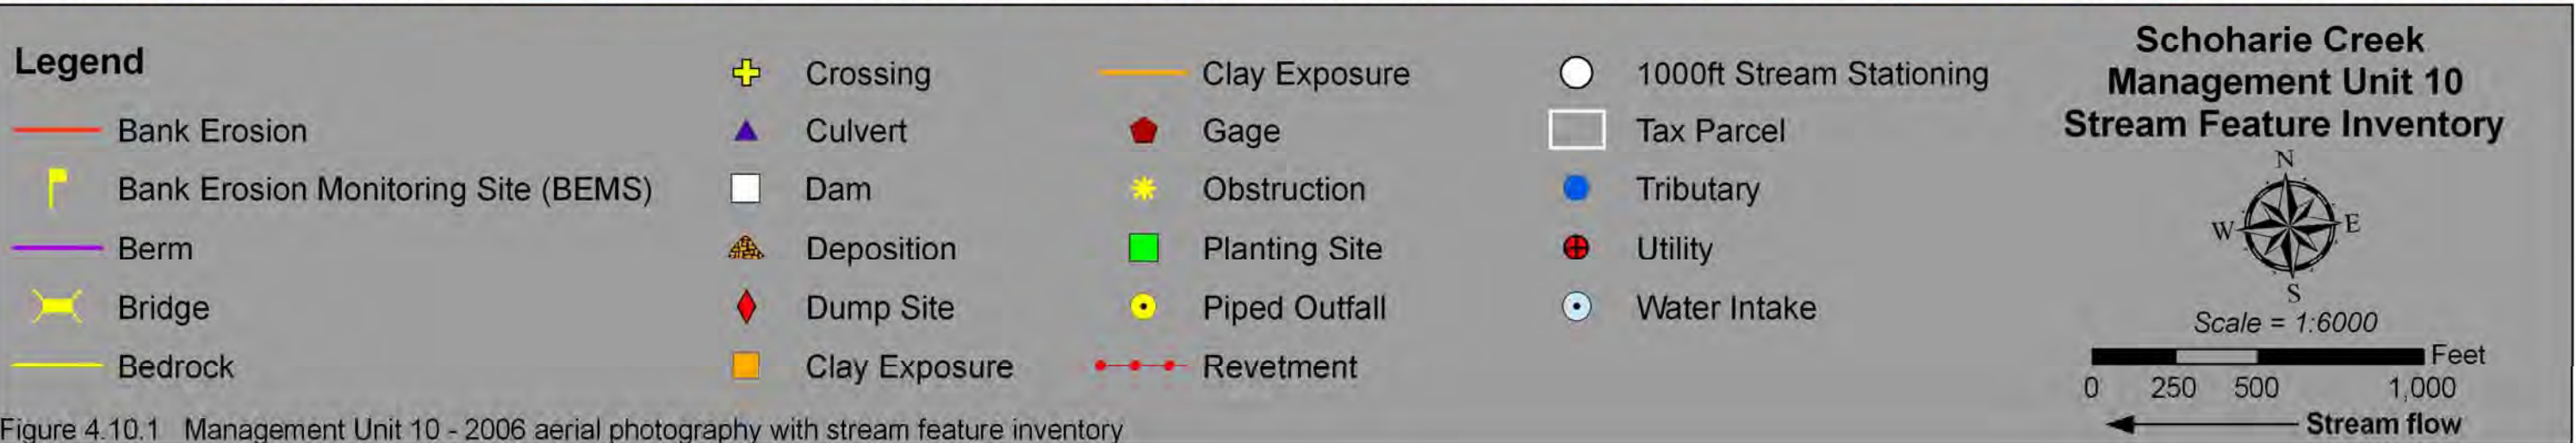
Figure 4.10.1 Management Unit 10 - 2006 aerial photography with stream feature inventory

The 2006 stream feature inventory revealed that 26.5% (3,820 ft) of the streambanks exhibited signs of active erosion along the 14,413 ft of total channel length in the unit (Figure 4.10.1). The total surface area of active erosion totaled approximately 30,731 ft<sup>2</sup>. *Revetment* has been installed on 25% (3,602 ft) of the streambanks. No *berms* were identified in this management unit at the time of the stream feature inventory.

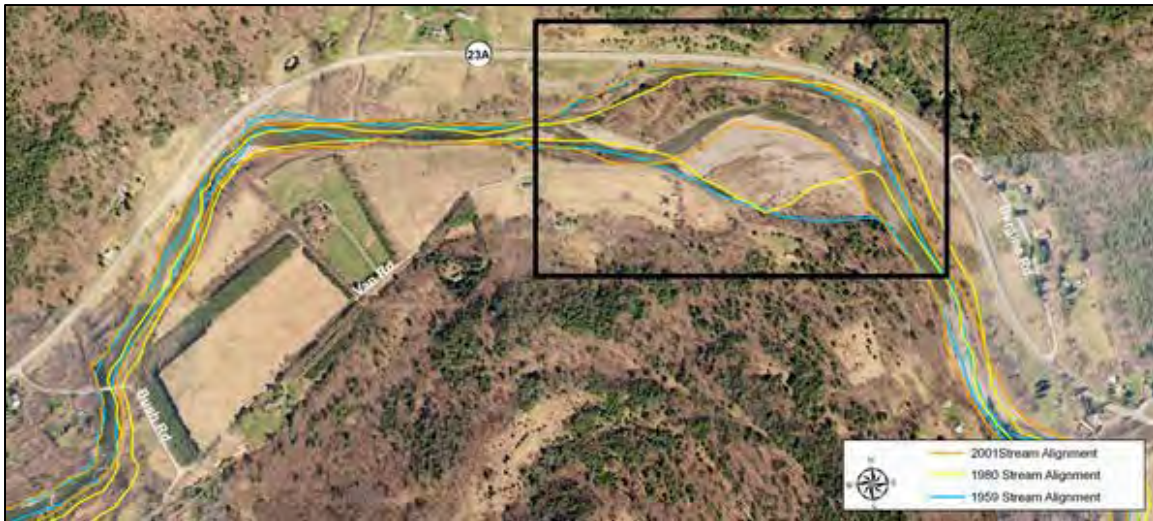
As seen from the historical stream alignments (below), the *planform* of the stream channel at the upstream half of the management unit has changed over the years (Station 69400-66700), but the downstream half has remained fairly stable since 1959.

*Historic stream channel alignments overlaid with 2006 aerial photograph*

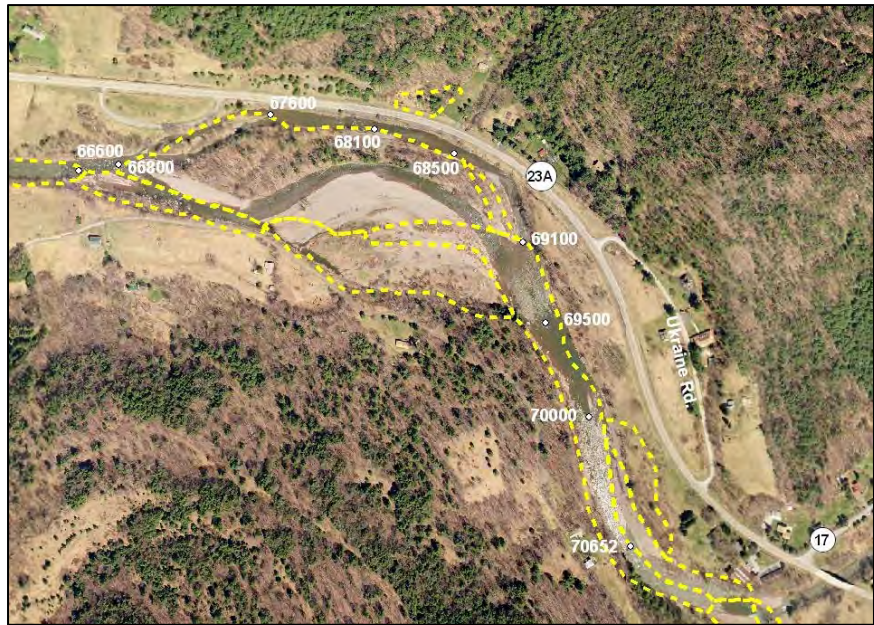
Most of the stream channel within this management unit was designated as a wetland. Five of these wetlands were classified as riverine lower perennial, signifying they were contained in the natural channel and characterized by a low gradient and slow water velocity (R2UBH, 7.1

*Wetlands in upstream half of management unit (Stations 70652-66600) approximate wetland boundary delineated by NWI*

ac, Station 70652-68500) (R2USC, 0.9ac, Station 70652-70150) (R2USC, 5.9ac, Station 69500-67600), (R2USC, 0.5ac, Station 69100-68500) (R2USC, 1.9ac, 67600-666000). A 1.9 acre palustrine wetland with a mixture of shrub-scrub and emergent vegetation was located along the right streambank near the upstream end of the management unit (PSS1/EM1A, Station 70652-70000). A 15 acre palustrine wetland with forested vegetation was located on the island between the stream channel divergence (PFO1A, Station 69000-66880). Wetlands are important features in the landscape that provide numerous beneficial functions including protecting and improving water quality, providing fish and wildlife habitats, storing floodwaters, and maintaining surface water flow during dry periods (see Section 2.6 for detailed wetland type descriptions).

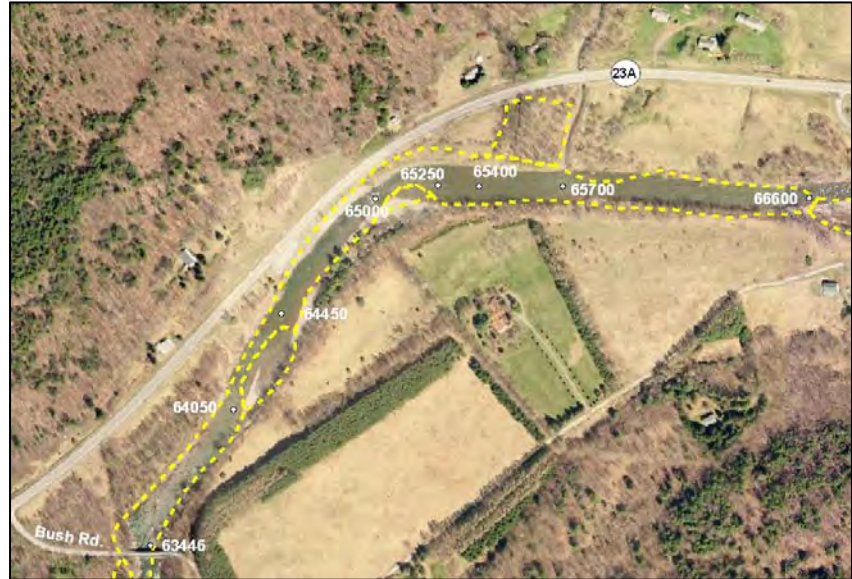
The downstream half of the management unit also contained many wetland areas. Four of these wetlands were classified as riverine lower perennial (R2UBH, 9.3ac, Station 66600-63446) (R2USA, 0.2ac, Station 65250-65000) (R2USC, 0.8ac, Station 64450-64050). A 1.2 acre palustrine wetland

*Wetlands in downstream half of management unit (Stations 66600-63446) approximate wetland boundary delineated by NWI*

with forested vegetation was located on the right streambank (PFO1A, Station 65700-65400).

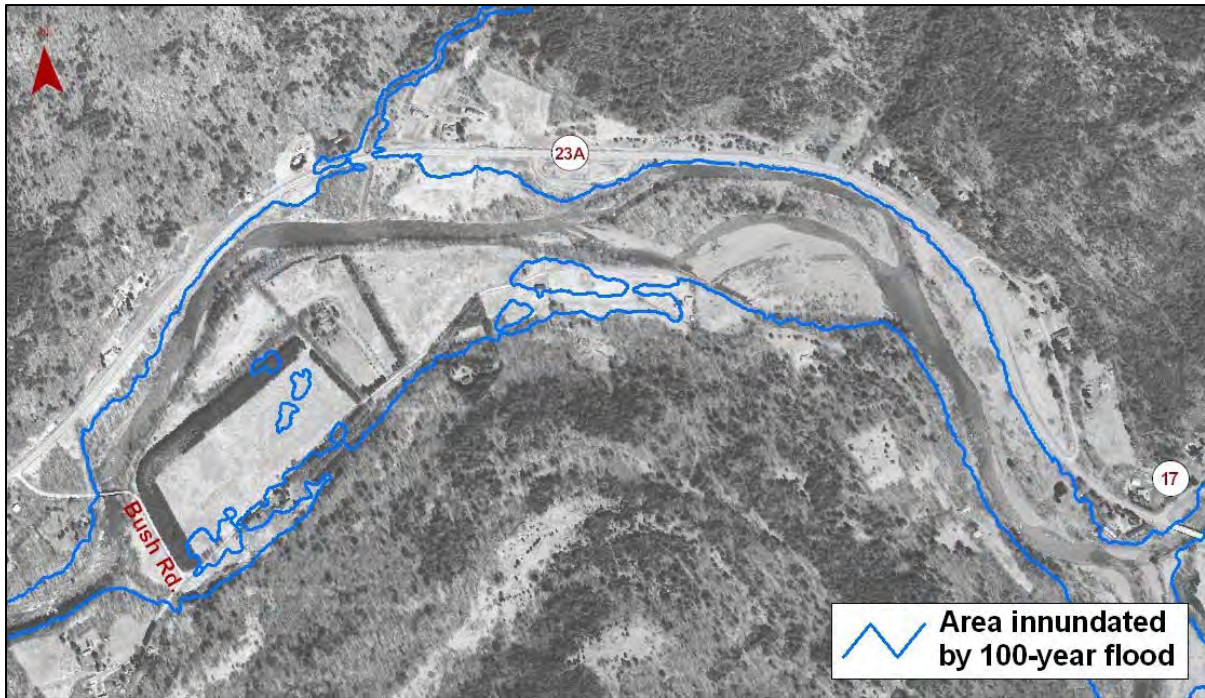
*100-year floodplain boundary map*

According to the current floodplain maps (below), one existing structure in this unit appeared to be situated within the estimated 100-year floodplain. The 100-year floodplain is that area predicted to be inundated by floods of a magnitude that is expected to occur once in any 100-year period, on the basis of a statistical analysis of local flood record. Most communities regulate the type of development that can occur in areas subject to these flood risks.
