# Schoharie Creek Management Unit 12

Town of Lexington – County Route 42 Bridge (Station 55350) to Station 48154

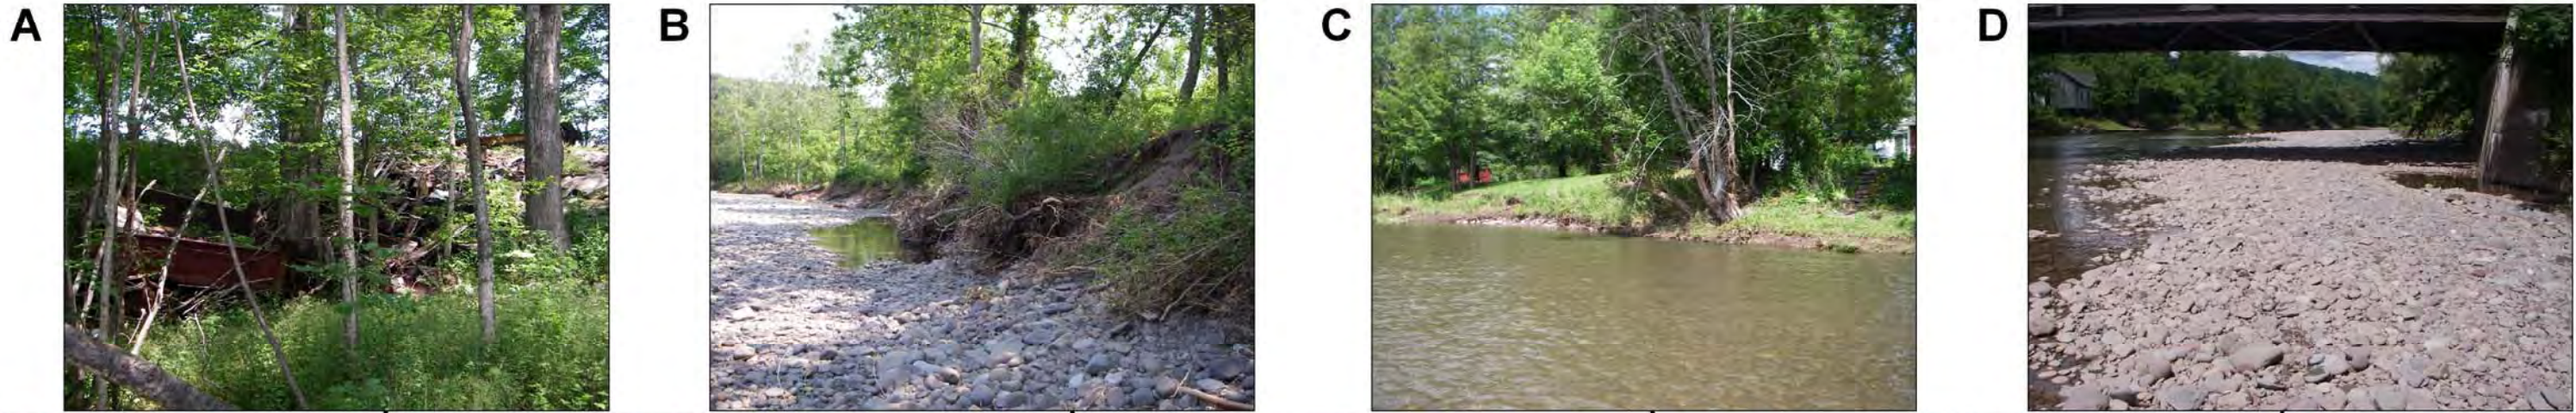
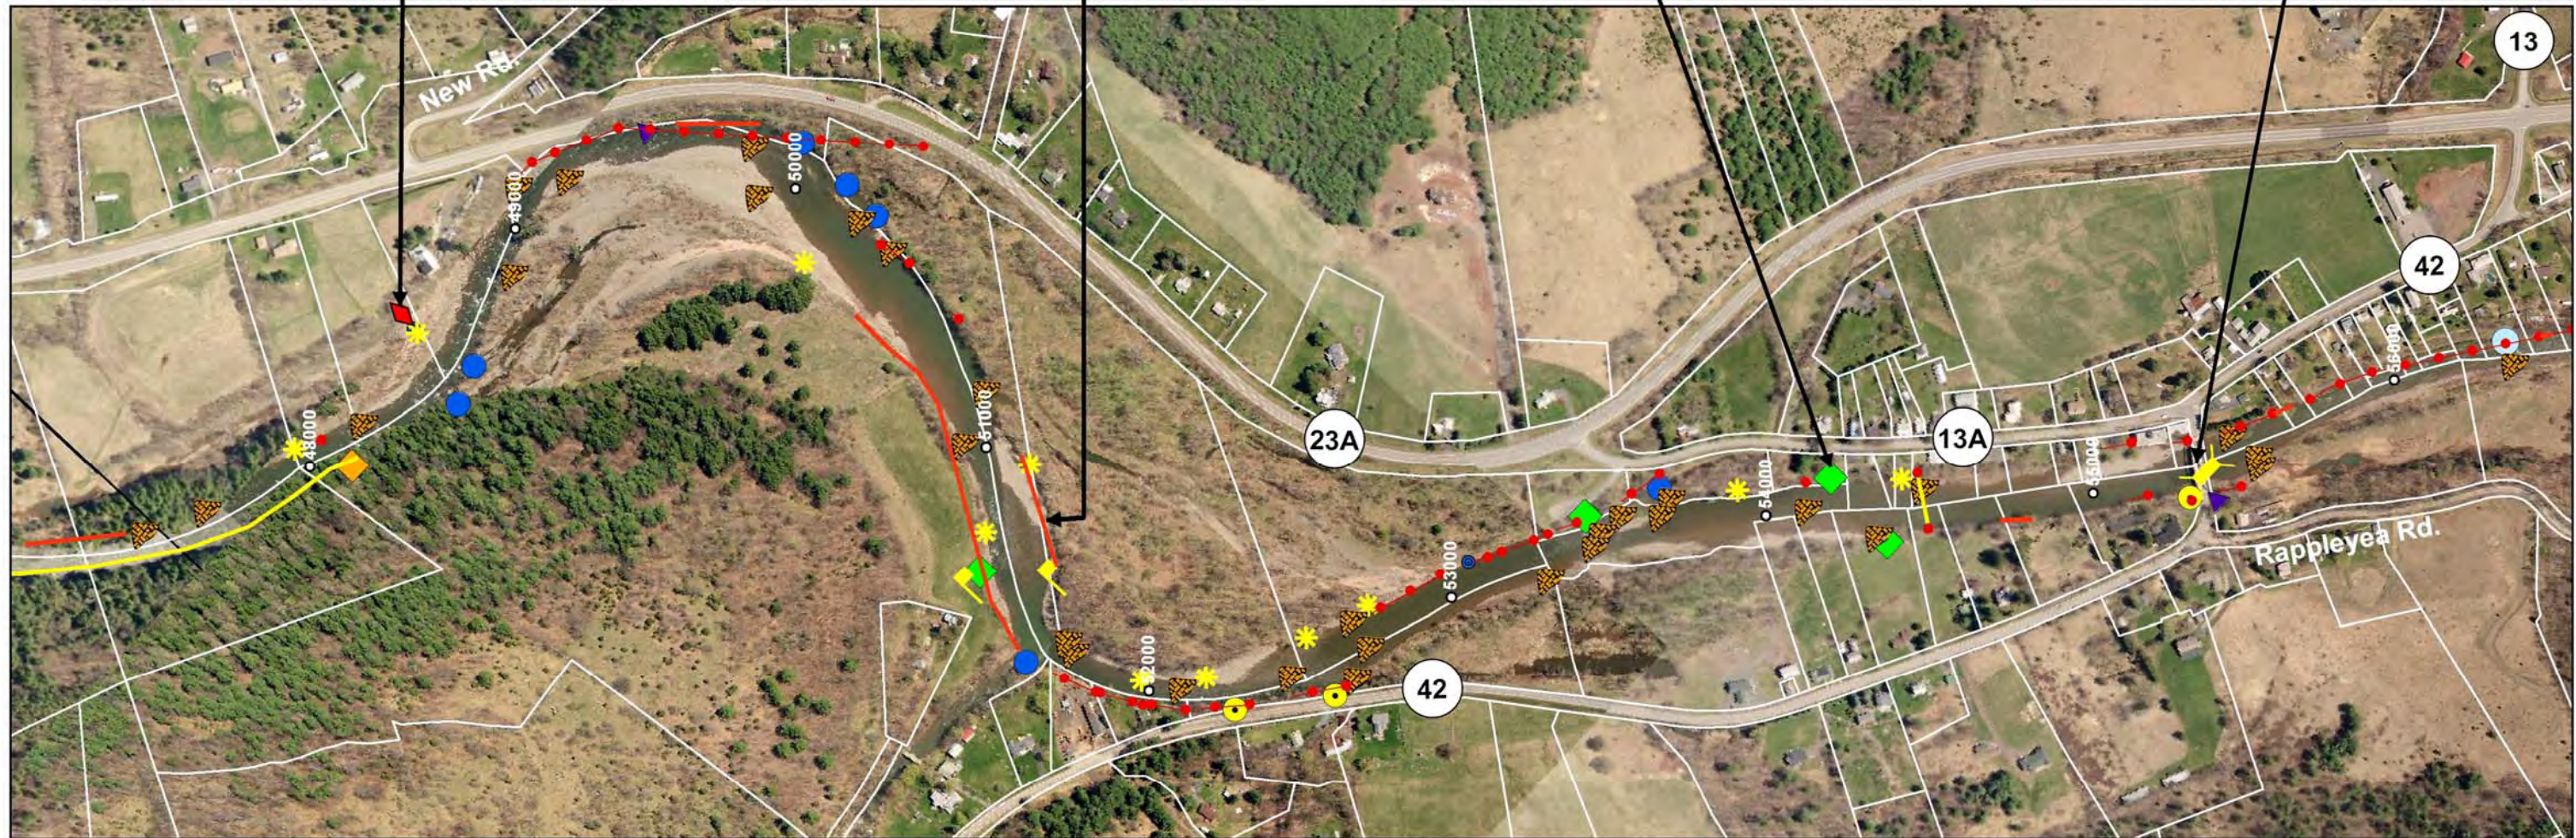
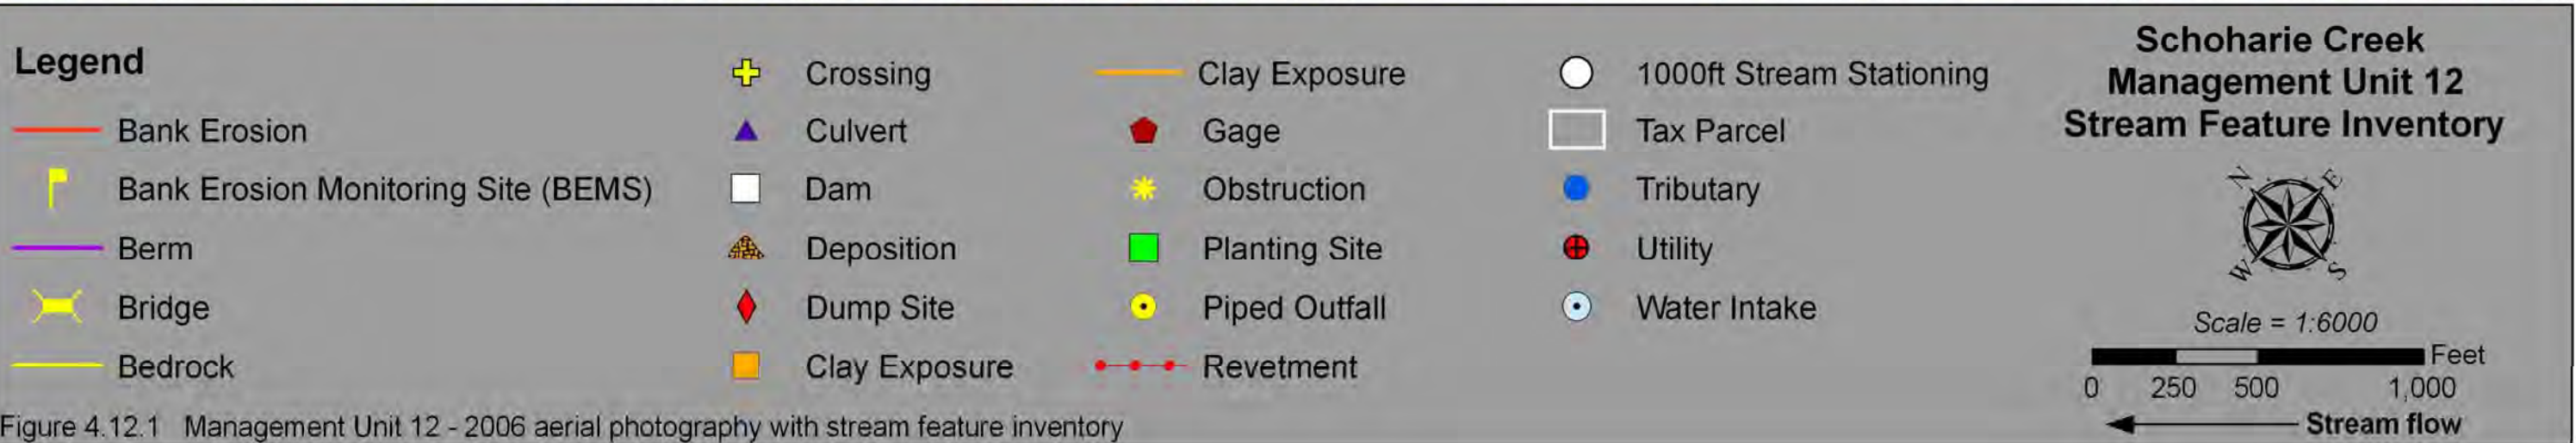
Figure 4.12.1 Management Unit 12 - 2006 aerial photography with stream feature inventory

The 2006 stream feature inventory revealed that 13.1% (1,884 ft) of the streambanks exhibited signs of active erosion along the 14,391 ft of total channel length in the unit (Figure 4.12.1). The total surface area of active erosion totaled approximately 9,794 ft<sup>2</sup>. *Revetment* has been installed on 22.3% (3,205 ft) of the streambanks. No *berms* were identified in this management unit at the time of the stream feature inventory.
