Schoharie Creek Management Unit 18

Town of Prattsville – County Route 23 Bridge (Station 10486) to Station 0

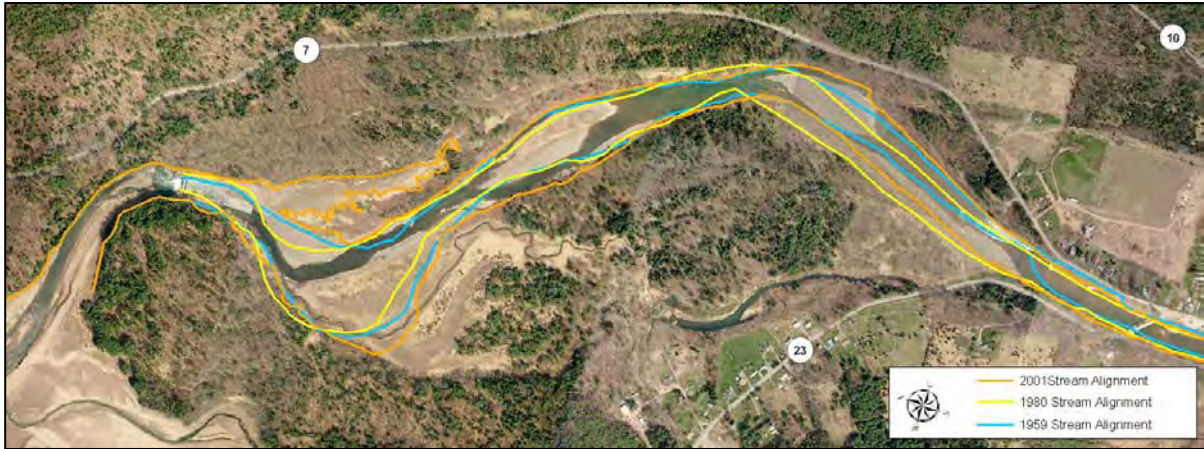
As seen from the historical stream alignments (below), the *planform* of the channel has remained fairly stable since 1959. As of 2006, according to available NYS DEC records dating back to 1996, no stream disturbance permits were issued in this management unit.

Historic stream channel alignments overlaid with 2006 aerial photograph

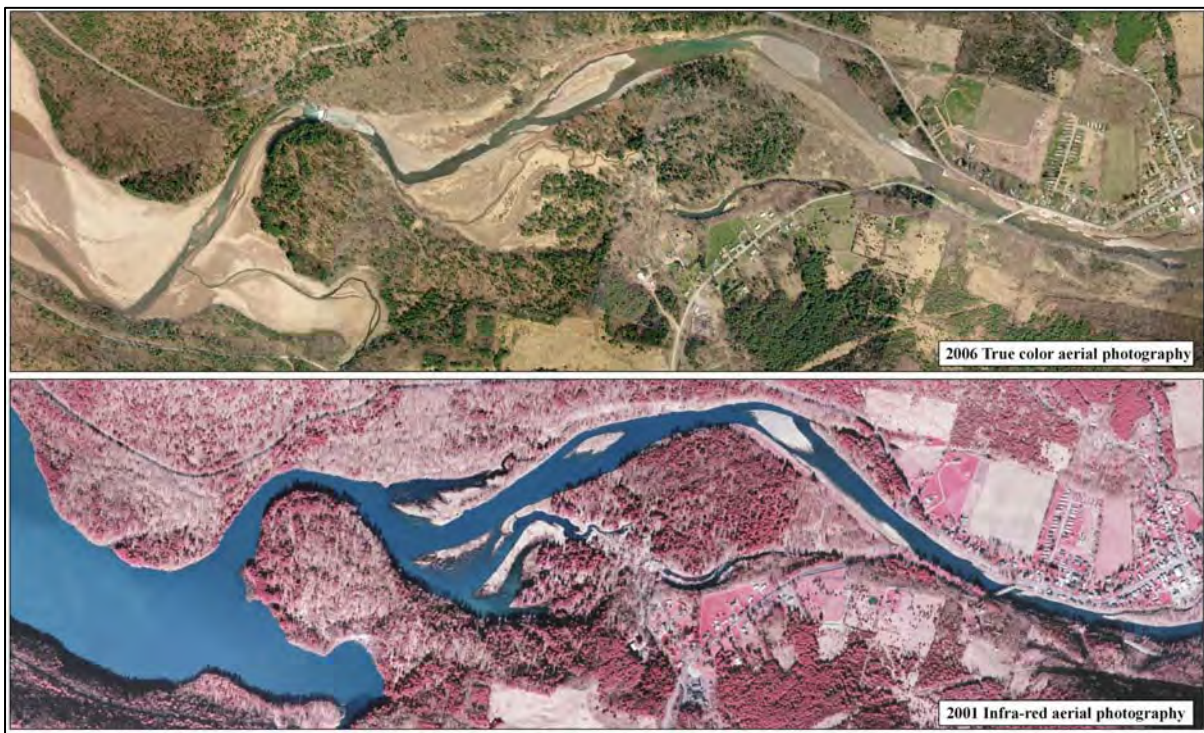
During the 2006 stream feature inventory water levels in management unit 18 were uncharacteristically low (photo below) due reduced water storage in the Schoharie Reservoir necessary while completing upgrades to the Gilboa dam located at the downstream end of the Schoharie reservoir. Following an engineering analysis in 2005, it was determined that the

2001 (bottom photo) & 2006 (top photo) Management Unit 18 aerial photographs

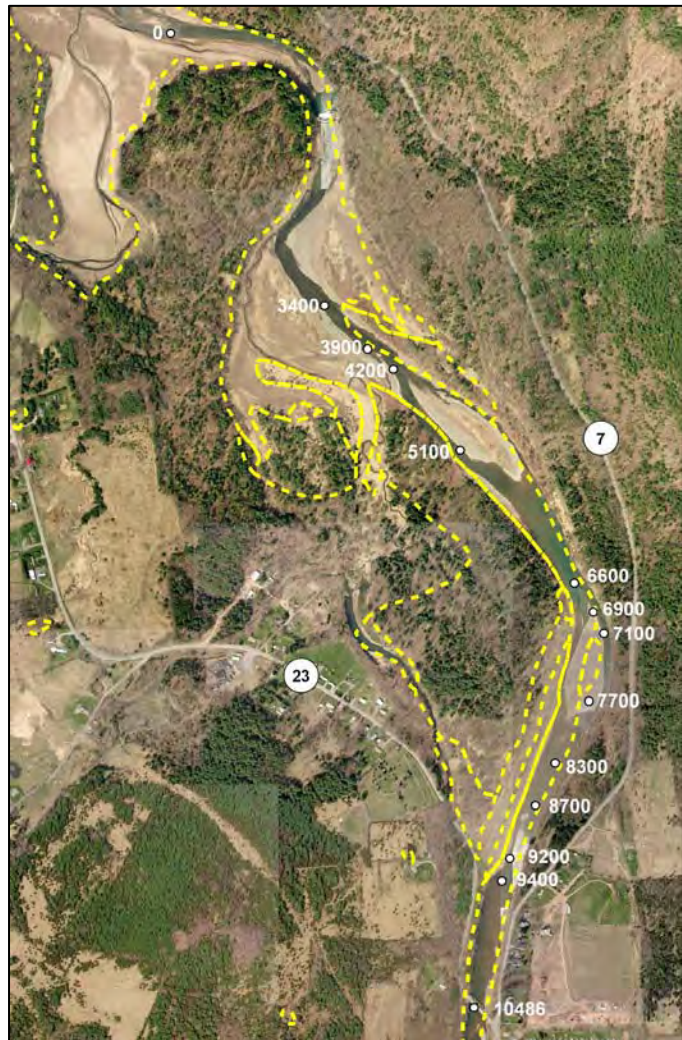
lacustrine wetland (L1UBHh, 95.5ac Station 10486-0). The remaining wetlands were all classified as palustrine wetlands; three were forested (PFO1Ch, 4.7ac, Station 9200-8300) (PFO1Ah, 60.7ac, Station 8700-4200) (PFO1Ah 6.9ac, Station 5100-3400), one had shrub-scrub vegetation (PSS1Ch, 4.3ac, Station 5100-3900) and four were dominated by emergent vegetation (PEM1Ch, 4.0ac, Station 9400-7100) (PEM1Ch, 1.1ac, Station 7700-7100) (PEM1Ch, 0.5ac, Station 6900-6600) (PEM1Ch, 2.5ac, Station 4200-3400). Wetlands are important features in the landscape that provide numerous beneficial functions including protecting and improving water quality, providing fish and wildlife habitats, storing floodwaters, and maintaining surface water flow during dry periods (see Section 2.6 for detailed wetland type descriptions).

*Wetlands (Station 0-10486)
approximate wetland boundary delineated by NWI*

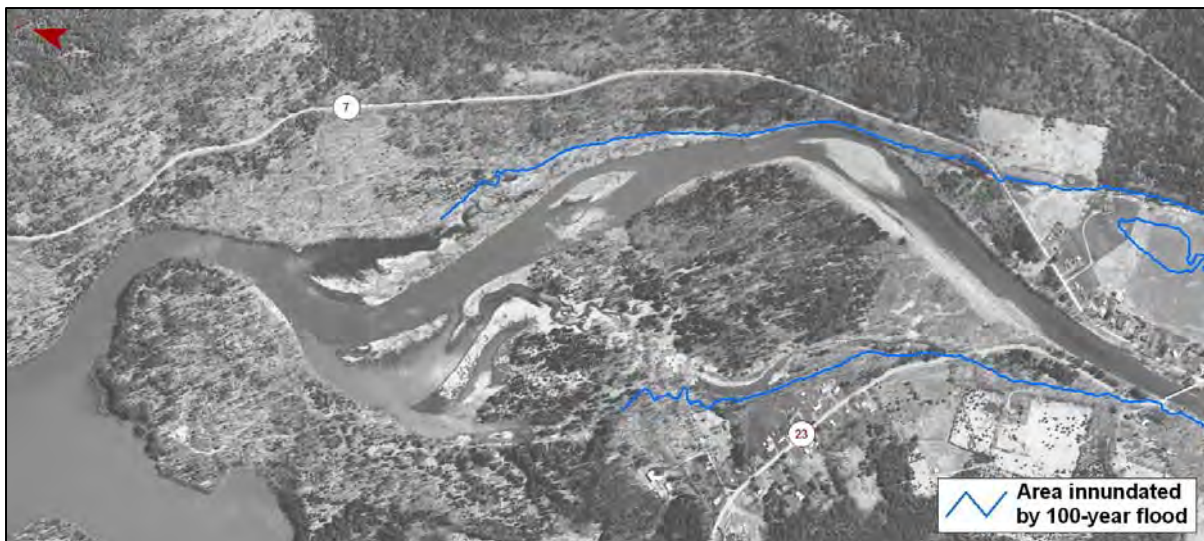
100-year floodplain boundary map
