# West Kill Management Unit 2

## Management Unit 2

Between Station 53971 and Station 51153

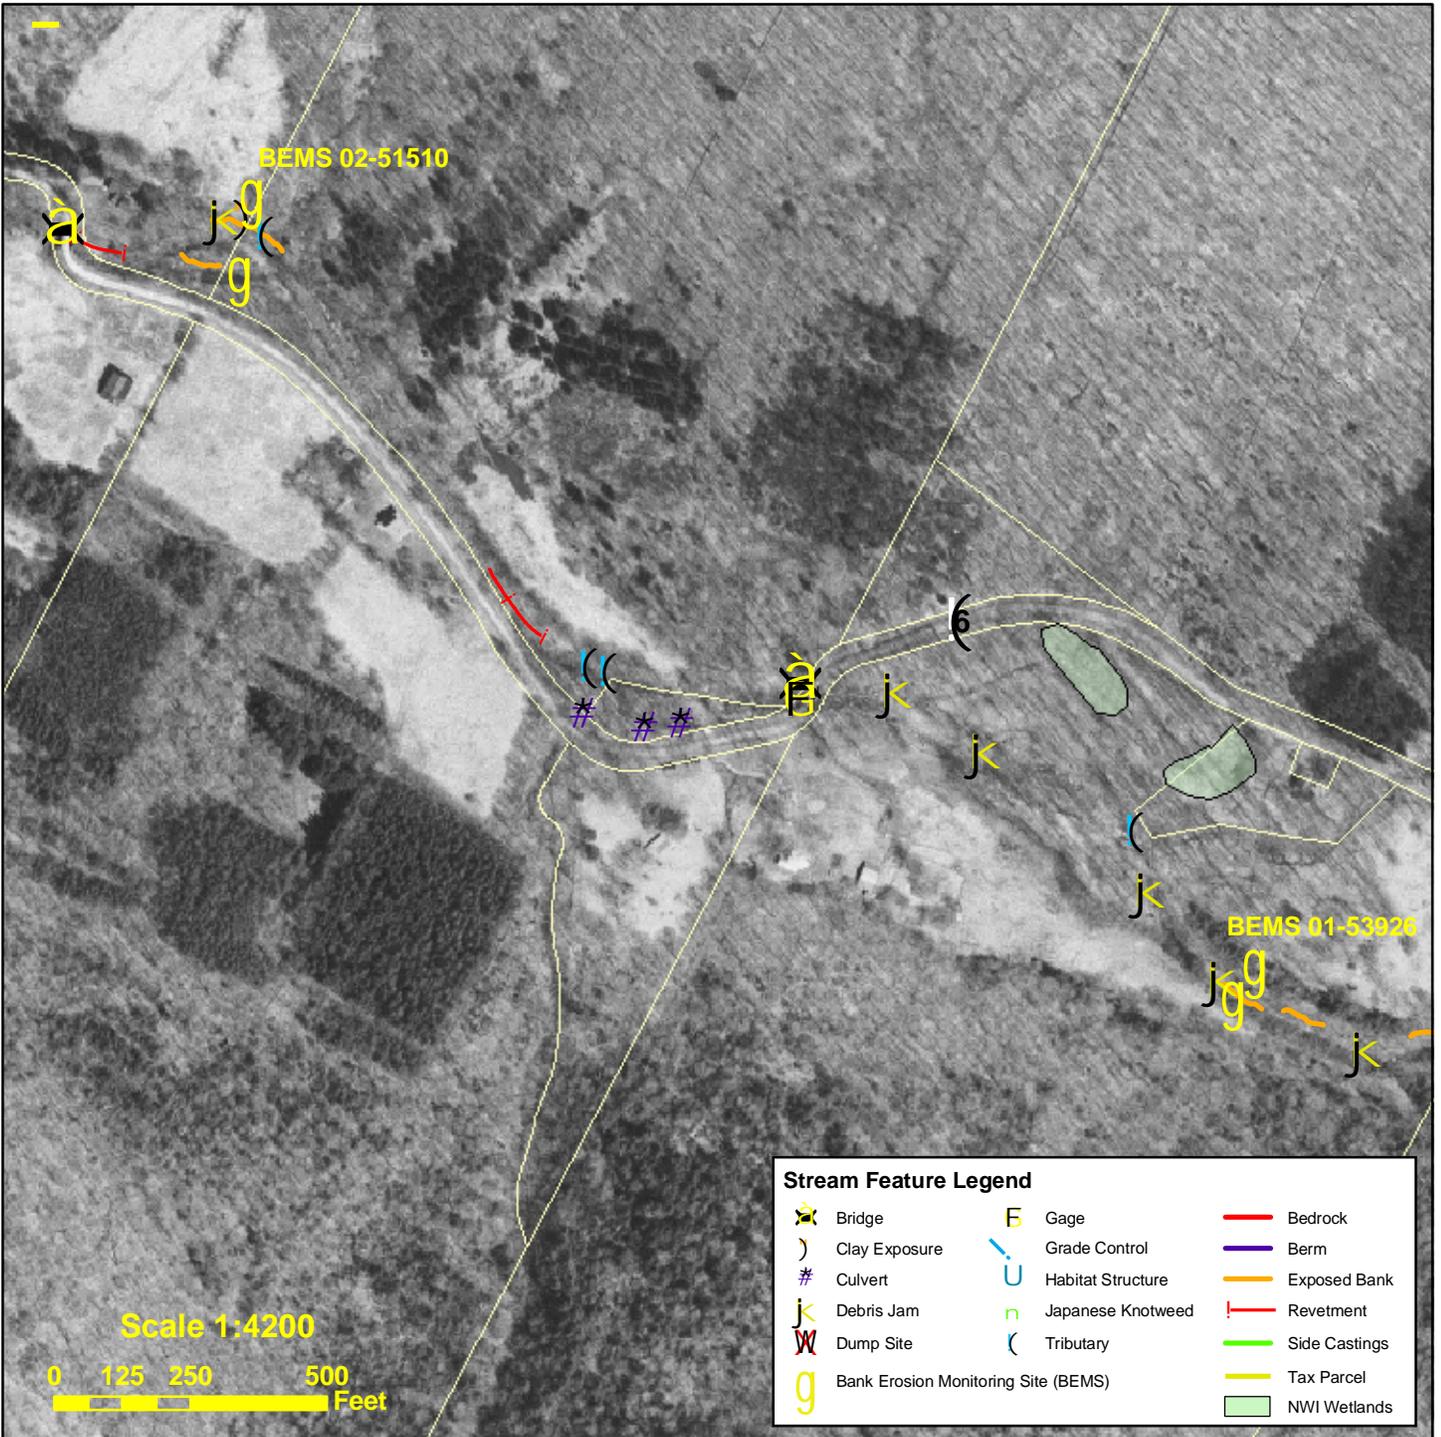
Figure 4.2.1 2004 aerial photography with stream feature inventory and tax parcels

The 2004 stream feature inventory revealed three eroding banks. Eleven (11) percent (297 ft.) of the total channel length (2818 ft.) exhibited signs of active erosion on one or both banks (Fig. 4.2.1). Two of these areas were significant enough to warrant documentation as Bank Erosion Monitoring Sites (BEMS). There was evidence of one clay exposure in the unit. Nine percent (256 ft.) of the total channel length was revetted, and no berms were observed.

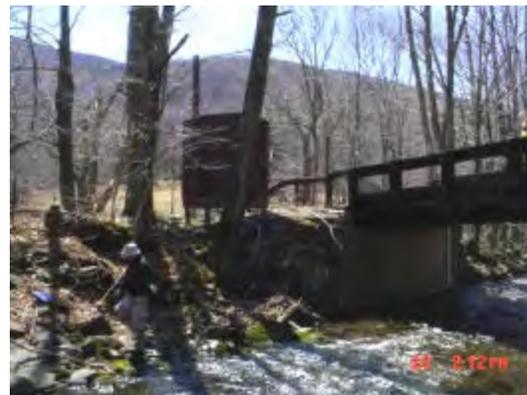
**USGS Gage Station**

As the channel bends to the left on approach to the Spruceton Road bridge (Inset C, Fig. 4.2.2) and USGS gaging station (Gage #01349711), slope increases to 2.2%, and the channel recovers its capacity to transport its sediment load. Dominant bed material remains cobble. A monumented cross-section below the bridge documents a stream type change to B3 (Station 52706).

The mortared stone bridge abutments, with a poured scour wall and a short wing wall upstream on the right, measure approximately 25 ft. from footer to footer. Bankfull channel width at the monumented cross-sections up- and downstream ranges from 36 to 40 ft. The channel constriction at the bridge may be responsible for the aggradational conditions documented upstream. Road ditch drainage enters downstream of the bridge, on the right.

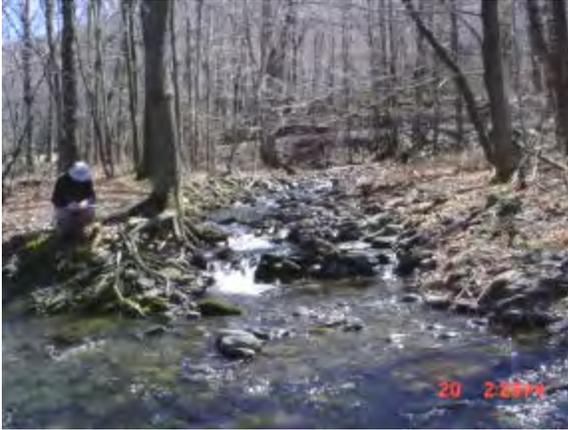
**Pettit Brook Confluence**

Just downstream, Pettit Brook also confluences from the left, through a well-connected floodplain, after passing through a 60” culvert under Spruceton Road (Inset G, Fig. 4.2.2).

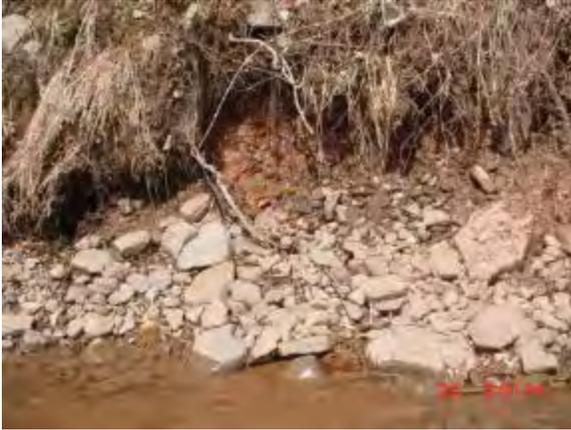
Lake clay also underlies the bed of the mainstem along the right bank, and grasses are growing in the channel bottom (Inset A, Fig. 4.2.2). Some groundwater piping through a clay-rich till exposure in a high bank is evident on the right bank of the right channel thread.

Erosion of the right bank, adjacent to the center bar, has been monumented as a Bank Erosion Monitoring Site (BEMS Station 02-51510) (Inset B, Fig. 4.2.2). In a prioritization of twenty-one BEMS sites throughout the West Kill watershed (see Section 3.3, Watershed Inventory and Assessment), this site ranked Medium Priority. The *thalweg*, or deepest part of the stream channel flows up against the terrace here. The hillslope is being undermined by toe erosion, leaving sections of the stream bank unvegetated. The *exposed ice contact deposits* and *lacustrine* soils have a high silt and clay content, contributing sediment through both *wet and dry ravel* and yielding a significant suspended sediment load during high flows. Clay inputs into a stream are a serious water quality concern because they increase *turbidity*, degrade fish habitat, and can act as a carrier for other pollutants and pathogens.

Recommendations for this site would be for Assisted Self-Recovery, including promotion of a single thread channel by closing the right channel thread with large rock or woody debris, to direct flows away from the terrace wall. This would likely involve establishment of a well-vegetated bench on the right with rock vanes to direct stream flows away from the right bank, and revegetation of the bank face. In-depth survey and design would be required to plan a stream restoration project at this site.
