# West Kill Management Unit 7

## Management Unit 7

Between 39851 and 36944

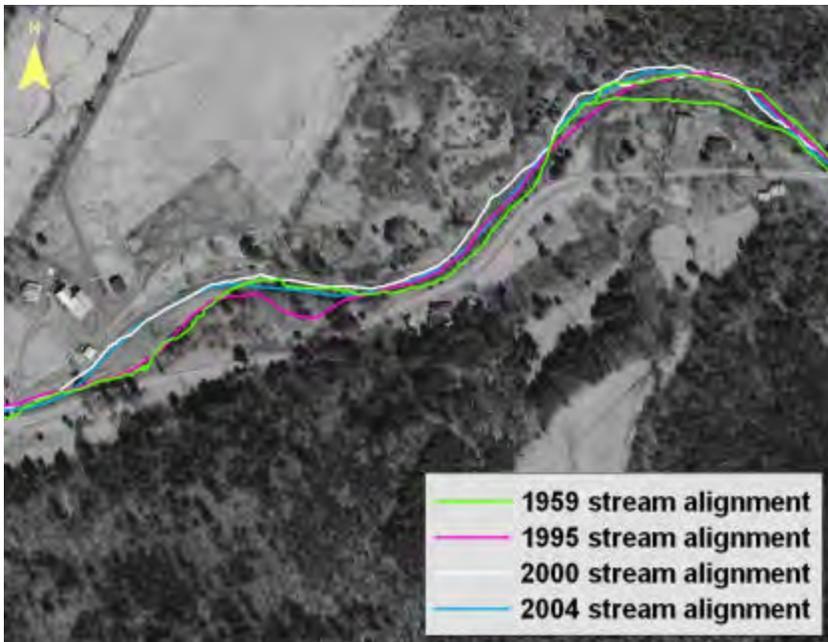
Historic Stream Channel Alignments in MU7

As seen from the historical stream alignments, the channel alignment has changed significantly over the years with some areas exhibiting nearly 100 ft. of lateral channel migration during the period between 1995 and 2000.

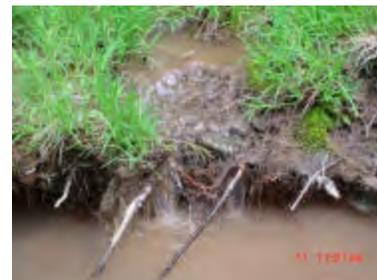
As the channel bends to the left, a small unnamed tributary enters from the right. The tributary flows across a well vegetated low floodplain, before spilling over a small shelf at the confluence. Knotweed was noted on the right bank near the tributary confluence. During the 2004 inventory, one stand of Japanese knotweed (*Fallopia japonica*), an invasive, exotic shrub species that can grow rapidly to

crowd out more beneficial streamside vegetation, was observed here on the right bank. In the 2005 inventory, the number of stands throughout the management unit had increased to four. A program of eradication of Japanese knotweed throughout the West Kill valley is recommended.

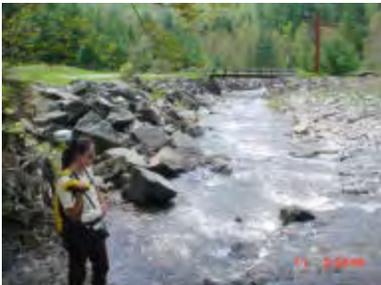
**Rip Rap**

As the channel approaches the Aufarth Road bridge, the channel becomes increasingly confined. A monumented cross-section (station 37179) documents a 256 ft. reach of F3 stream type. The channel slope increases to 1.7% and the stream bed material is dominated by cobble.

The Greene County Route 6 embankment, on the left of this confined approach, is protected by large angular rip-rap. The rip-rap continues downstream of the bridge, extending into Management Unit 8, and is in good condition. Gravel deposits upstream of bridges are commonly caused by inadequate sizing of the bridge opening. An undersized bridge opening causes water to back up upstream of the bridge, reducing stream velocity, which results in sediment deposition. In high stage, the floodwater may seek conveyance through alternative paths, forming new channels around the bridge constriction, as appears to have happened at this site. Additional *floodplain drainage*, using culverts set at the floodplain elevation under the north bridge approach, may help mitigate this problem. Even bankfull flows appear to be constricted by this bridge, and higher flows likely backwater, resulting in the upstream aggradation.

Recommendations in this area include interplanting of the rip-rap, enhancement of the riparian buffer on both the left and right floodplains, and hydraulic analysis of the bridge at Aufarth Road to determine its capacity to convey flood flows.

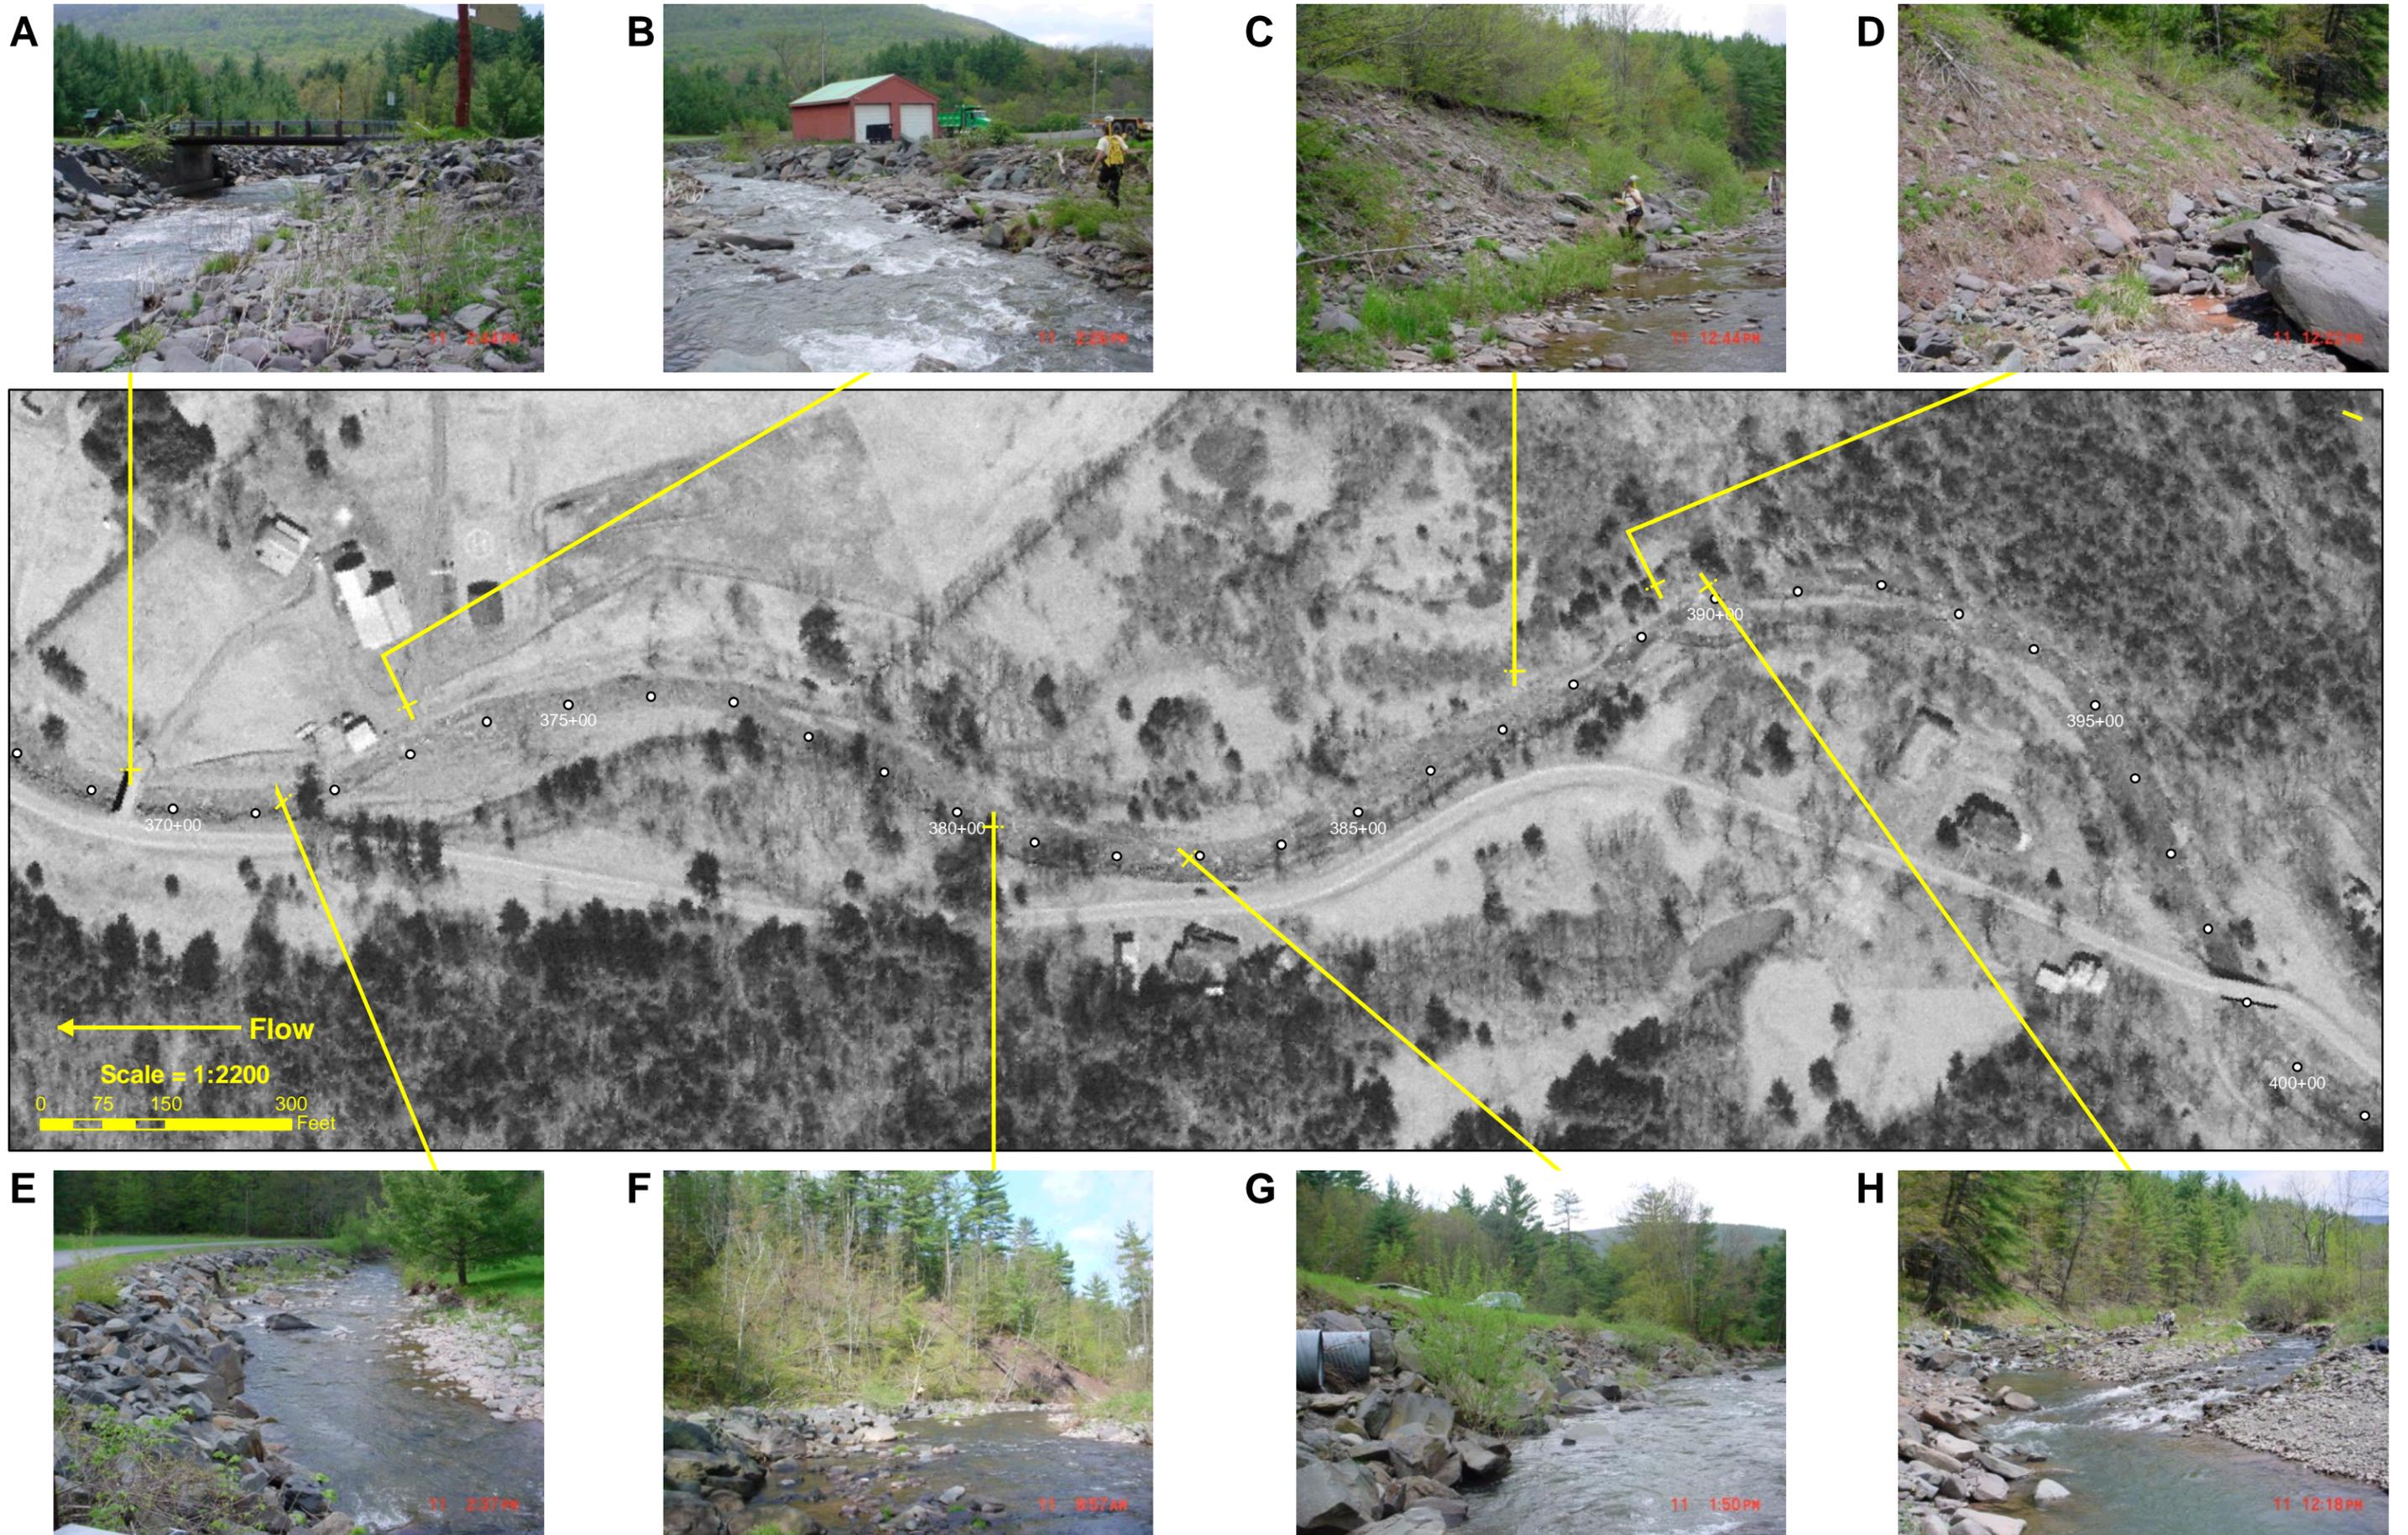
Figure 4.7.2 Management Unit 7 - 2004 aerial photography

The left and right channel threads converge at the tail of the center bar near station 39000 (Inset H, Fig. 4.7.2). A headcut is evident near the convergence of the two channel threads, with several exposures of clay in the reaches immediately downstream of the headcut.

Toe scour prevails at the downstream end of the rip-rap, resulting in significant bank erosion (Inset D, Fig. 4.7.2). This site is documented as a Bank Erosion Monitoring Site (BEMS 07-38945). In a prioritization of twenty-one BEMS sites throughout the West Kill watershed (see Section 3.3, Watershed Inventory and Assessment), this site ranked Medium

As Greene County Rte. 6 again begins to encroach on the stream corridor, and channel confinement increases, bank erosion is evident on the right bank (Inset C, Fig. 4.7.2). A small lateral bar at the toe of the erosion has begun to vegetate, improving the recovery potential of this bank exposure. This site was not documented as a Bank Erosion Monitoring Site.

Approximately 100 ft. downstream of the culvert, rip-rap has been installed on the right bank (Inset B, Fig. 4.7.2). The rip-rap protects a garage located immediately at the top of the bank. The garage and its contents are threatened by both erosion and inundation in the event of a large flood event.

Full restoration is recommended for this site. This would likely involve establishment of a well-vegetated bench on the right with rock vanes to direct stream flows away from the right bank, and revegetation of the bank face. In-depth survey and design would be required to plan a stream restoration project at this site.
