# West Kill Management Unit 10

## Management Unit 10

Between Station 32092 and Station 30263

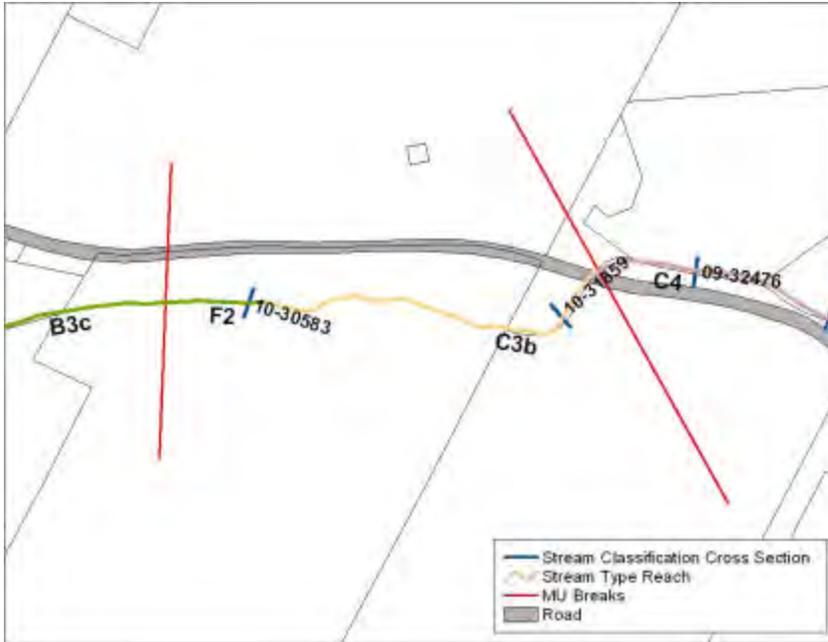
**Cross-sections and Rosgen stream types in Management Unit 10**

Management Unit 10 begins with a 1442 ft. reach of C3b streamtype as documented by a monumented cross-section at Station 31859. Downstream of the bridge, the slope increases significantly to 2.4%, and the dominant material in the channel transitions from gravel to cobble. A healthy riparian buffer protects streambank stability on the left here, and should be preserved. Higher flows have floodplain access on both banks. The riparian vegetation on the right is less mature, and should be allowed to grow into maturity. The channel flows up against the rip-rap protecting the downstream, right embankment and bridge approach, the toe of which is stabilized with sheet piling (see Inset D, Fig. 4.10.2).

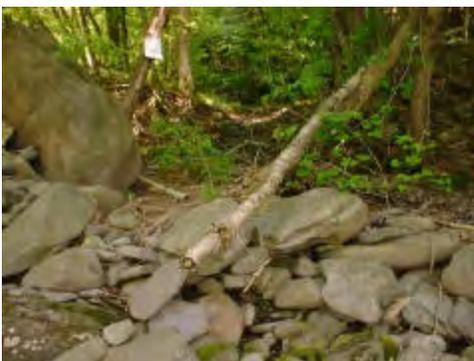
**Tributary, left**

A small tributary enters from the left through the forested buffer, over a somewhat perched floodplain, with good outfall protection. During the 2005 inventory, a number of clusters of Japanese knotweed, an invasive, exotic shrub species that can grow rapidly to crowd out more beneficial streamside vegetation, were observed here on the left bank. A program of eradication of Japanese knotweed throughout the West Kill valley is recommended. The streambed includes abundant small boulders here.

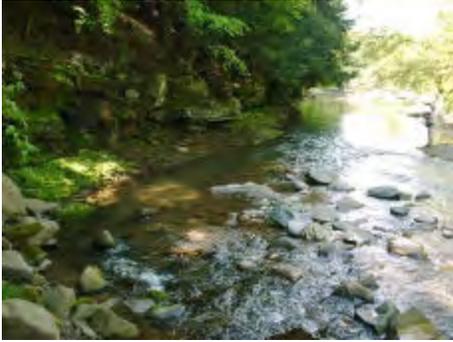
**Bed Rock sill at bend in channel**

As the channel meets the base of the valley wall, it is turned to the right by a bedrock bank and bed on the left; it is likely that bedrock provides grade control across the entire channel width, as sub-pavement under the cobble bed, but it could not be confirmed on the right.

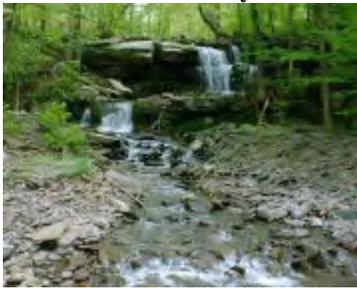
**Hagadore Brook confluence, left, perched**

A major tributary, Hagadore Brook (0.7mi.<sup>2</sup>) confluences from the left over a bedrock ledge, forming a waterfall and then crossing a narrow lateral bar. Downstream of the tributary confluence, the bedrock bank on the left encroaches on the stream, transitioning to a laid stone wall.

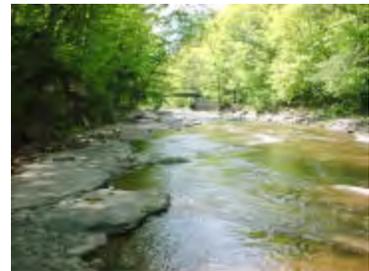
**Bed Rock grade control**

On the approach to the bridge crossing at RCH stables, the bedrock on the left extends into and across the bed, providing grade control. At the bridge itself, the abutments narrow the channel considerably. As described earlier, this undersized bridge opening causes water to back up upstream of the bridge, reducing stream velocity,

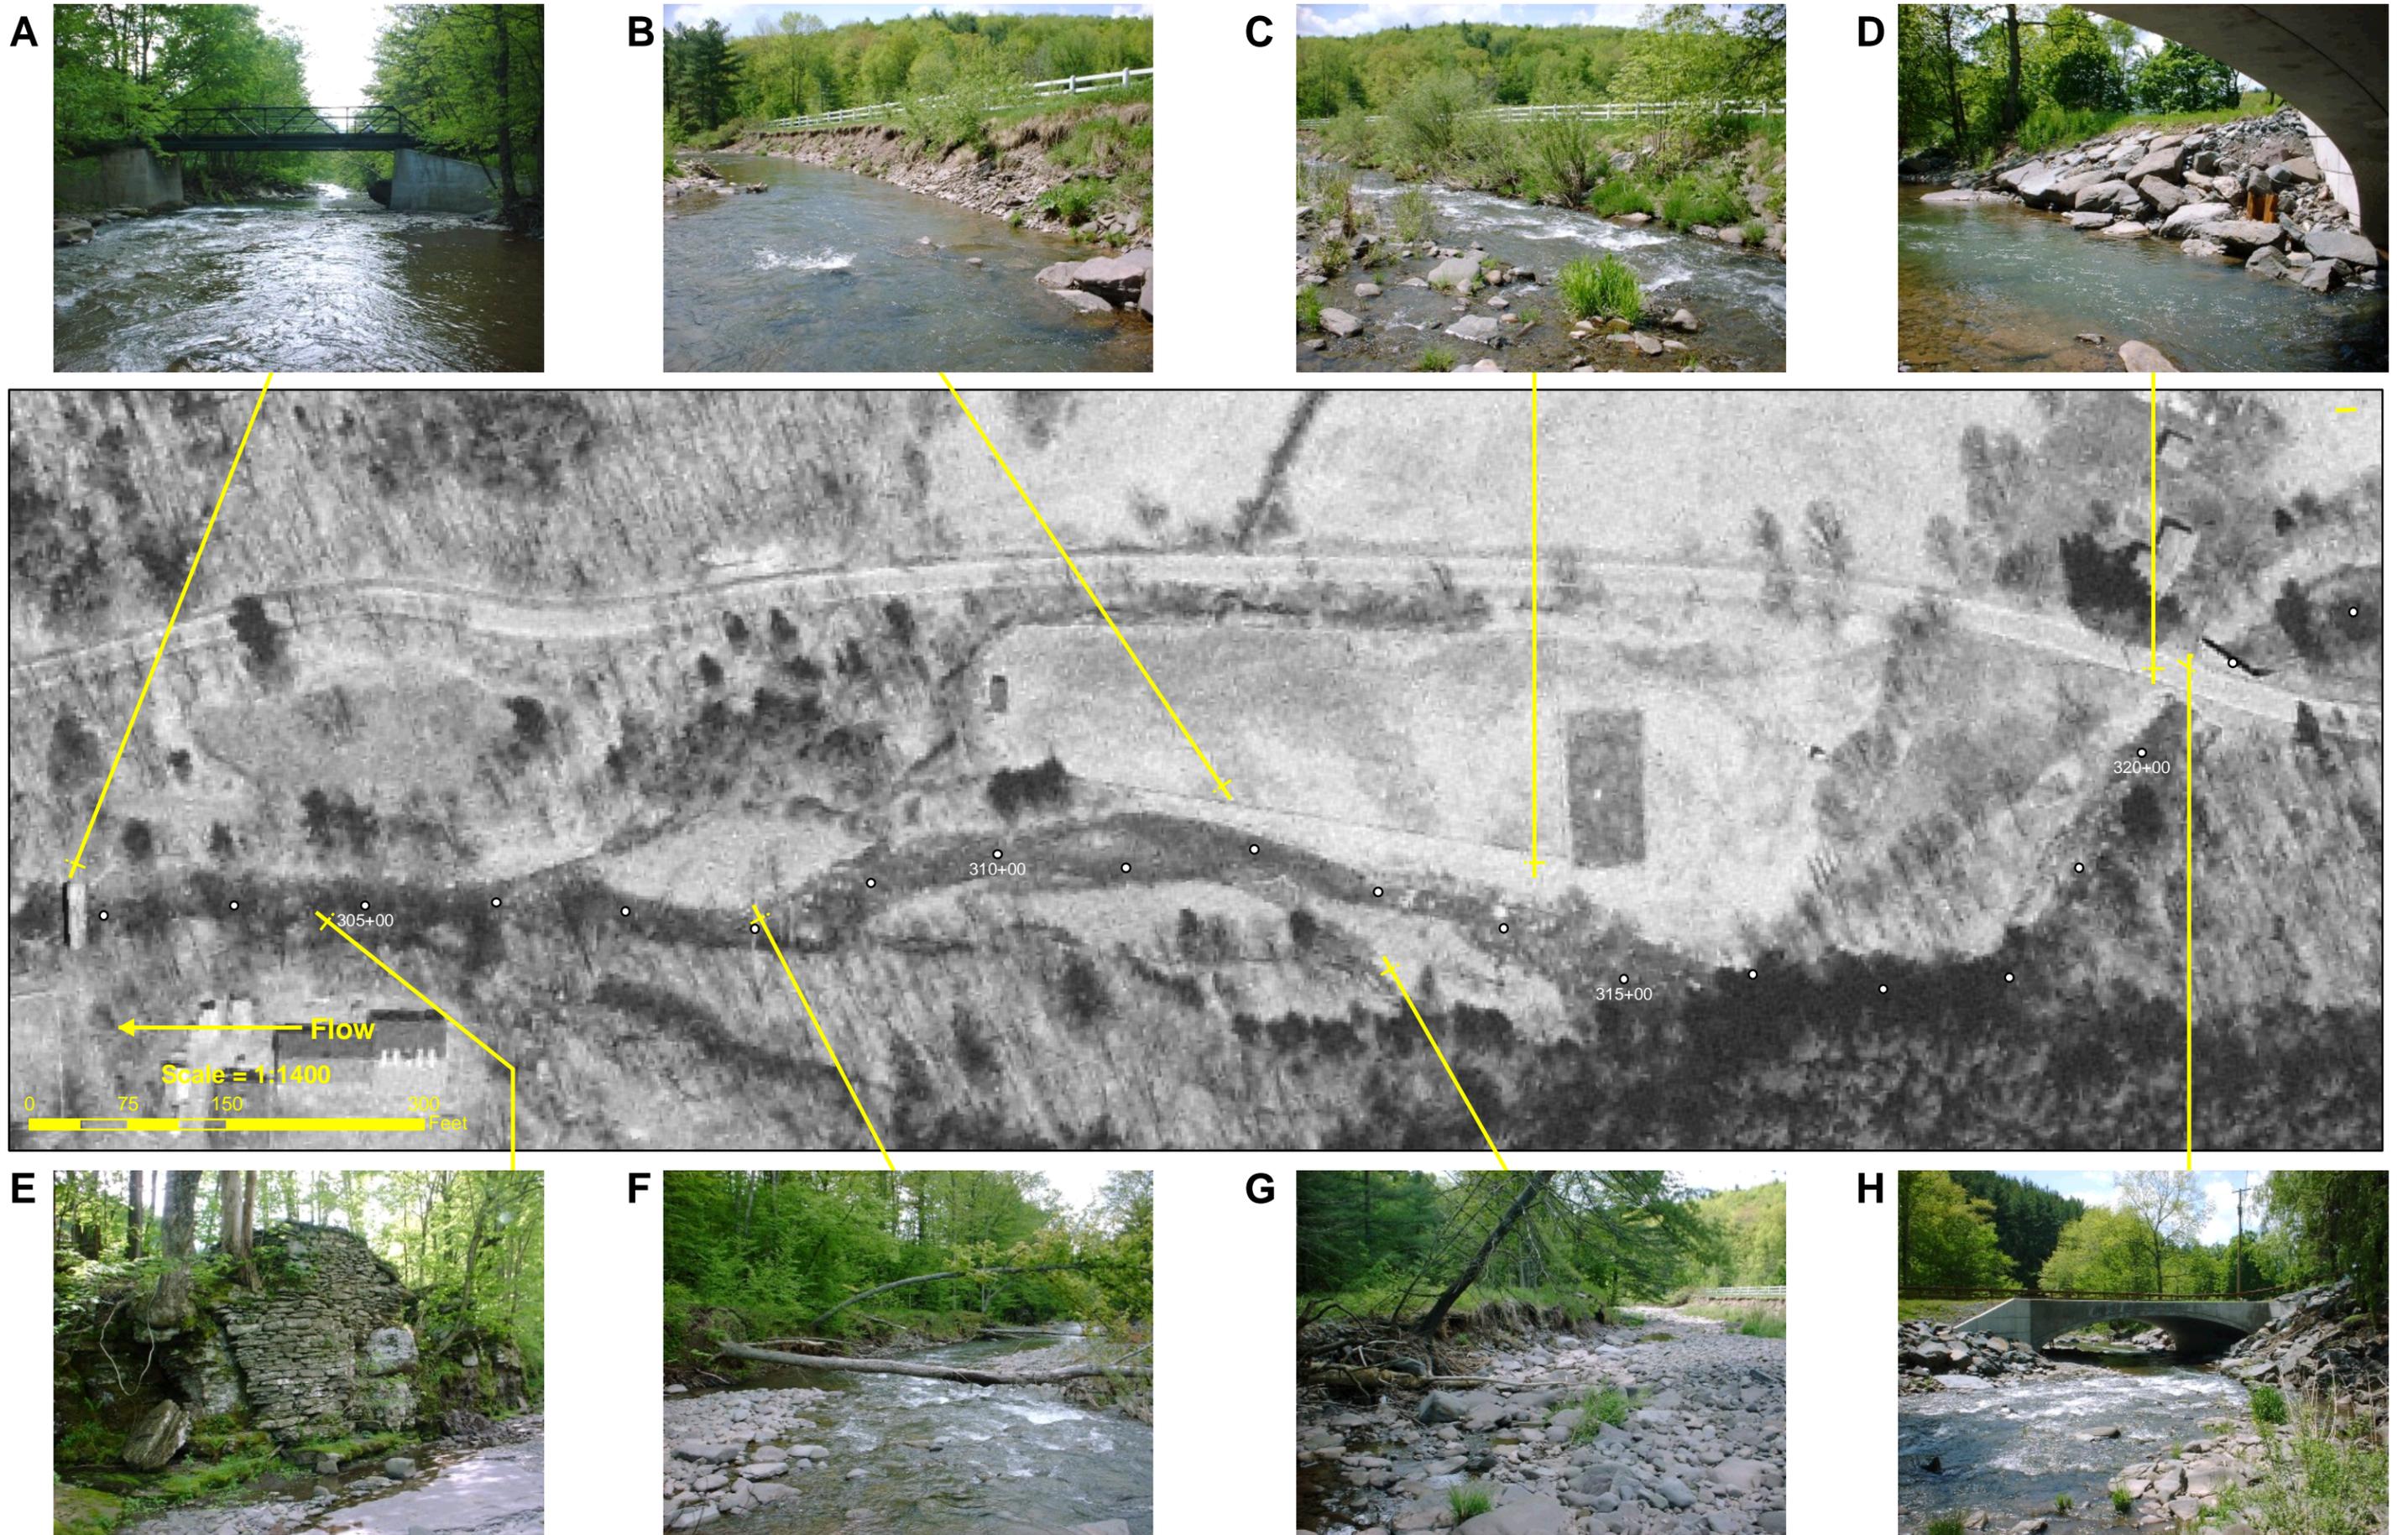
Figure 4.10.2 Management Unit 10 - 2004 aerial photography

- 31% of stream length is experiencing erosion
- 26% of stream length has been stabilized
- 8.6 acres of inadequate vegetation within the 300 ft. buffer
- 0 ft. of stream is within 50 ft. of the road
- 0 houses located within the 100-year floodplain boundary

Summary of Recommendations Management Unit 10	
Intervention Level	Full Restoration at bank erosion sites in the middle of the management unit.
Stream Morphology	Design of channel morphology to improve sediment transport effectiveness.
Riparian Vegetation	Reestablishment of vegetative buffer along pasture.
Infrastructure	Interplant stable reve tment; replace failing riprap with natural channel design treatments.
Aquatic Habitat	Watershed-wide study.
Flood Related Threats	Mitigate erosion threats.
Water Quality	Isolate clay exposures; improve buffer at pasture.
Further Assessment	Investigate areal extent of lacustrine clay lens.
