West Kill Management Unit 11

Stream Feature Statistics

Management Unit 11
Between Station 30263 and Station 26957

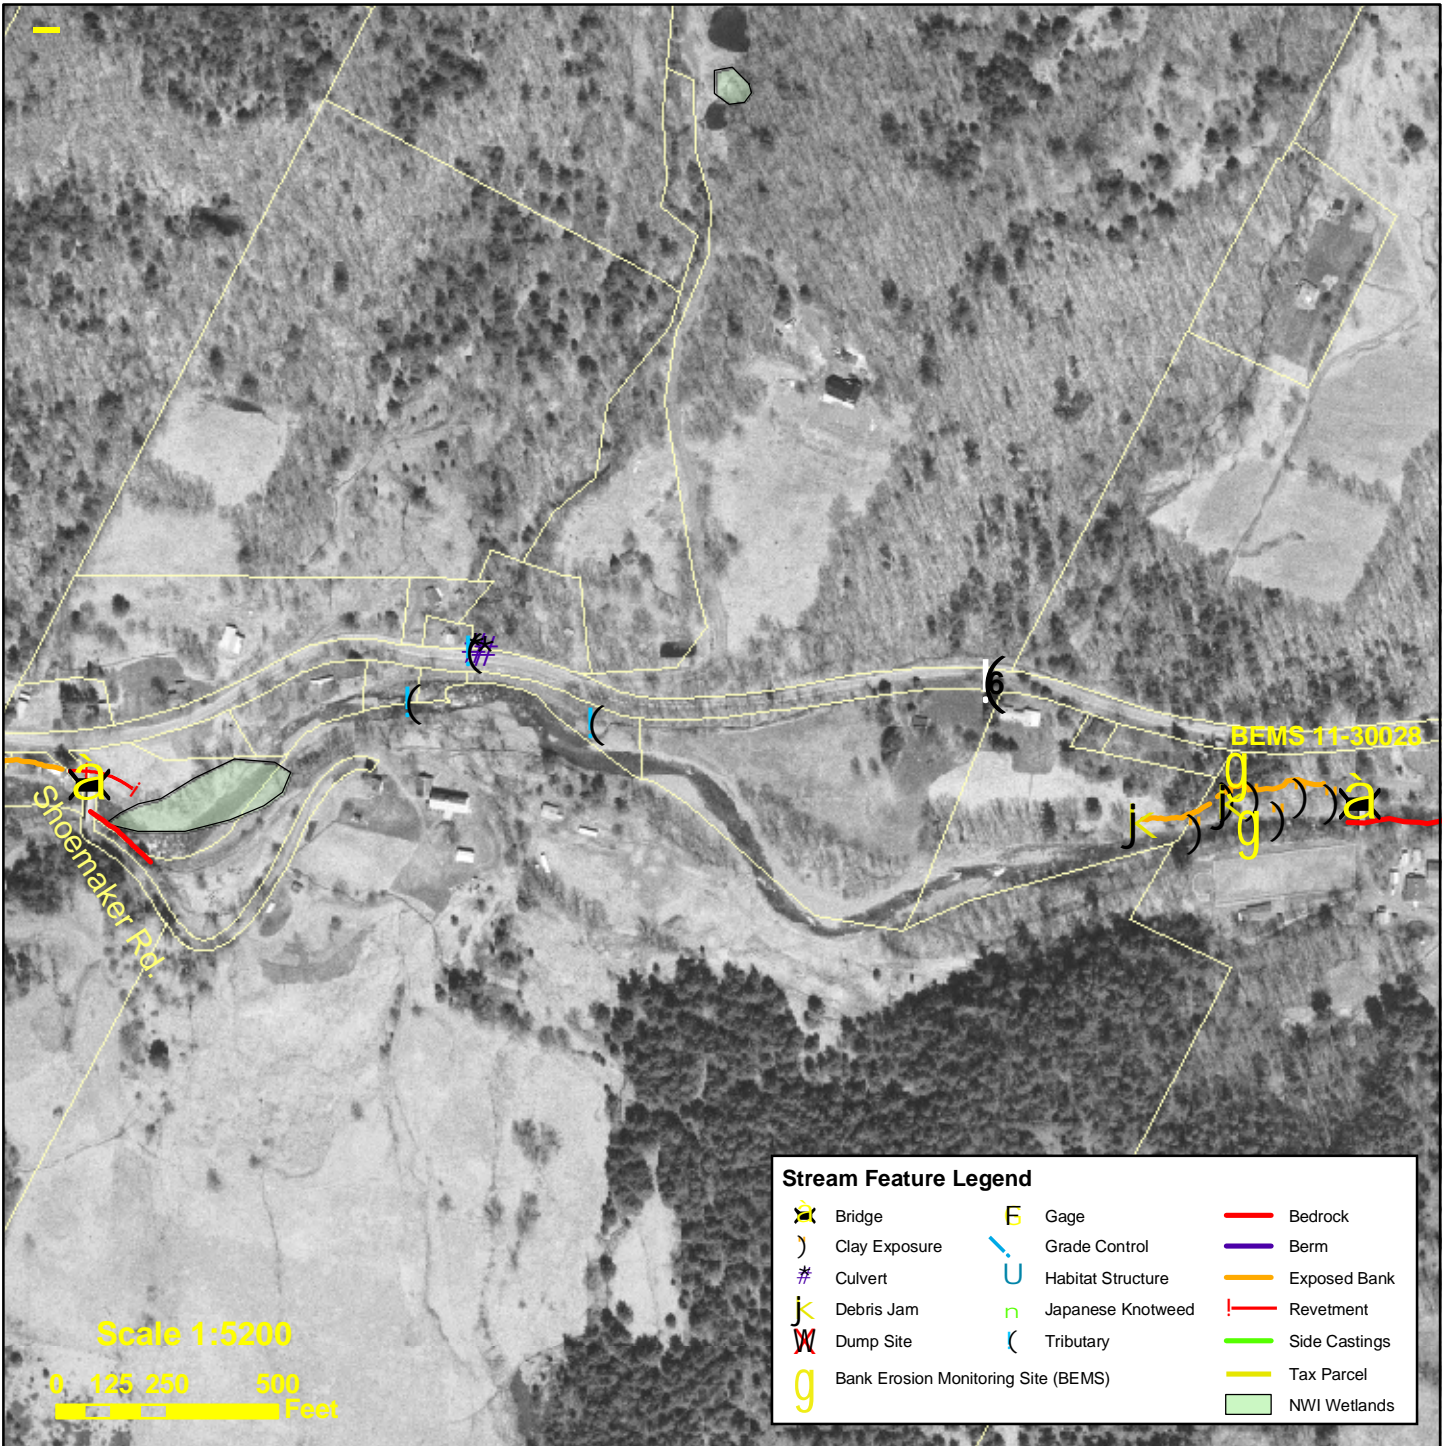
Figure 4.11.1 2004 aerial photography with stream feature inventory and tax parcels

- 13% of stream length is experiencing erosion
- 3% of stream length has been stabilized
- 19.6 acres of inadequate vegetation within the 300 ft. buffer
- 89 ft. of stream is within 50 ft. of the road
- 7 houses located within the 100-year floodplain boundary

The 2004 stream feature inventory revealed that 13% (423 ft.) of the stream exhibited signs of active erosion along 3306 ft. of total channel length (Fig. 4.11.1). Revetment has been installed on 3% (96 ft.) of the stream. This figure, however, does not include a

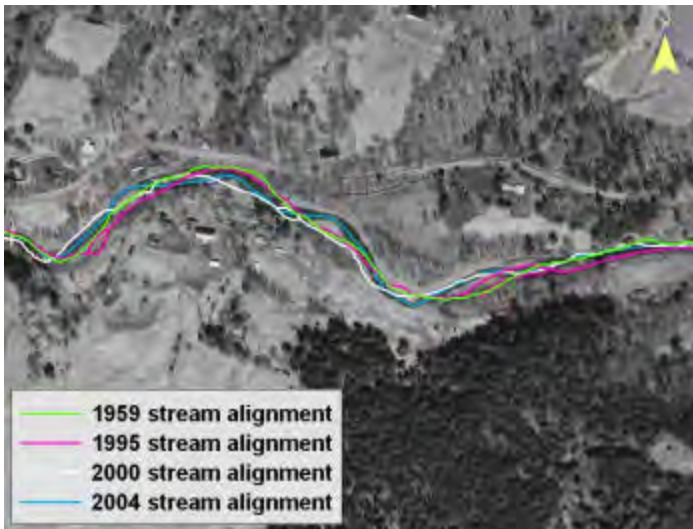
Historic Stream Channel Alignments in MU11

As seen from the historical stream alignments, the channel alignment has changed somewhat over the years. Channel alignment changes evident in the 2004 stream alignment are the result of channel modifications made as a component of the West Kill Demonstration Project #1. Changes evident in previous years, however, indicate a history of lateral extension, trending toward increased sinuosity and belt width.

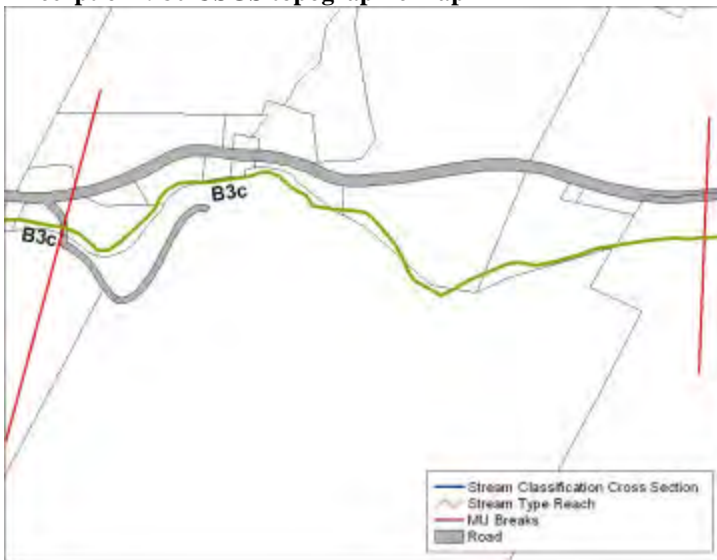
Cross-sections and Rosgen stream types in Management Unit 11

This management unit is bounded by pinch points and bedrock grade controls at the RCH Stable bridge, and the bridge at Shoemaker Road. Though the alluvial terrace to the north broadens, the channel remains confined, with little access to the floodplain. This management unit contains West Kill Stream Restoration Demonstration Project #1.

Management Unit #11 is characterized by a 3306 ft. reach of B3c stream type. The channel is moderately *entrenched*, or somewhat confined within the stream

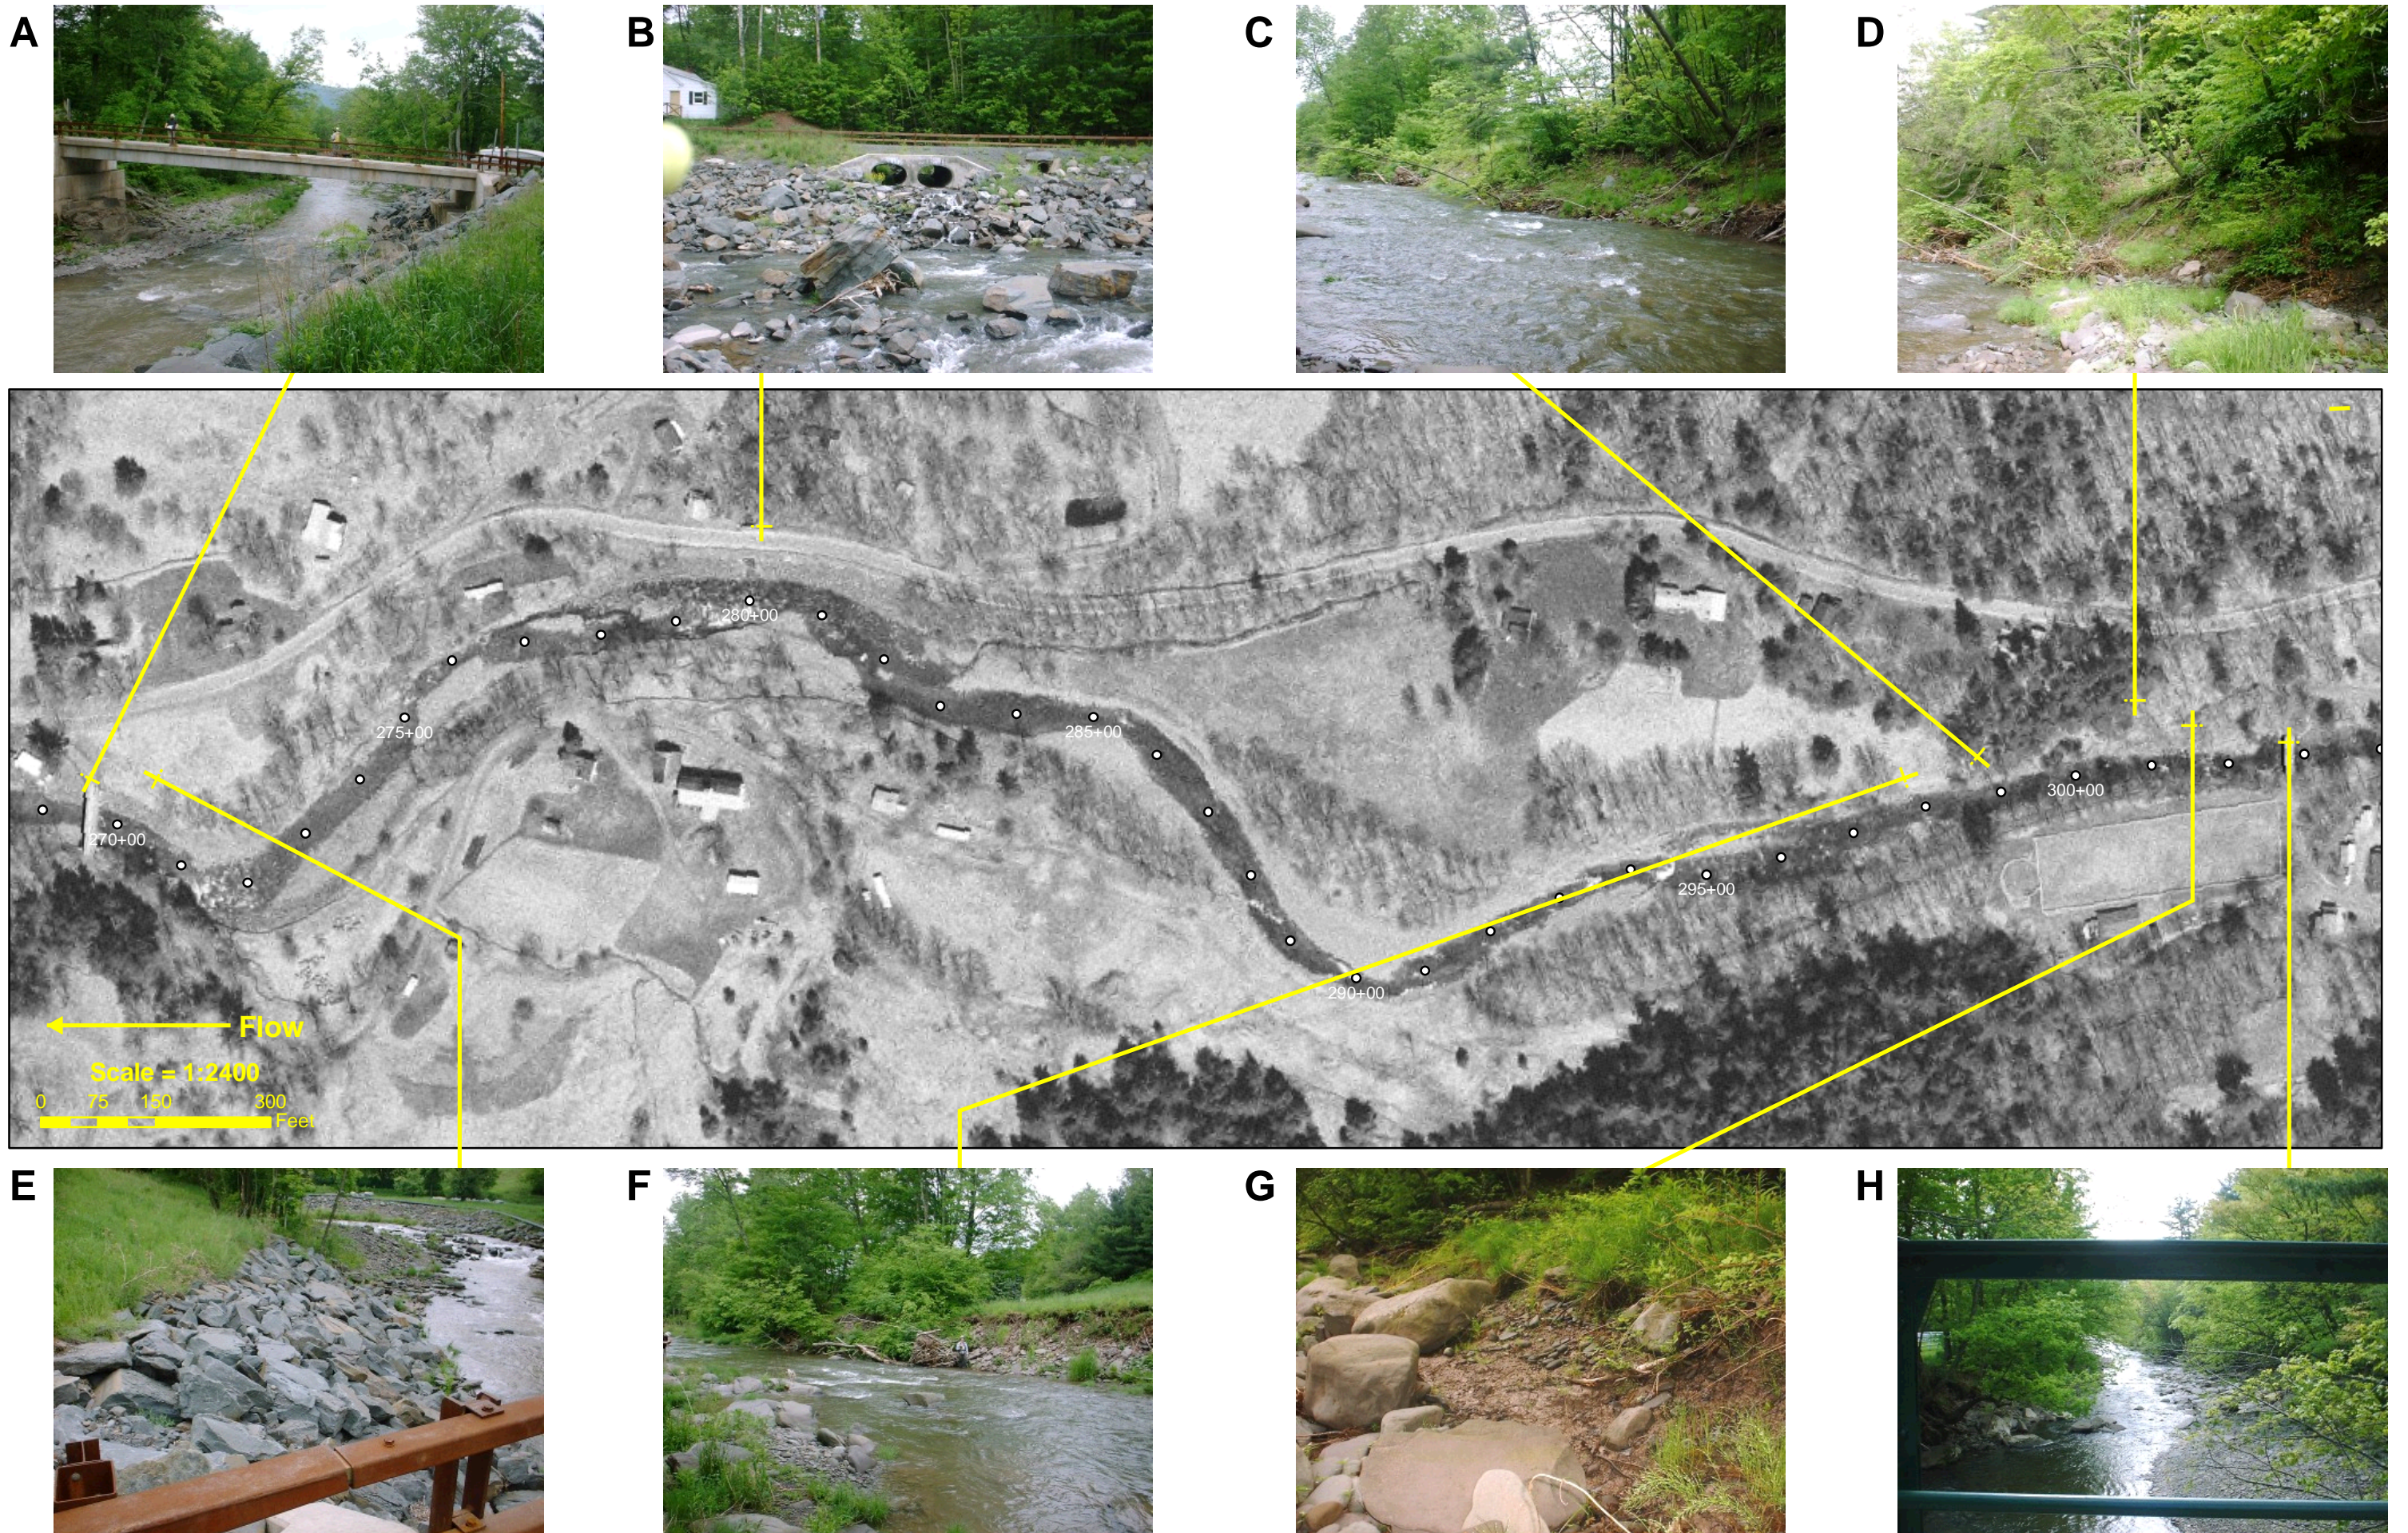
Figure 4.11.2 Management Unit 11 - 2004 aerial photography

Six significant clay exposures (Inset G, Fig. 4.11.2) were identified during the 2004 walkover in the reach between Station 30250 and Station 29900. The exposed lacustrine clay deposits

were discovered on both the left and right banks and in the bed throughout the reach. The *exposed lacustrine* deposits have a high silt and clay content, contributing sediment through both *wet and dry ravel* and yielding a significant suspended sediment load during high flows. Clay inputs into a stream are a serious water quality concern because they increase *turbidity*, degrade fish habitat, and can act as a carrier for other pollutants and pathogens.

bank, and several have become entangled in debris jams (Inset F, Fig. 4.11.2) located on the right bank, at the downstream end of the both the first and second erosion locations. The debris is aligned parallel to the bank, providing some measure of toe protection and creating only a minimal flow obstruction.

The brook flows under Greene County Route 6 through a concrete twin-elliptical culvert structure before outfalling onto the heavily armored road embankment. A smaller culvert (Inset B, Fig. 4.11.2) just upstream of the concrete culvert conveys roadside drainage to the West Kill under Greene County Route 6.

Shoemaker Road bridge (Insets A and E, Fig. 4.11.2), replaced following the 1996 flood, marks the downstream limit of Management Unit #11 (MU11). The left abutment is poured on bedrock, and the right is armored with heavy rip-rap. No scour is evident at either of the abutments.
