West Kill Management Unit 15

Stream Feature Statistics

Management Unit 15
Between Station 18646 and Station 16010

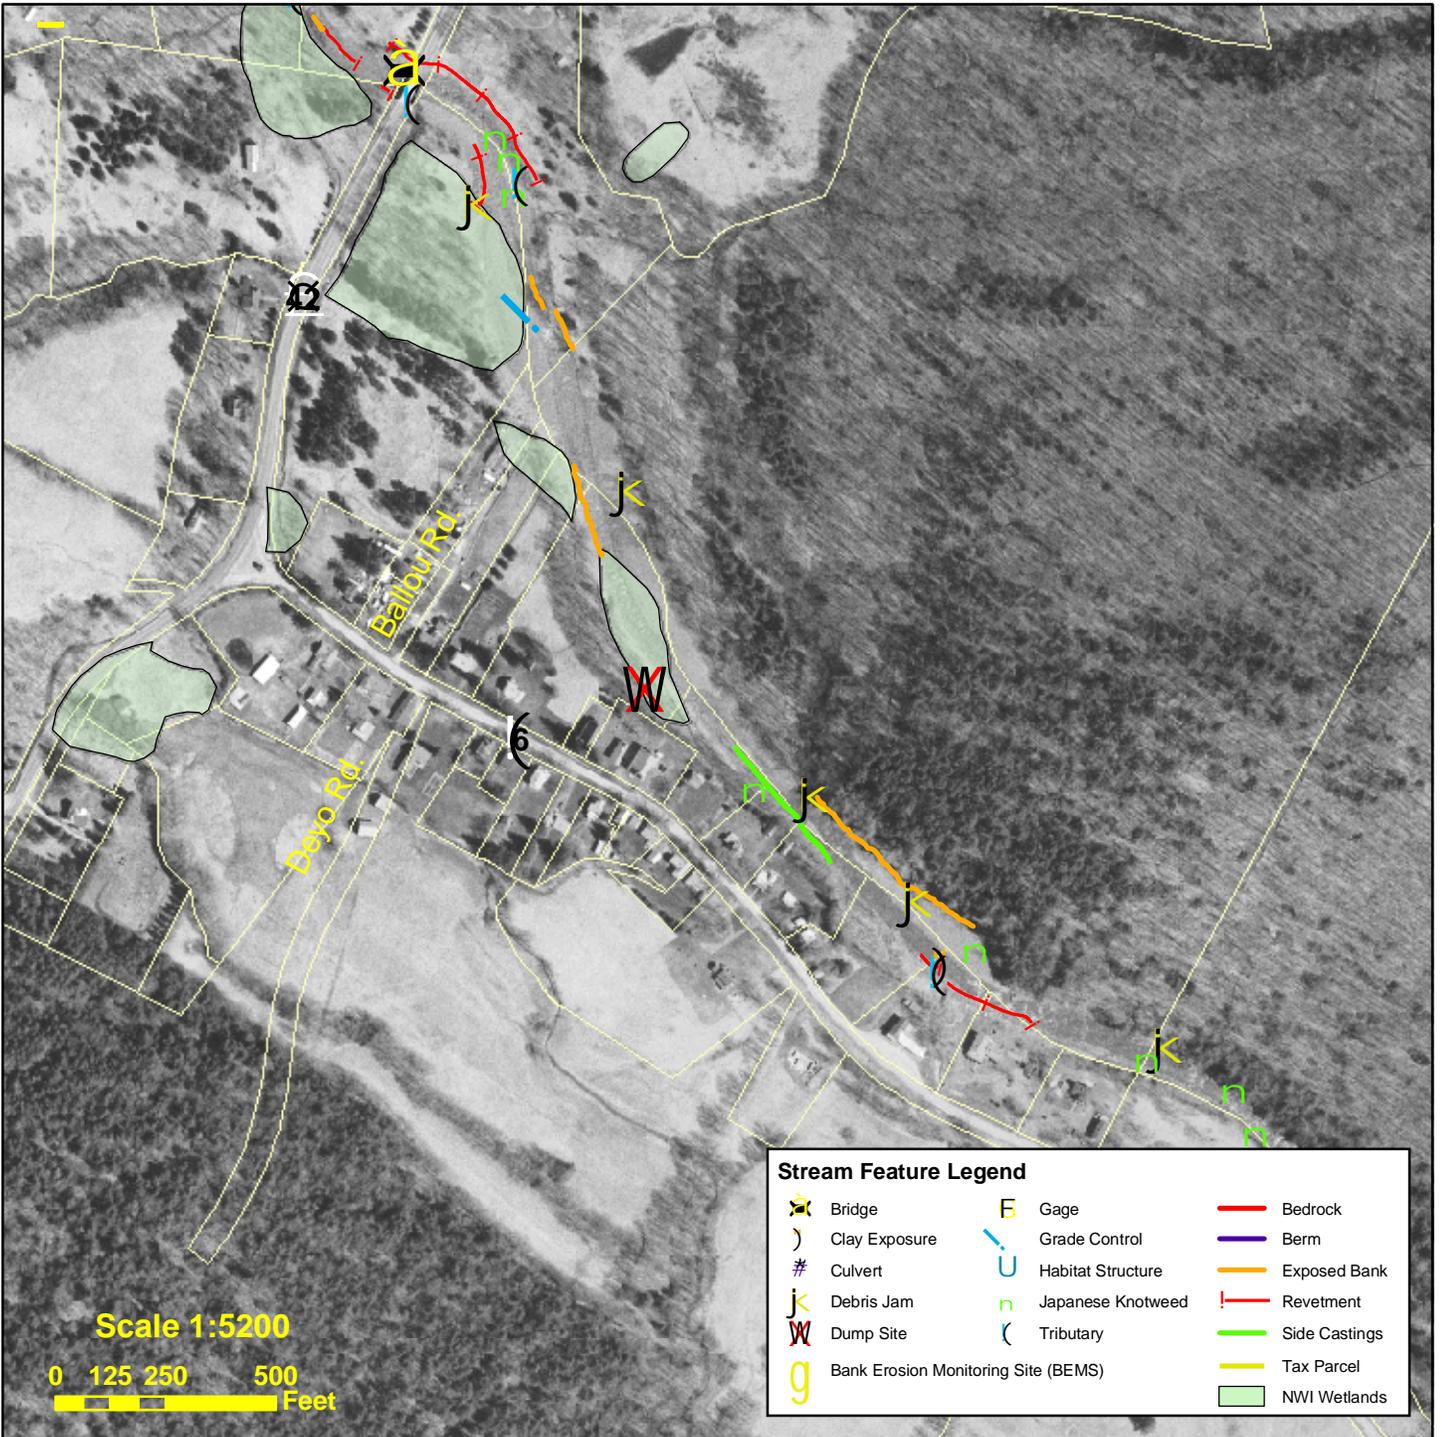
Figure 4.15.1 2004 aerial photography with stream feature inventory and tax parcels

34% of stream length is experiencing erosion
 29% of stream length has been stabilized
 14.0 acres of inadequate vegetation within the 300 ft. buffer
 45 ft. of stream is within 50 ft. of the road
 3 houses located within the 100-year floodplain boundary

The 2004 stream feature inventory revealed that 34% (888 ft.) of the stream length exhibited signs of active erosion along 2636 ft. of total channel length (Fig. 4.15.1).

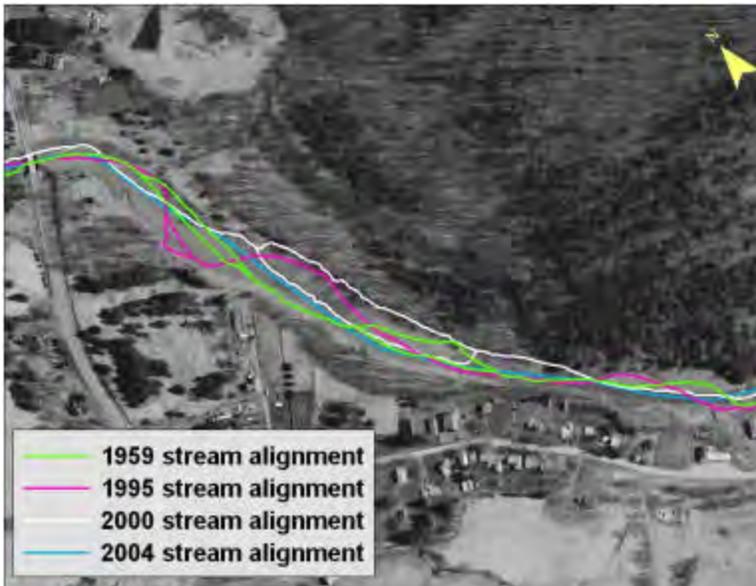
Historic Stream Channel Alignments in MU15

As seen from the historical stream alignments, the channel alignment has changed somewhat over the years. Center bars, evident throughout the period of photographic record, indicate a history of aggradation and lateral migration in this unit.

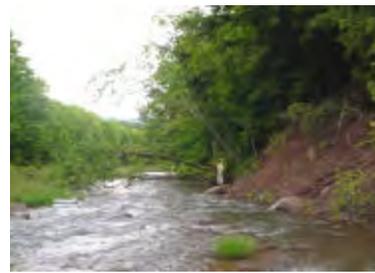
A large bank failure (see Inset D, Fig. 4.15.2) at the right has a large bar formed at its toe. The 482 ft. long failure appears active, with large debris sliding down its face, forming two debris jams at the toe. The first jam is set back on a bar, clear of low flow, but the second spans the low flow channel and causes a significant obstruction at higher flows. The bank is composed of clay rich till, posing a threat to water quality. The recovery potential of this failure is high due to the bar formation at the toe, reducing toe scour and

Debris Jam, right

enhancing the overall stability of the bank. This failure was not monumented as a Bank Erosion Monitoring Site, but monitoring of this failure is recommended.

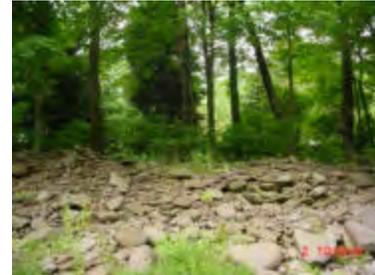
A small stand of Knotweed is found on the terrace just beyond the side castings.

Knotweed, left

Knotweed is observed on a gravel bar to the right of the stream. The stand is small and isolated. During the 2004 inventory, five stands of Japanese knotweed (*Fallopia japonica*), an invasive, exotic shrub species that can grow rapidly to crowd out more appropriate streamside vegetation, were observed throughout this management unit. In the 2005 inventory, the number observed had decreased to four. A program for eradication of Japanese knotweed throughout the West Kill valley is recommended.

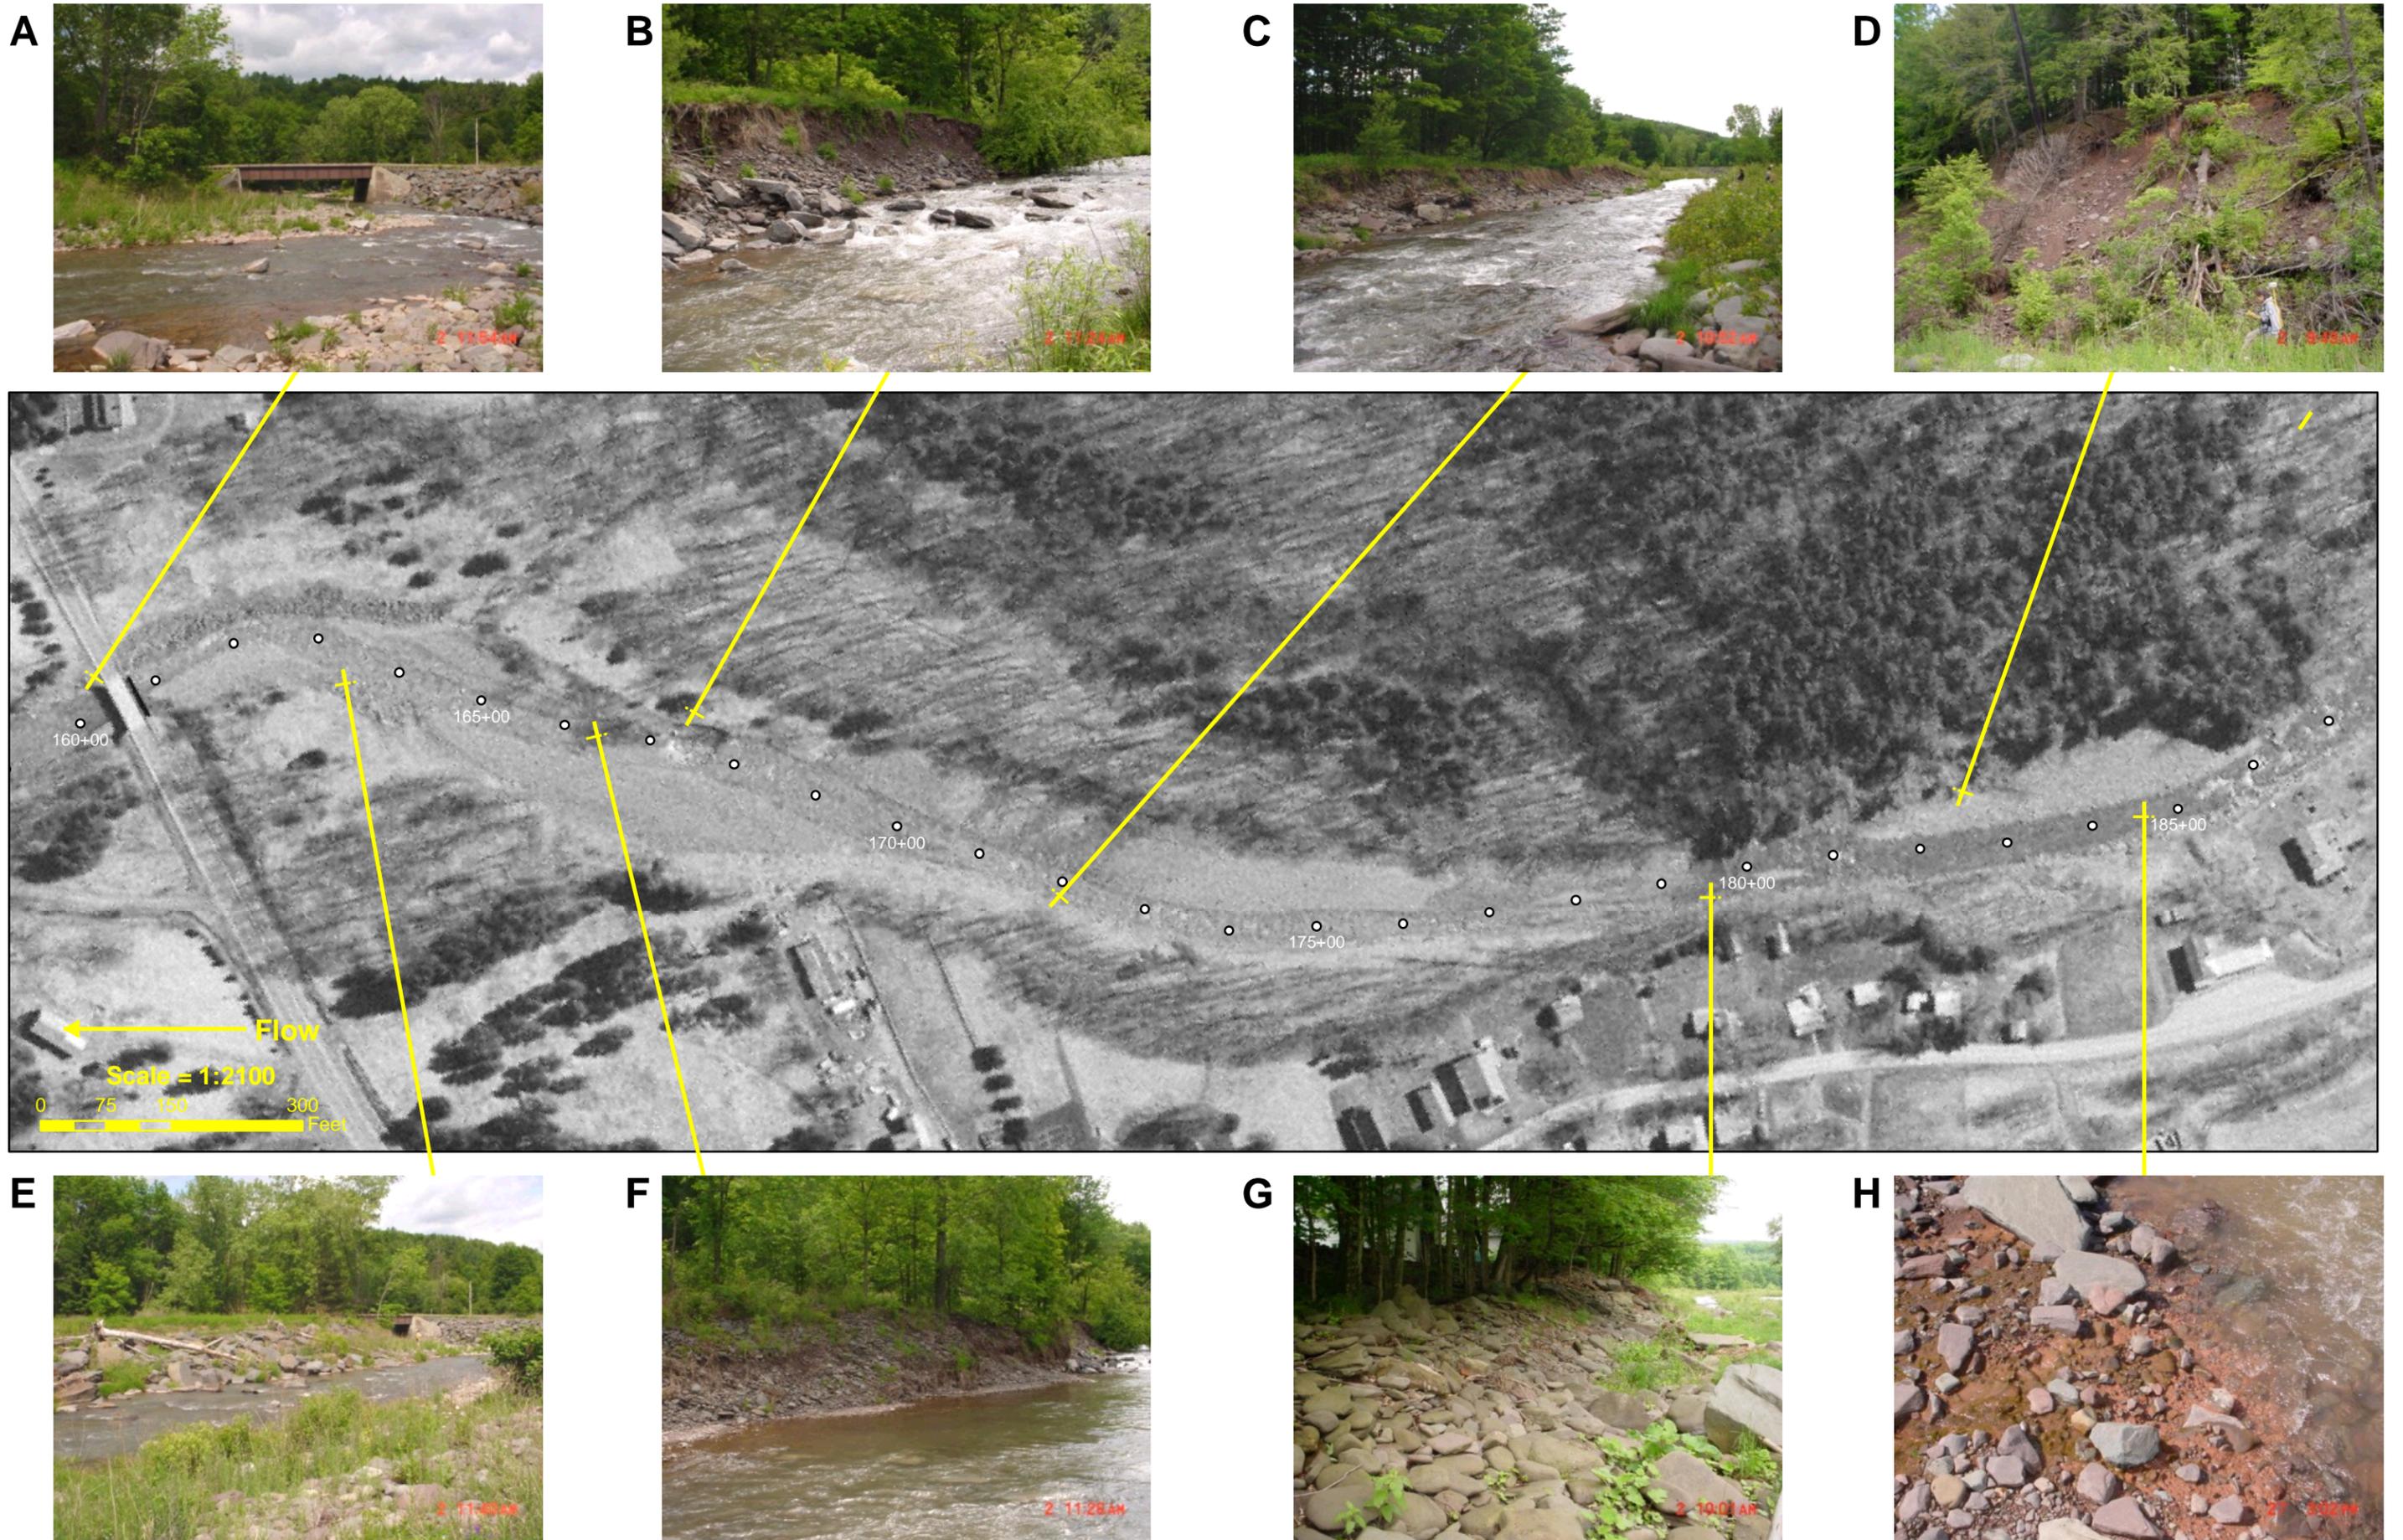
Figure 4.15.2 Management Unit 15 - 2004 aerial photography

Glacial till deposits (see Inset H, Fig. 4.15.2) are exposed near the mouth of the tributary in the left and right benches and in the bed. The *glacial till deposits* have a high silt and clay content, contributing sediment through both *wet and dry ravel* and yielding a significant suspended sediment load during high flows. Clay inputs into a stream are a serious water quality concern because they increase *turbidity*, degrade fish habitat, and can act as a carrier for other pollutants and pathogens.

Evidence of side casting (see Inset G, Fig. 4.15.2) is observed along 338 ft. of the left bank. This is a likely relic of gravel removal in this aggradational setting.

Bank erosion (Inset C, Fig. 4.15.2) is active along 231 ft. of the left bank, beginning near Station 17250. The bank

The bank appears to have formerly been rip-rapped, as large angular rock lies in the stream bed along the erosion. The rock seems to have been pulled from the bank that it once armored. The rock does provide some measure of grade control (Inset B, Fig. 4.15.2) to the channel.
