West Kill Management Unit 17

Stream Feature Statistics

Management Unit 17
Between Station 14742 and Station 9304

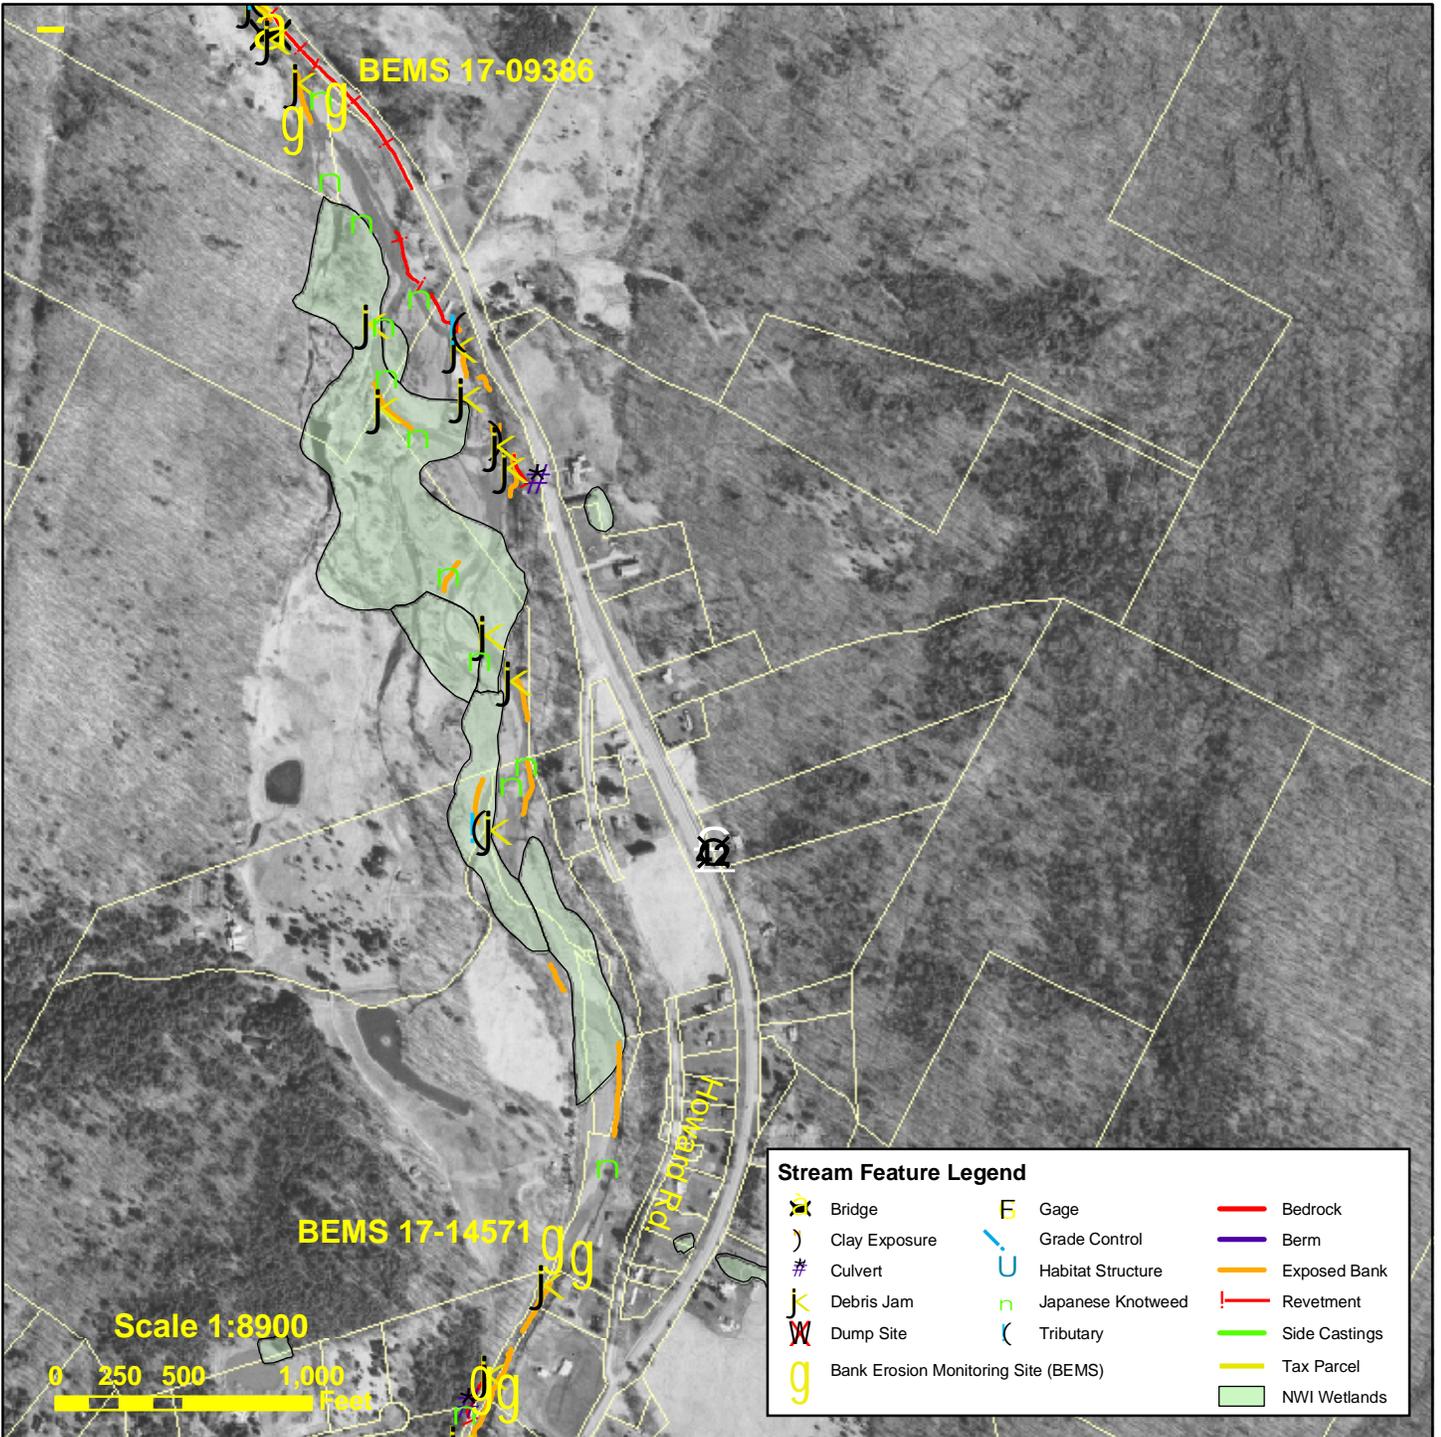
Figure 4.17.1 2004 aerial photography with stream feature inventory and tax parcels

36% of stream length is experiencing erosion
 20% of stream length has been stabilized
 35.9 acres of inadequate vegetation within the 300 ft. buffer
 0 ft. of stream is within 50 ft. of the road
 0 houses located within the 100-year floodplain boundary

The 2004 stream feature inventory revealed that 36% (1967 ft.) of the stream exhibited signs of active erosion along 5438 ft. of total channel length (Fig. 4.17.1). Revetment has been installed on 20% (1095 ft.) of the stream. No berms were identified in this management unit at the time of the stream feature inventory.

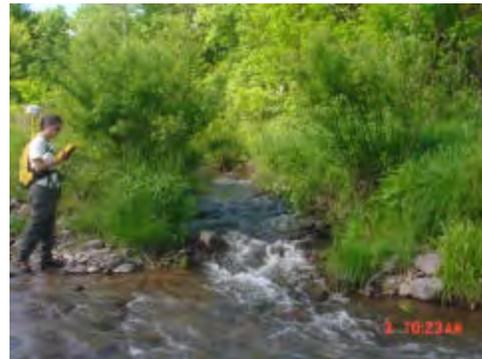
Tributary, left

An unnamed tributary enters from the left, draining the 2.2 mi² Condon Hollow subbasin. This confluence may deliver only a portion of the Condon Hollow discharge; other confluences on the left may deliver the remainder. The confluence is well-connected, well-vegetated, and very stable.

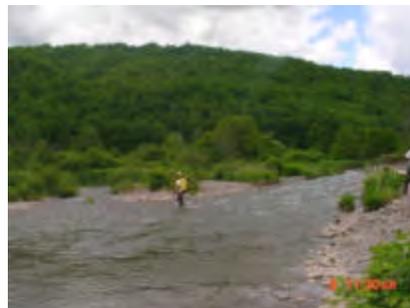
Channel divergence

The channel diverges into multiple threads around this center bar.

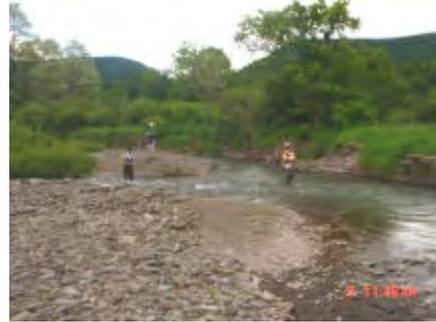
Channel convergence

As the channels converge at the tail of the center bar (Inset F, Fig. 4.17.2), 133 ft. of erosion is evident on the low terrace at the left.

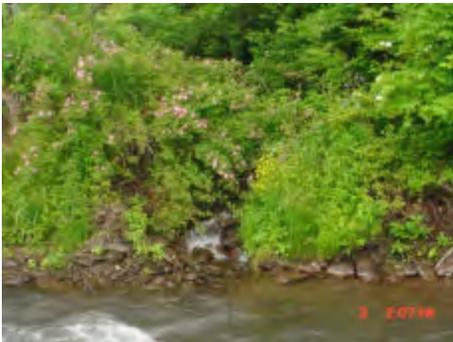
Tributary, right

As the valley begins to narrow, multiple channel threads converge. A small unnamed tributary enters from the right. The confluence is steep, but well vegetated.

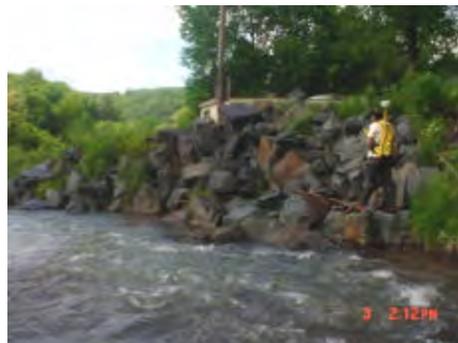
Rip-rap, right

The right bank downstream of the tributary is nearly continuously armored with large rip-rap through the remaining 1100 ft. of the unit.

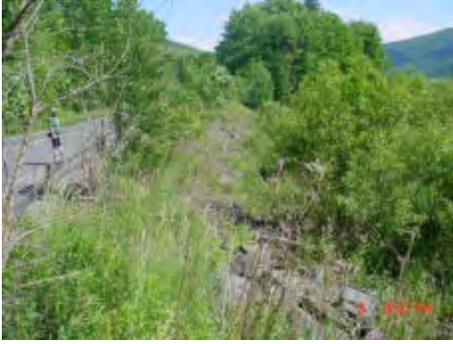
Riprap, NYS Route 42 embankment, looking upstream

Two installations protect residential properties adjacent to the stream (Inset A, Fig. 4.17.2), while a third armors the NYS Route 42 embankment at the right edge of the floodplain.

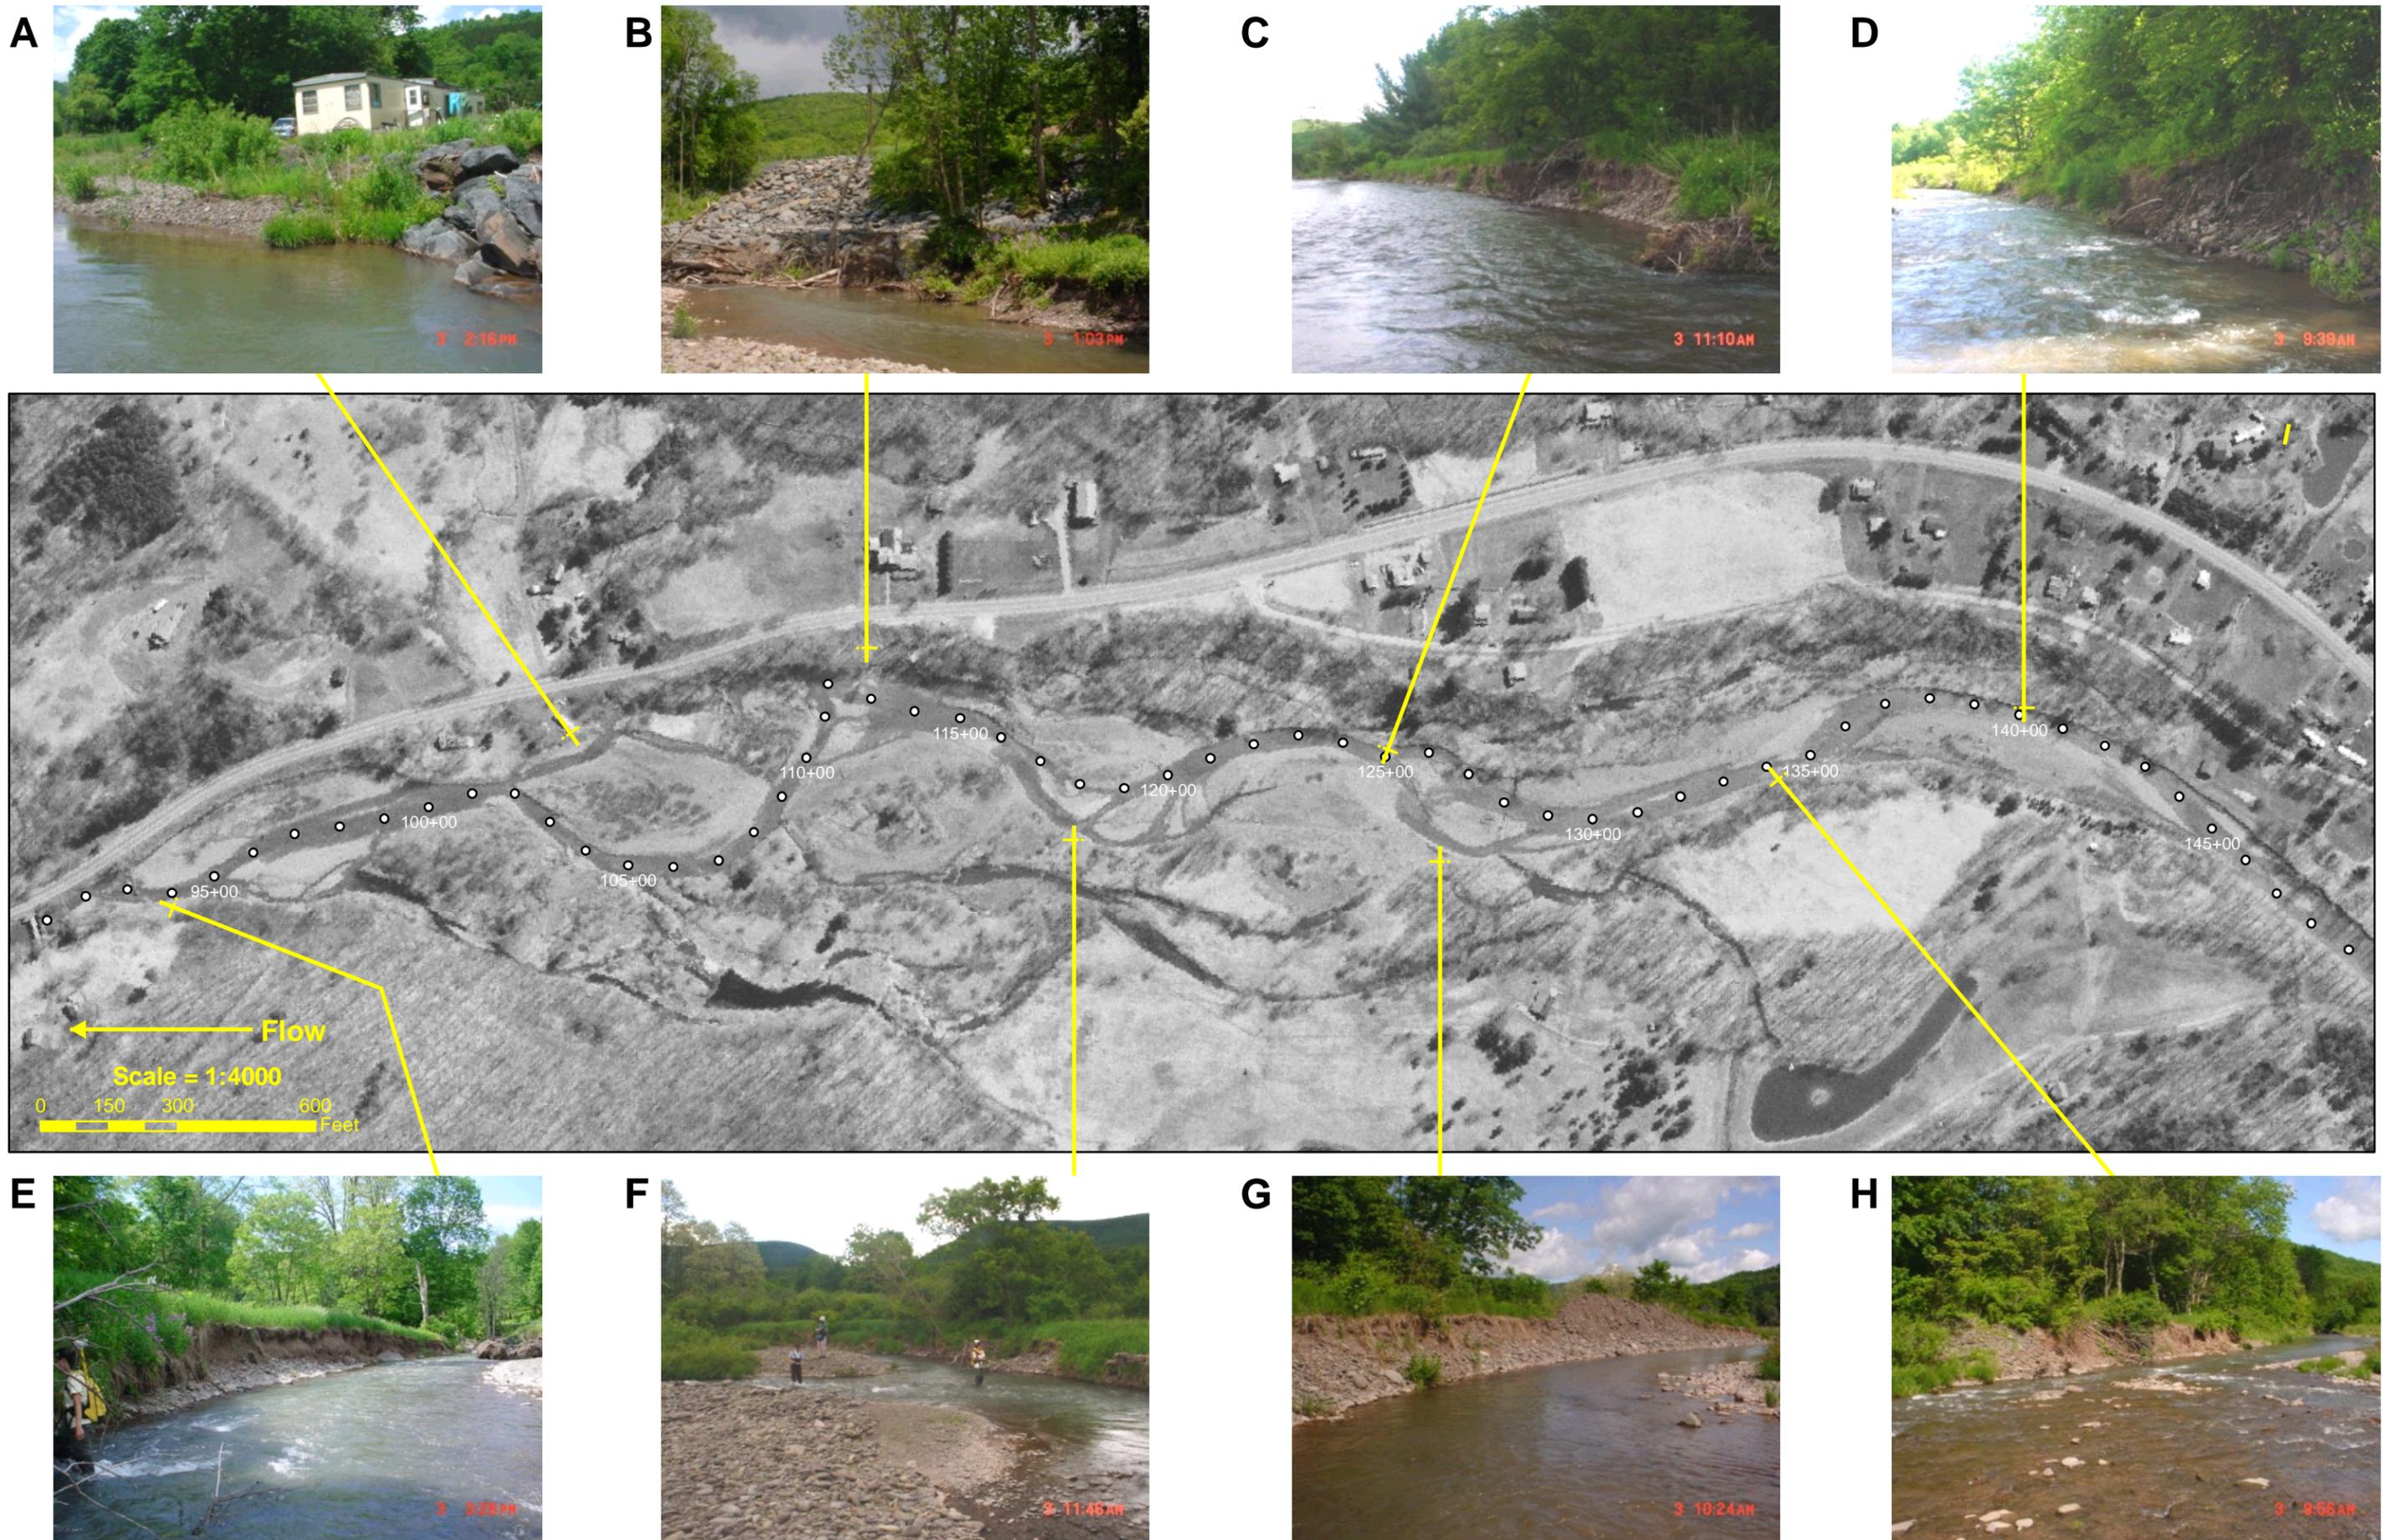
Figure 4.17.2 Management Unit 17 - 2004 aerial photography

Bank erosion is evident along 369 ft. of the alluvial terrace to the right (Inset D, Fig. 4.17.2). The erosion is mild, and yields relatively small amounts sediment. This erosion was not monumented as a Bank Erosion Monitoring Site.

Transverse flow across the headcut results in toe scour and 124 ft. of bank erosion on the left bank. Aggradation is again noted immediately downstream of the exposed bank (Inset H, Fig. 4.17.2).

Downstream of the confluence, the low terrace banks on both sides of the channel are experiencing erosion (Inset G , Fig. 4.17.2). Erosion at the left is scouring the toe of a recently deposited spoil pile. Erosion at the right leaves vegetation from a more mature riparian buffer over-hanging the channel.

Bank erosion is evident on the right bank downstream of a pool formed at the convergence of two channel threads (Inset C, Fig.4.17.2).

Throughout the unit, severe aggradation exacerbates bank erosion as seen here at the toe of a large rip-rap installation on the NYS Route 42 embankment (Inset B, Fig. 4.17.2).
