Neversink River East Branch

MANAGEMENT UNIT 12

E A S T B R A N C H M A N A G E M E N T U N I T 1 2
B E T W E E N S T A T I O N 4 3 6 5 0 A N D S T A T I O N 4 2 2 0 0

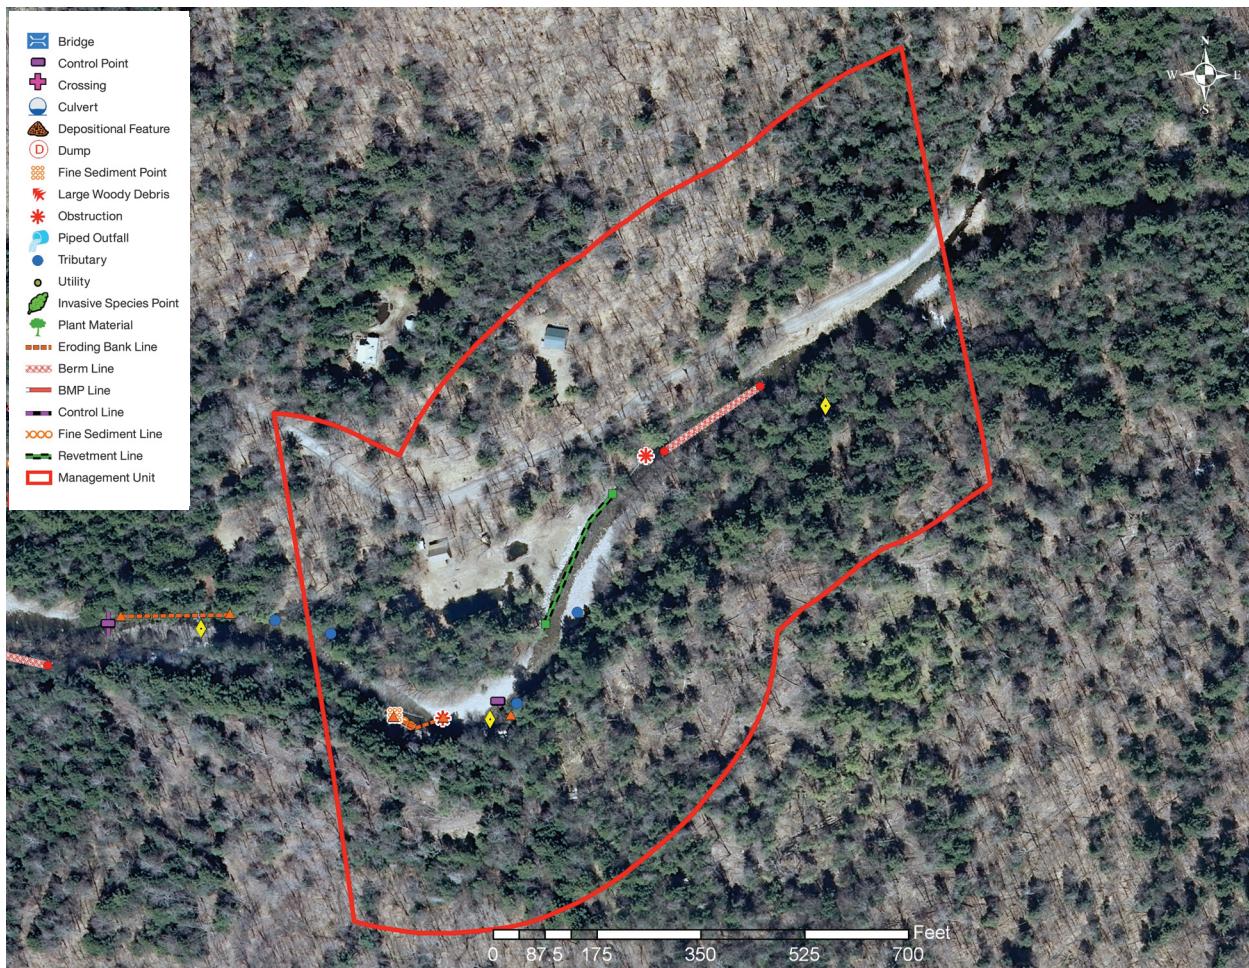
Stream Feature Inventory 2010 (Figure 1)

- 3 % of stream length is experiencing erosion
- 8.45 % of stream length has been stabilized
- 2.34 acres of inadequate vegetation within the riparian buffer
- 460 ft. of stream is within 50 ft. of the road
- No structures are located within the 100-year floodplain boundary

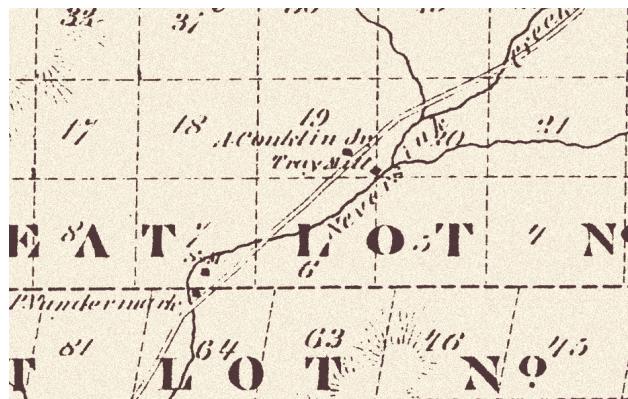
Excerpt from 1875 Beers Map (Figure 2)

The 1875 Beers Atlas of this area indicates that by that time, the stream had been harnessed for manufacturing, primarily saw mills, woodworking shops and tanneries (*Figure*

2). Raceways were built in the floodplains to divert water to ponds for use as needed. Floodplains were profoundly altered in the process, as these watercourses also became areas of preferential channelized flow when floodwaters inundated the floodplains. When woody debris jams blocked the primary channels, these raceways sometimes eroded out to become major secondary channels, or even took over the full flow to become a new primary watercourse.
