# Neversink River East Branch

## MANAGEMENT UNIT 14

EAST BRANCH MANAGEMENT UNIT 14  
BETWEEN STATION 46900 AND STATION 50100

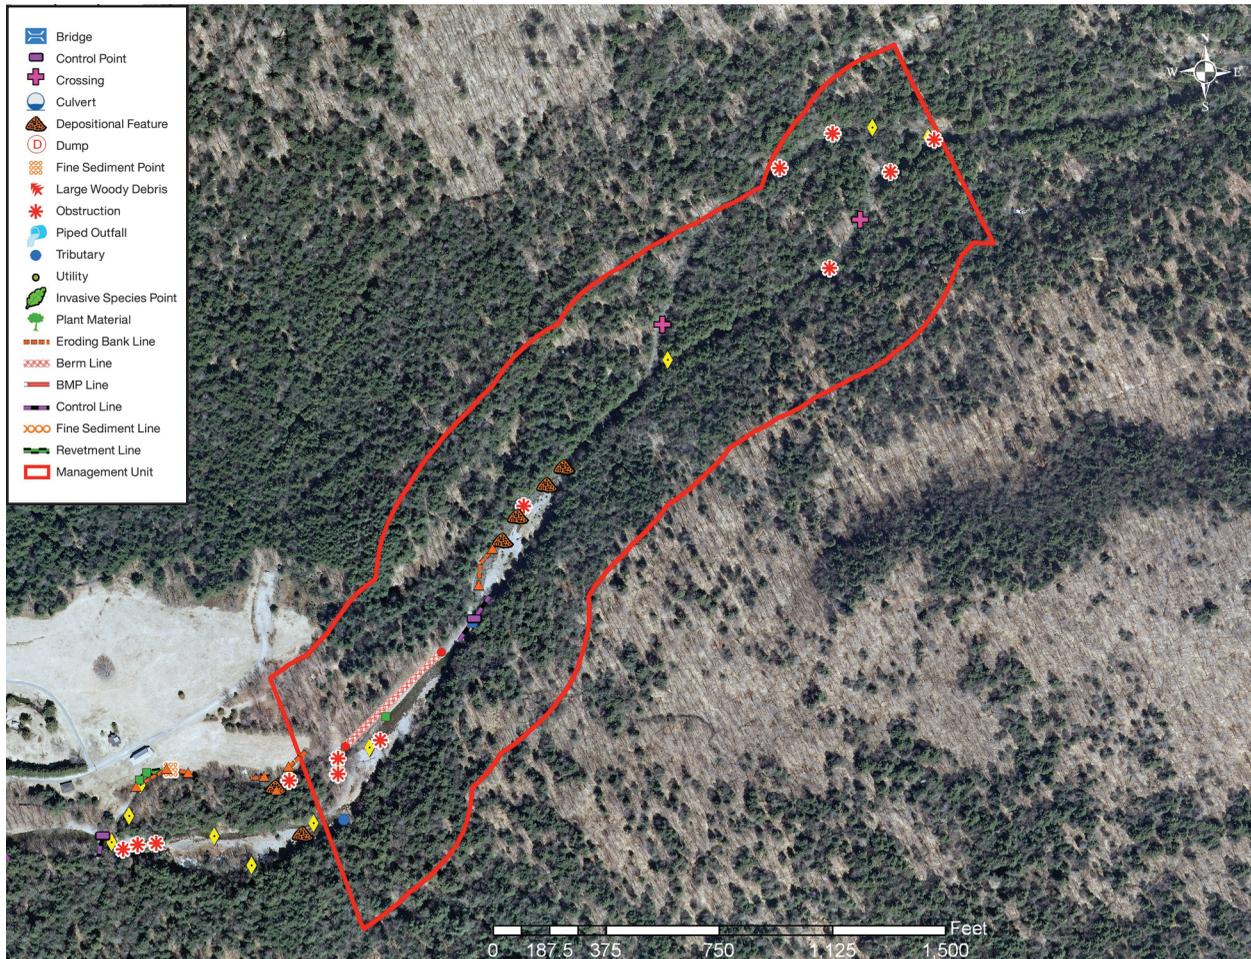
Stream Feature Inventory 2010 (Figure 1)

- 2 % of stream length is experiencing erosion
- 0.25 % of stream length has been stabilized
- 2.11 acres of inadequate vegetation within the riparian buffer
- None of stream is within 50 ft. of the road
- No houses are located within the 100-year floodplain boundary

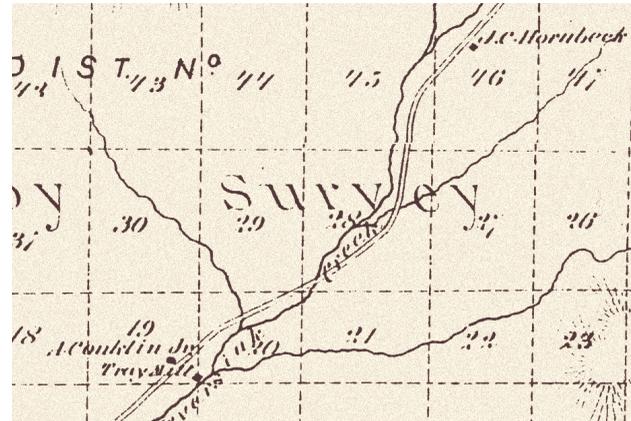
*Excerpt from 1875 Beers Map (Figure 2)*

The 1875 Beers Atlas of this area indicates that by that time, the stream had been harnessed for manufacturing, primarily saw mills, woodworking shops and tanneries (*Figure 2*).
