# Neversink River East Branch

## MANAGEMENT UNIT 2

EAST BRANCH MANAGEMENT UNIT 2  
BETWEEN STATION 5270 AND STATION 1450

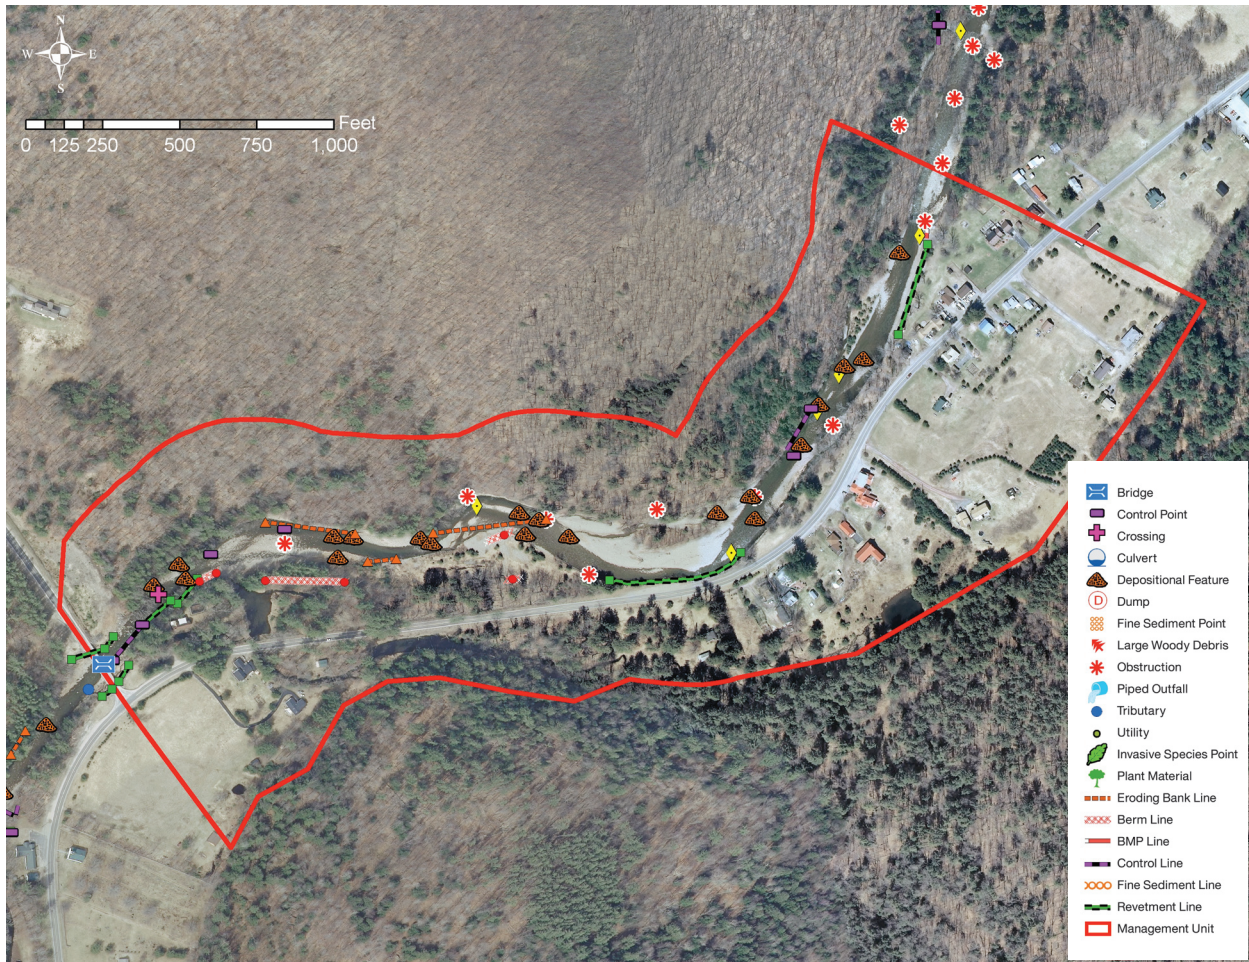
Stream Feature Inventory 2010 (Figure 1)

- 11% of stream length is experiencing erosion
- 14.91% of stream length has been stabilized
- 36.02 acres of inadequate vegetation within the riparian buffer
- 460 ft. of the stream length is within 50 ft. of the road
- No structures are located within the 100-year floodplain boundary

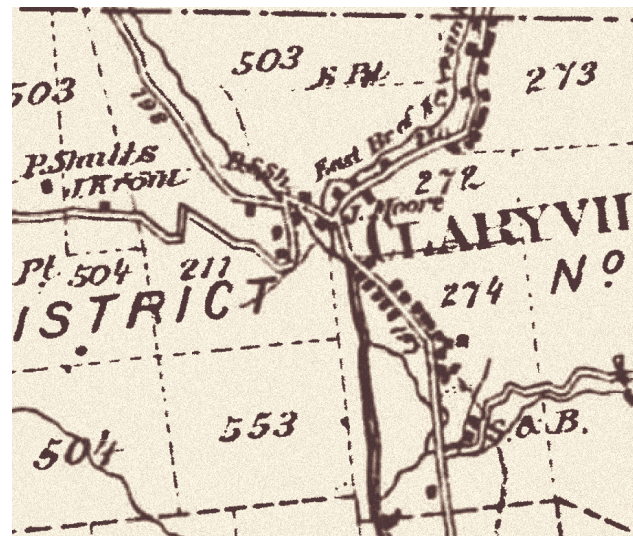
Excerpt from 1875 Beers Map (Figure 2)

The 1875 Beers Atlas of this area indicates that by that time, the stream had been harnessed for manufacturing, primarily saw mills, woodworking shops and tanneries (Figure 2). Raceways were built in the floodplains to divert water to ponds for use as needed. Floodplains were profoundly altered in the process, as these watercourses also became areas of preferential channelized flow when floodwaters inundated the floodplains. When woody debris jams blocked the primary channels, these raceways sometimes eroded out to become major secondary channels, or even took over the full flow to become a new primary watercourse.
