Neversink River East Branch

MANAGEMENT UNIT 3

EAST BRANCH MANAGEMENT UNIT 3
BETWEEN STATION 9200 AND STATION 5270

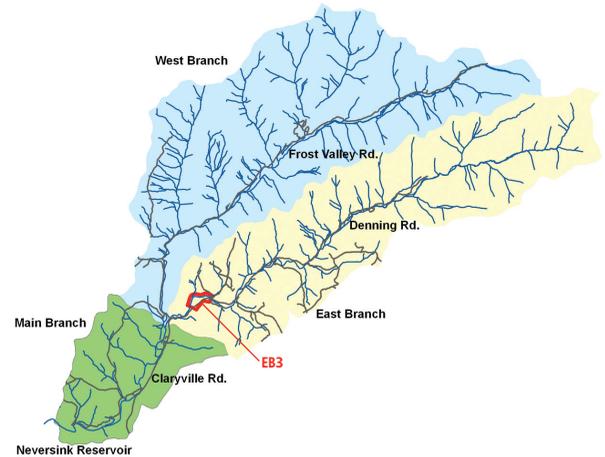
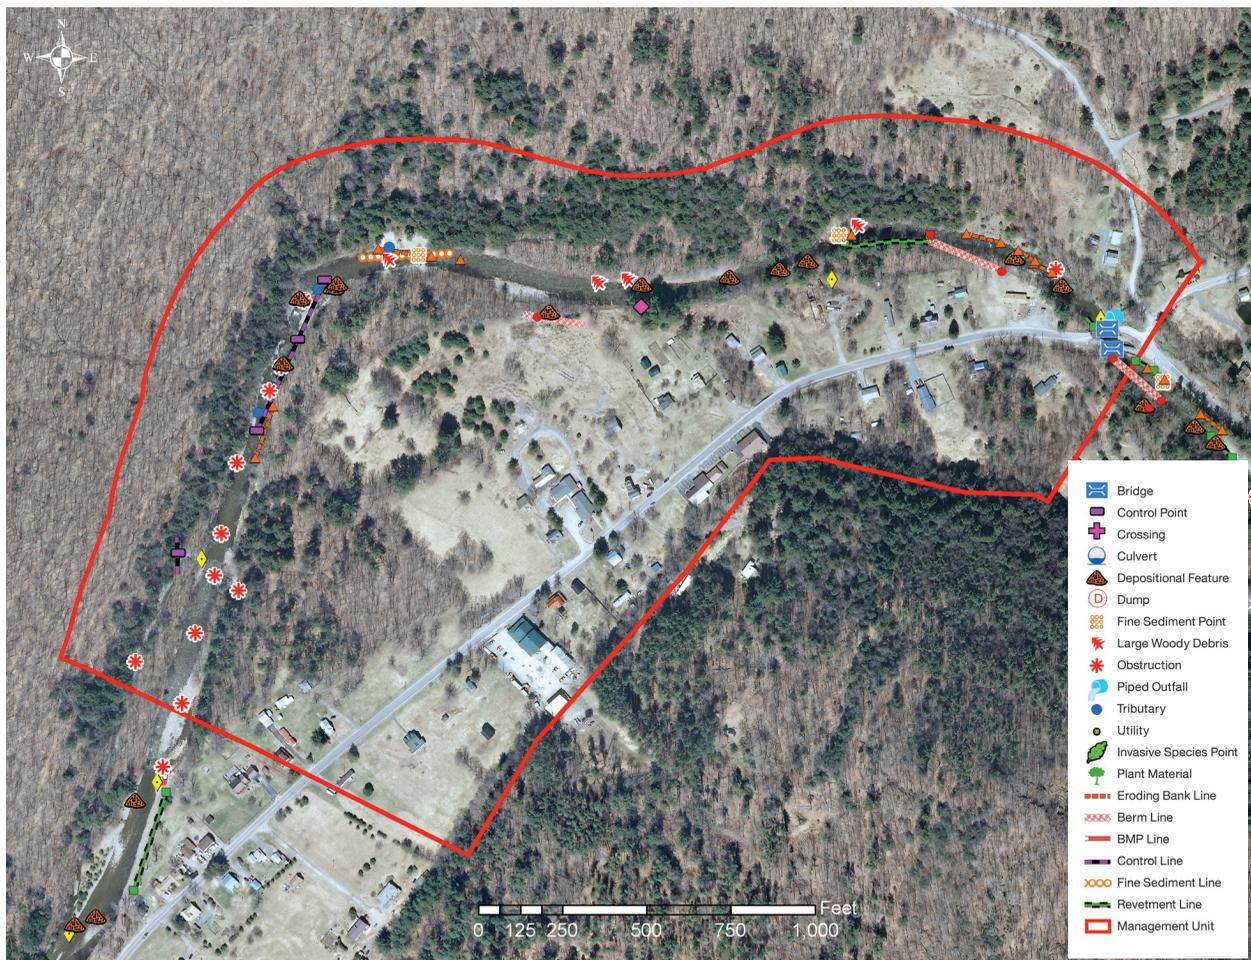
Stream Feature Inventory 2010 (Figure 1)

- 8% of stream length is experiencing erosion
- 3.82% of stream length has been stabilized
- 39.78 acres of inadequate vegetation within the riparian buffer
- 50 ft. of the stream length is within 50 ft. of the road
- 8 structures are located within the 100-year floodplain boundary

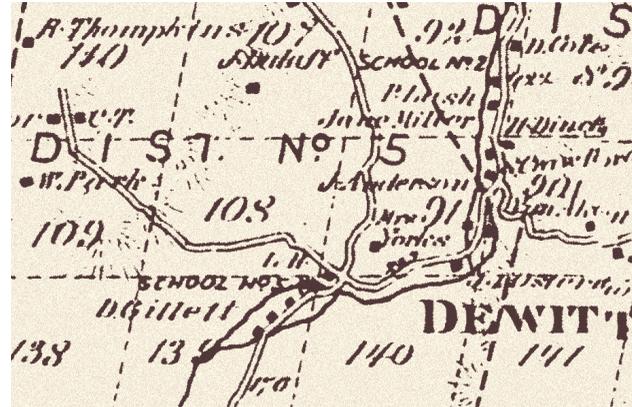
Excerpt from 1875 Beers Map (Figure 2)

The 1875 Beers Atlas of this area indicates that by that time, the stream had been harnessed for manufacturing, primarily saw mills, woodworking shops and tanneries (*Figure*

2). Raceways were built in the floodplains to divert water to ponds for use as needed. Floodplains were profoundly altered in the process, as these watercourses also became areas of preferential channelized flow when floodwaters inundated the floodplains. When woody debris jams blocked the primary channels, these raceways sometimes eroded out to become major secondary channels, or even took over the full flow to become a new primary watercourse.
