# Neversink River East Branch

## MANAGEMENT UNIT 4

EAST BRANCH MANAGEMENT UNIT 4  
BETWEEN STATION 13450 AND STATION 9200

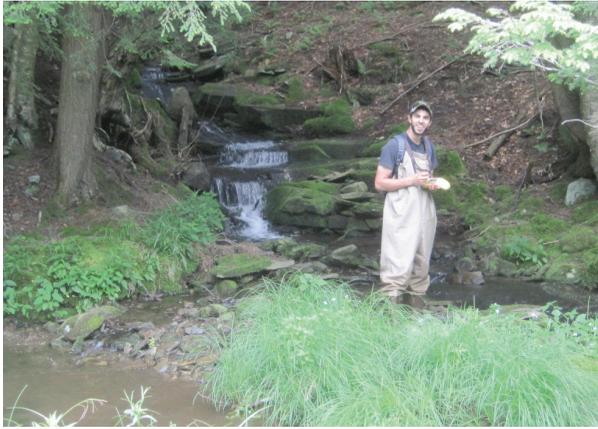
*Tributary entering through exposed bedrock on left valley wall (B201)*

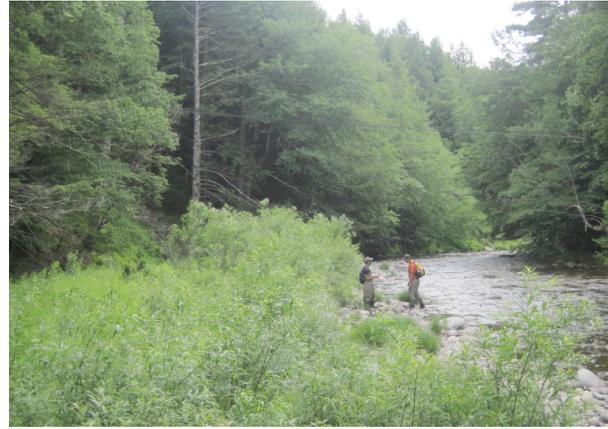
*Willow trees on left side of stream (B203)*

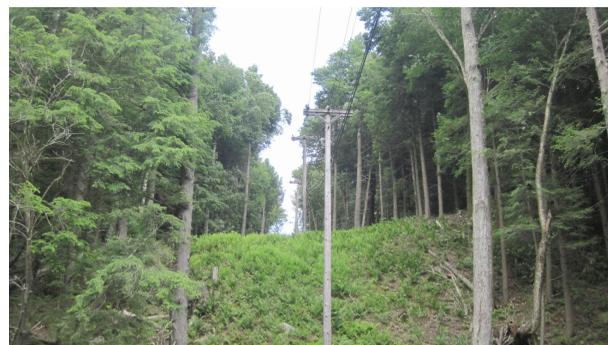
*Power line clearing on left valley wall (B205)*

berm and continue in a cleared path over the left valley wall. (B205) A small tributary enters from the left at Station 12850, contributing a perennial flow.

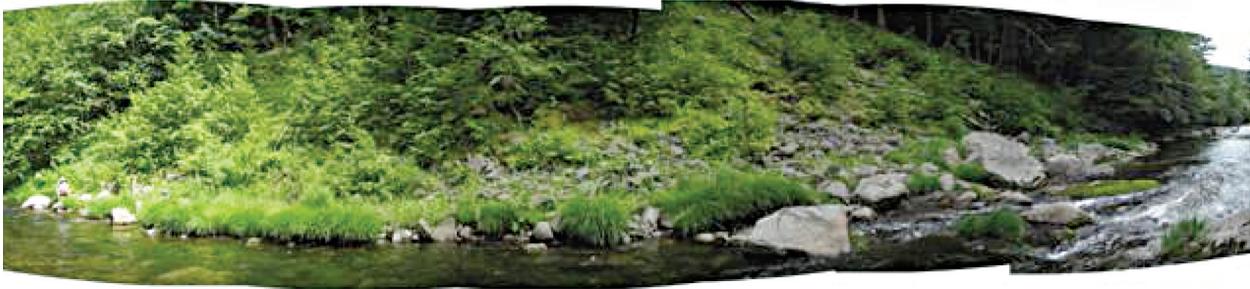
*Naturally repaired left bank failure (A210-215)*

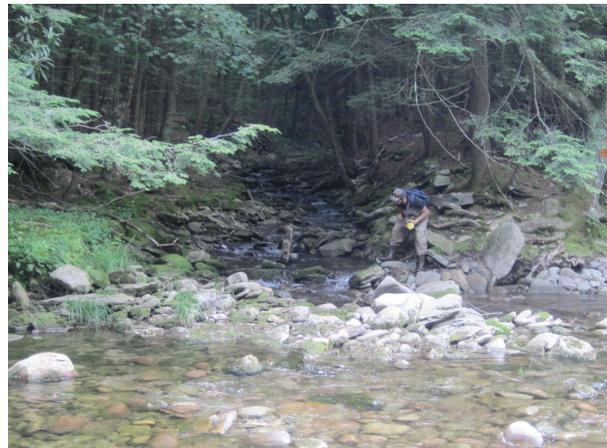
*Tributary entering on right (B211)*

Continuing downstream, another tributary enters from the right side at Station 12200. (B211) Excessive large woody debris accumulation becomes evident within the channel beginning

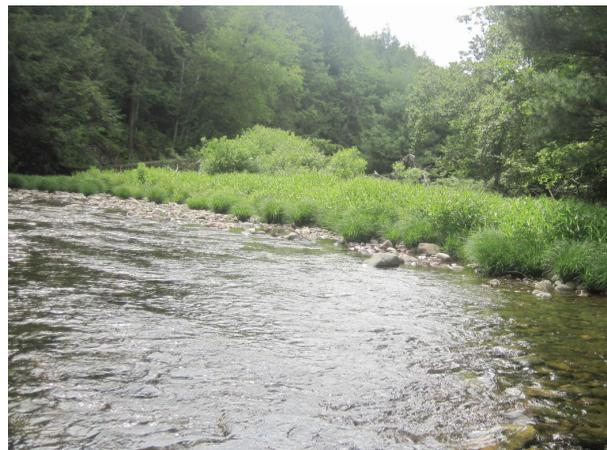
*(B219) Depositional side bar with sedge and willow*

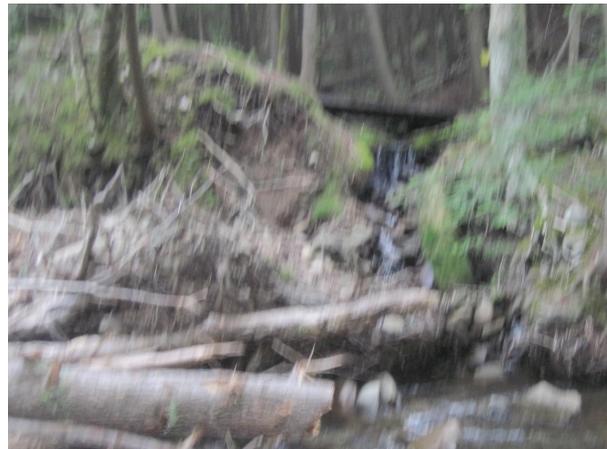
*(B232) Small tributary entering stream*

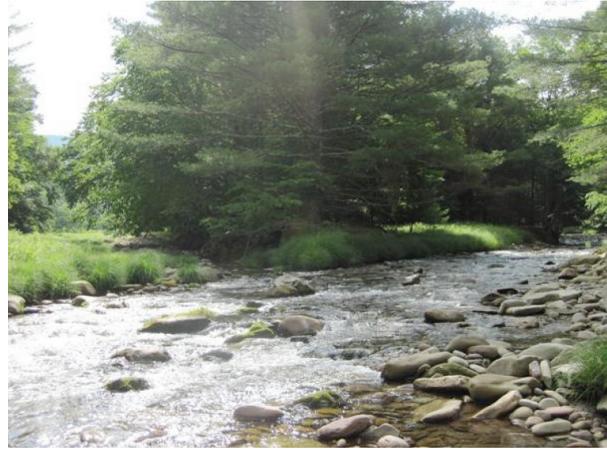
The right and left channels converge to form one main channel at Station 10500. *(A258)* Both banks were bermed in the vicinity of this convergence in an attempt to mitigate flood risks to surrounding infrastructure. These berms consist of old sidecast stream and earthen materials and appear to be

*(A258) Looking upstream at convergence of right and left channel*

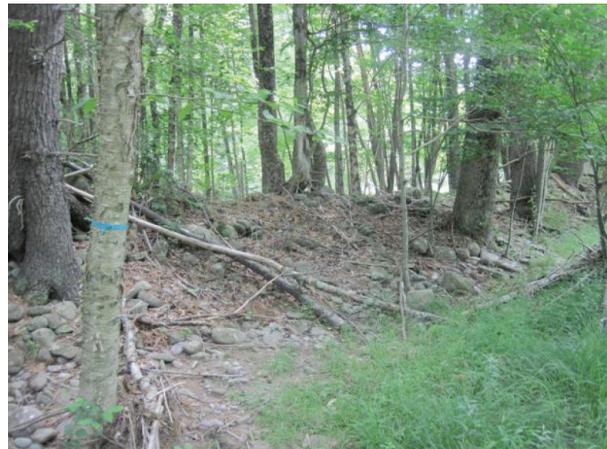
very old, as is evidenced by the mature trees that are growing through them. Along the right bank, a berm begins at Station 10700, continuing approximately 460-feet to Station 10250. There is a brief break in this berm before it again picks up at Station 10240 and continues until Station 10140. *(A267)* The berm along the left bank is located between Station 10500 and Station 10250. *(A262)* This berm is located only 150-feet from a building structure in the left floodplain. Japanese Barberry, which is an invasive plant species to the Catskills region, was documented along the left side of the stream in front of the berm at Station 10450. *(A260)* Invasive species such as this can out-compete native vegetation and have negative effects on the surrounding landscape.

*(A267) Old berm on right bank*

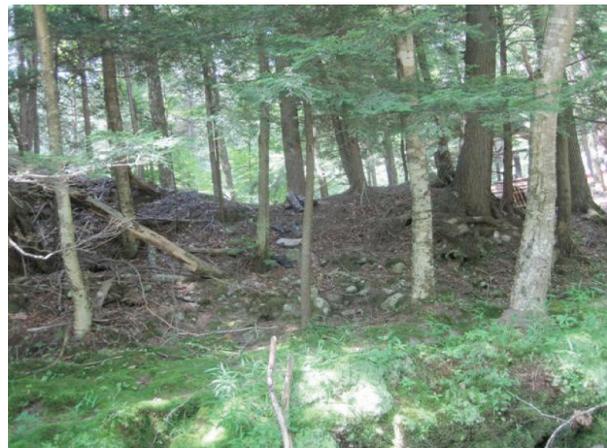
*(A262) Berm along left bank*

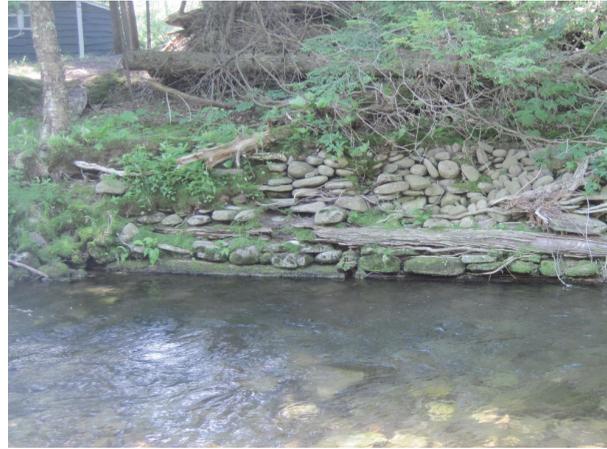
(B248) *Cobble and log revetment along left bank*

is approximately 60-feet in length, ending near Station 9930. (B248) Directly downstream of this structure, the left bank shows signs of hydraulic erosion beginning at Station 10020, continuing downstream for 45-feet until Station 9975 (BEMS ID # NEB4\_9900). (B249) Although this erosion was not severe at the time of this inventory, it does not appear that it will be able to stabilize without treatment. Therefore, recommendations for this bank erosion site minimally include monitoring for significant changes in condition and possible assisted restoration.

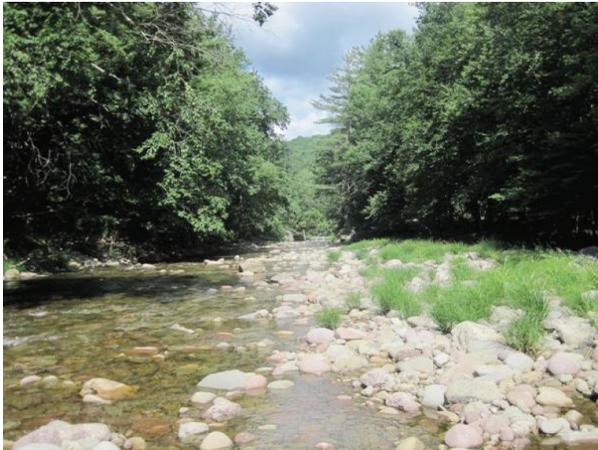
At Station 9790 a cobble side bar begins along the right bank, continuing for approximately 200-feet to Station 9590. (A277) This bar is well vegetated with sedges and other herbaceous species. Two trees have fallen from the left bank and situated in the channel perpendicular to flow. The obstruction to flow created by these trees is causing minor scour both upstream and downstream.

*(A277) Cobble side bar along right bank*

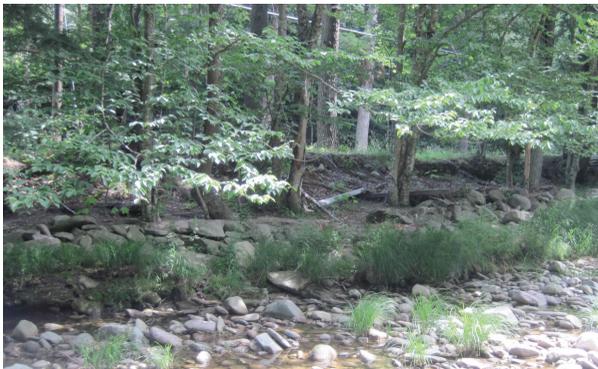
*(B257) Cobble stone revetment along right bank*

Approaching the downstream end of this management unit, the stream begins to flow in closer proximity to Denning Road. The right bank is revetted with cobble sized stones beginning at Station 9620 and continuing 90-feet downstream until Station 9530. *(B257)* This revetment appears to have been placed in order to prevent flows from further aggravating a hydraulic bank erosion site located higher up on the right embankment adjacent to the road. This bank erosion is approximately 80-feet in length, beginning at Station 9550 and continuing until Station 9470 (BEMS ID# NEB\_9400). *(A284)* The site is actively eroding at the upstream end, but appears to be currently inactive at the downstream end. Cobble sized materials are exposed throughout much of this bank, and leaning trees with exposed root structures threaten to fall into the stream and further destabilize the bank. Due to the close proximity of this site to the road, assisted restoration is recommended including the removal of severely leaning trees and techniques to stabilize the bank. This site should also be monitored for future changes in condition.

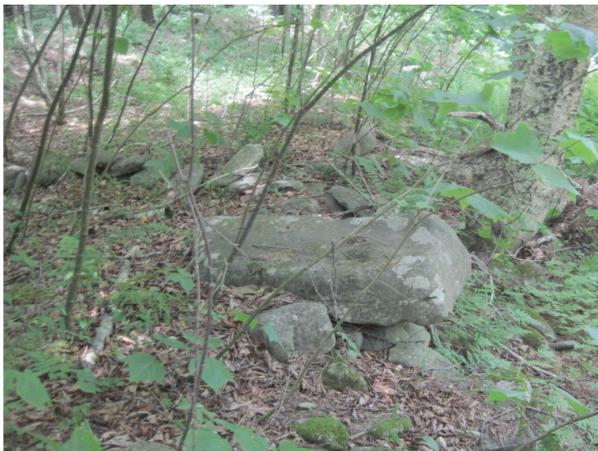
*(B267) Berm on left bank*

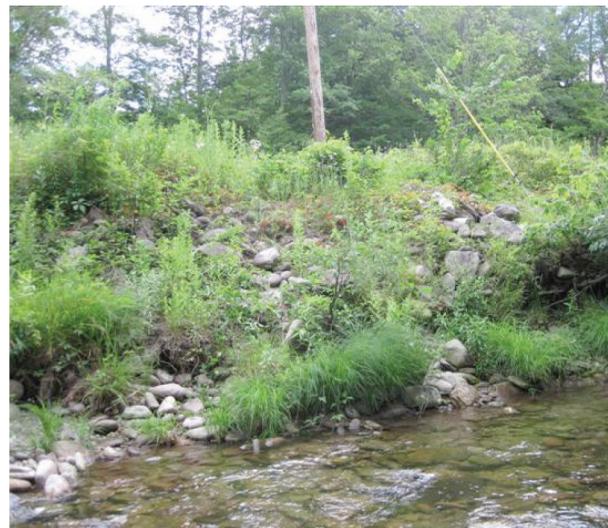
A rip-rap revetment begins along the right bank beginning near the downstream end of the bank erosion at Station 9280, continuing for 60-feet to the bridge abutment. These cobble sized stones were placed to protect the bank from hydraulic pressure during higher flows. (A315) Though documented in fair condition at the time of this inventory, it is not likely that over a significant period of time this rip-rap will sufficiently protect the bank or adjacent road from the effects of flooding.

*(A315) Rip rap revetment on right bank*
