# Neversink River East Branch

## MANAGEMENT UNIT 5

**EAST BRANCH MANAGEMENT UNIT 5**  
**BETWEEN STATION 18600 AND STATION 13450**

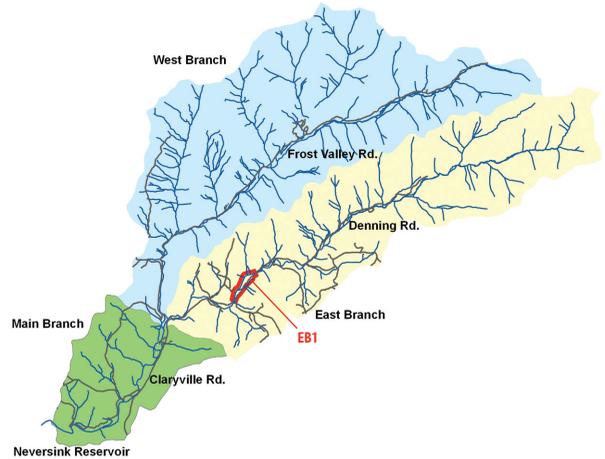
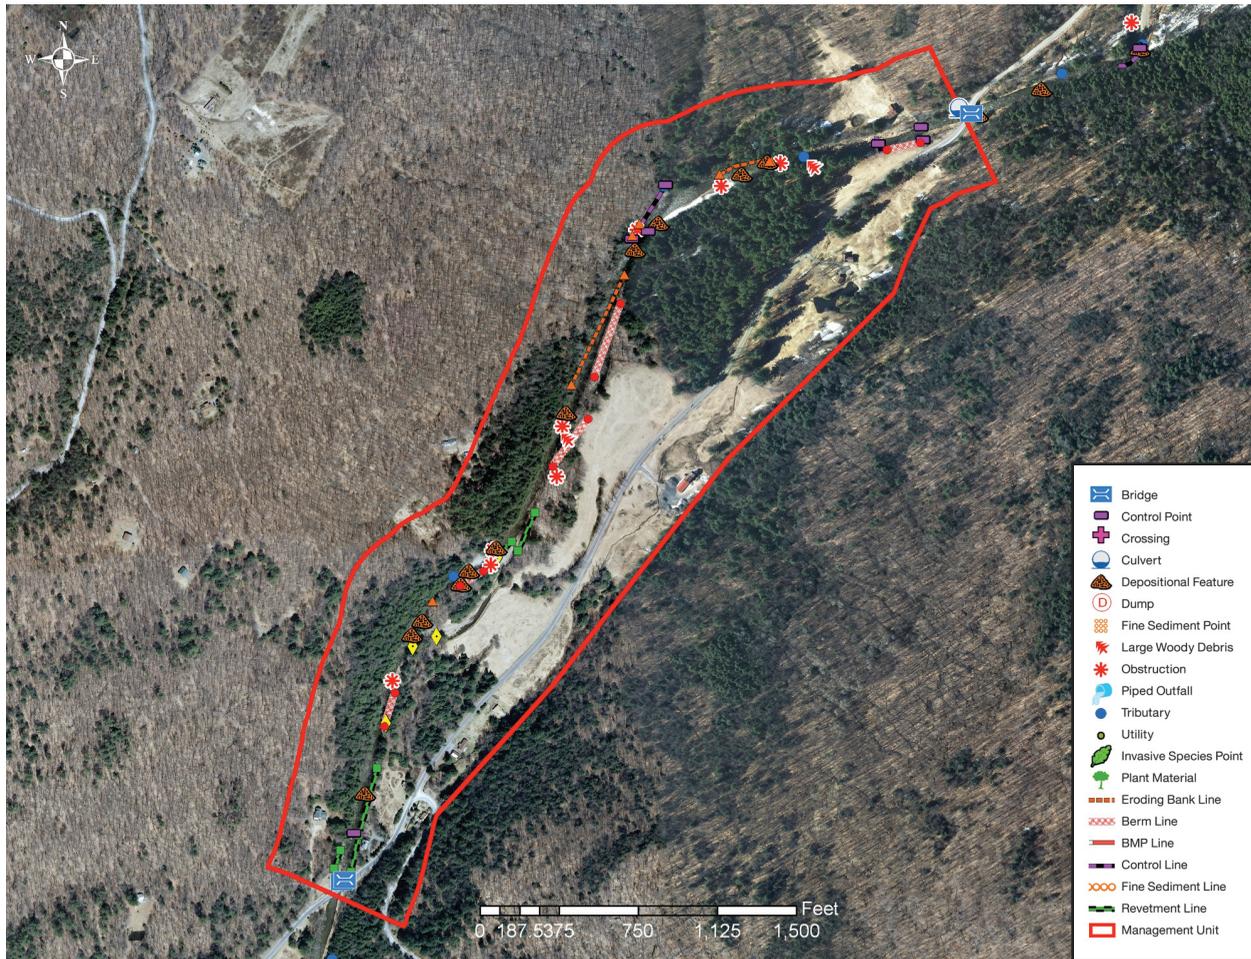
Stream Feature Inventory 2010 (Figure 1)

- 9% of stream length is experiencing erosion
- 9.23% of stream length has been stabilized
- 36.56 acres of inadequate vegetation within the riparian buffer
- 225 ft. of the stream length is within 50 ft. of the road
- 2 structures are located within the 100-year floodplain boundary

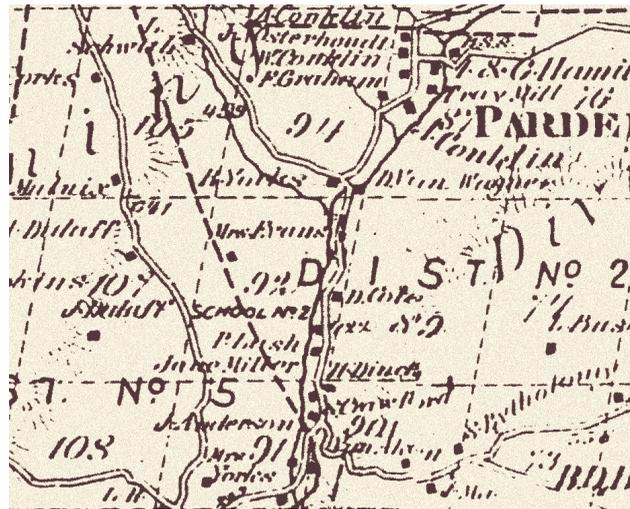
Excerpt from 1875 Beers Map (Figure 2)

The 1875 Beers Atlas of this area indicates that by that time, the stream had been harnessed for manufacturing, primarily saw mills, woodworking shops and tanneries (Figure 2). Raceways were built in the floodplains to divert water to ponds for use as needed. Floodplains were profoundly altered in the process, as these watercourses also became areas of preferential channelized flow when floodwaters inundated the floodplains. When woody debris jams blocked the primary channels, these raceways sometimes eroded out to become major secondary channels, or even took over the full flow to become a new primary watercourse.
