Neversink River East Branch

MANAGEMENT UNIT 6

EAST BRANCH MANAGEMENT UNIT 6
BETWEEN STATION 25030 AND STATION 18700

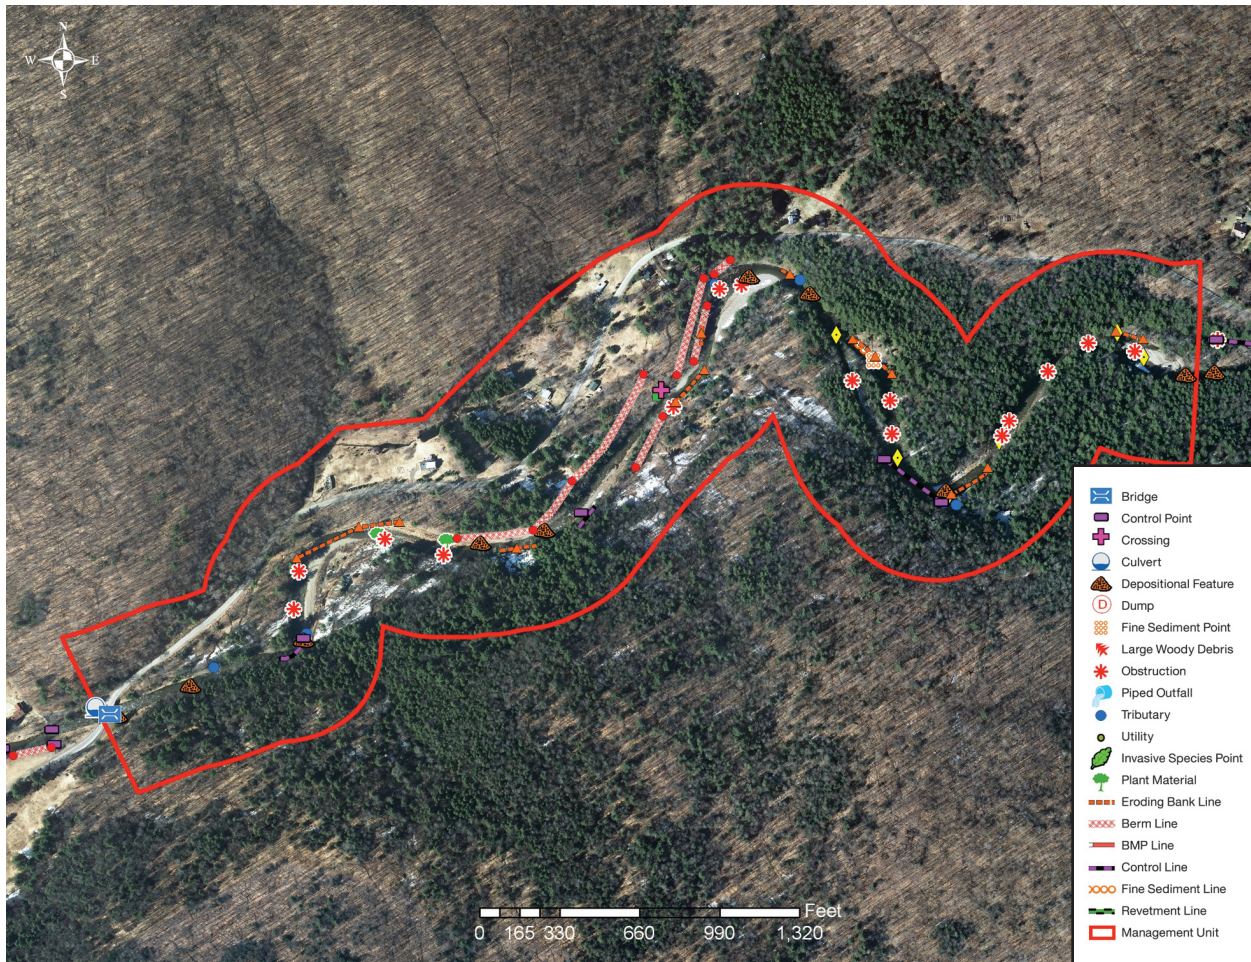
Stream Feature Inventory 2010 (Figure 1)

- 12% of stream length is experiencing erosion
- 0.48% of stream length has been stabilized
- 16.12 acres of inadequate vegetation within the riparian. buffer
- 100 ft. of the stream length is within 50 ft. of the road
- 10 structures are located within the 100-year floodplain boundary

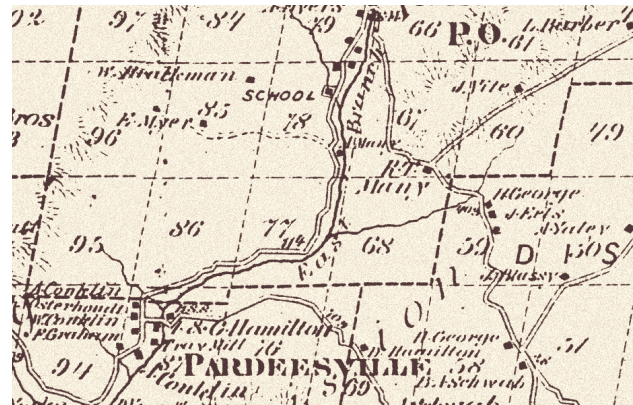
Excerpt from 1875 Beers Map (Figure 2)

The 1875 Beers Atlas of this area indicates that by that time, the stream had been harnessed for manufacturing, primarily saw mills, woodworking shops and tanneries (Figure

2). Raceways were built in the floodplains to divert water to ponds for use as needed. Floodplains were profoundly altered in the process, as these watercourses also became areas of preferential channelized flow when floodwaters inundated the floodplains. When woody debris jams blocked the primary channels, these raceways sometimes eroded out to become major secondary channels, or even took over the full flow to become a new primary watercourse.
