# Neversink River East Branch

## MANAGEMENT UNIT 7

EAST BRANCH MANAGEMENT UNIT 7  
BETWEEN STATION 28000 AND STATION 25030

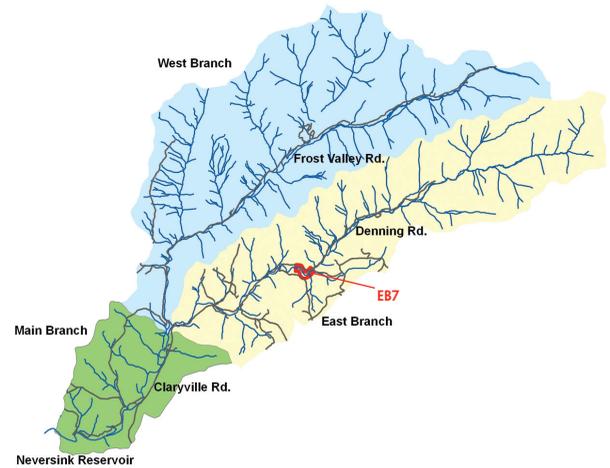
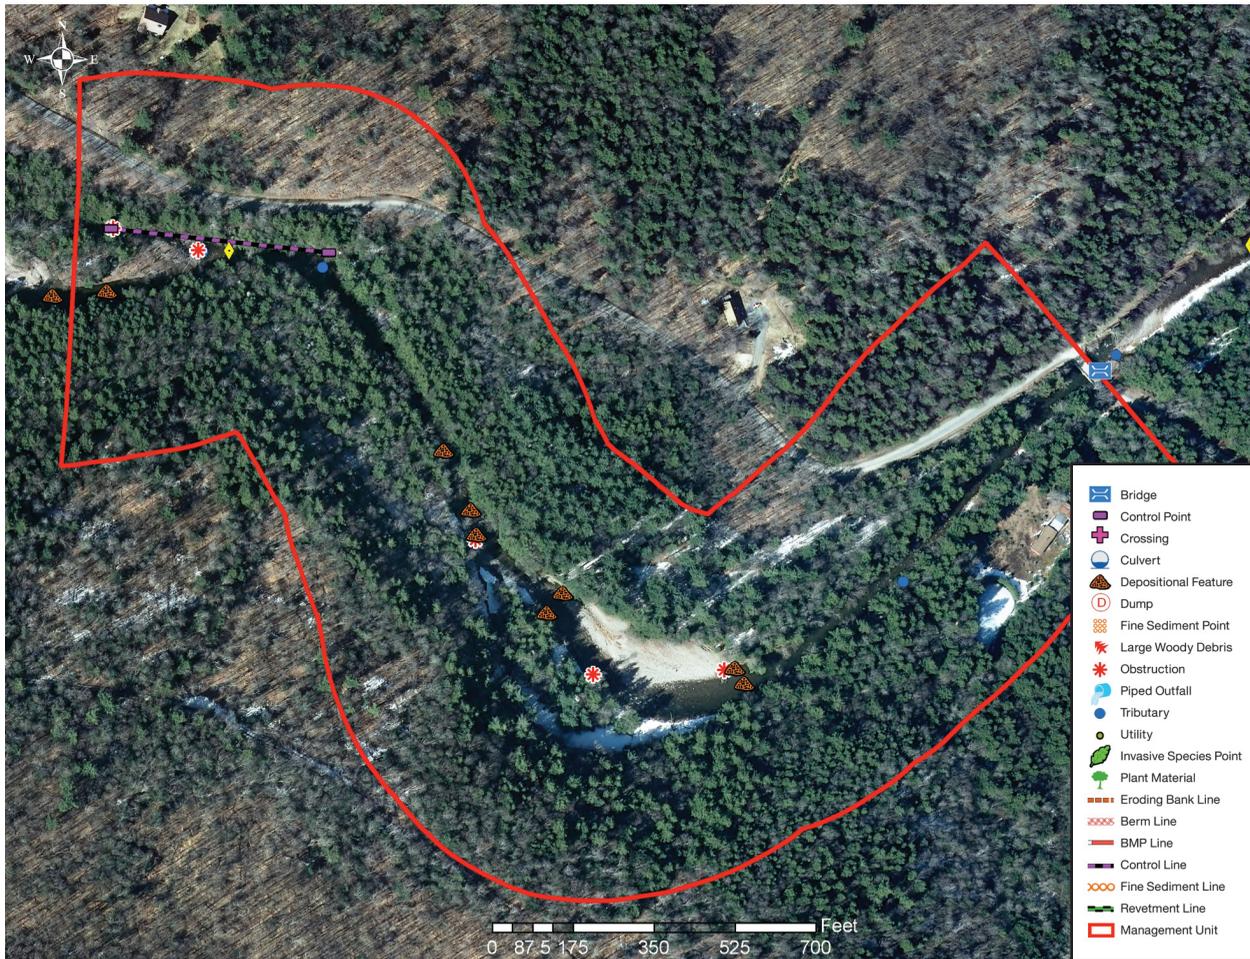
Stream Feature Inventory 2010 (Figure 1)

- None of stream length is experiencing erosion
- None of stream length has been stabilized
- 3.23 acres of inadequate vegetation within the riparian buffer
- 1,550 ft. of the stream length is within 50 ft. of the road
- No structures are located within the 100-year floodplain boundary
