Neversink River East Branch

MANAGEMENT UNIT 9

EAST BRANCH MANAGEMENT UNIT 9
BETWEEN STATION 34900 AND STATION 30800

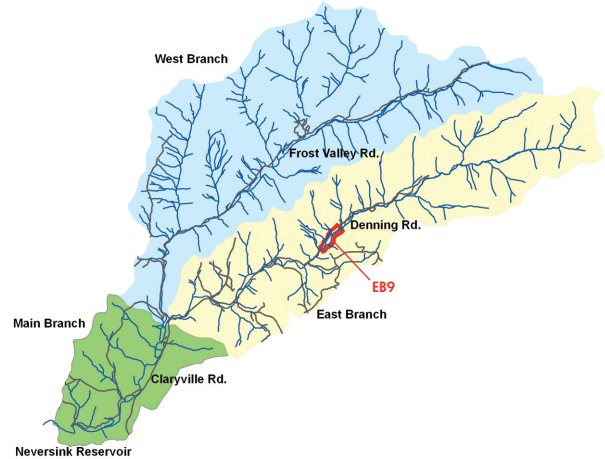
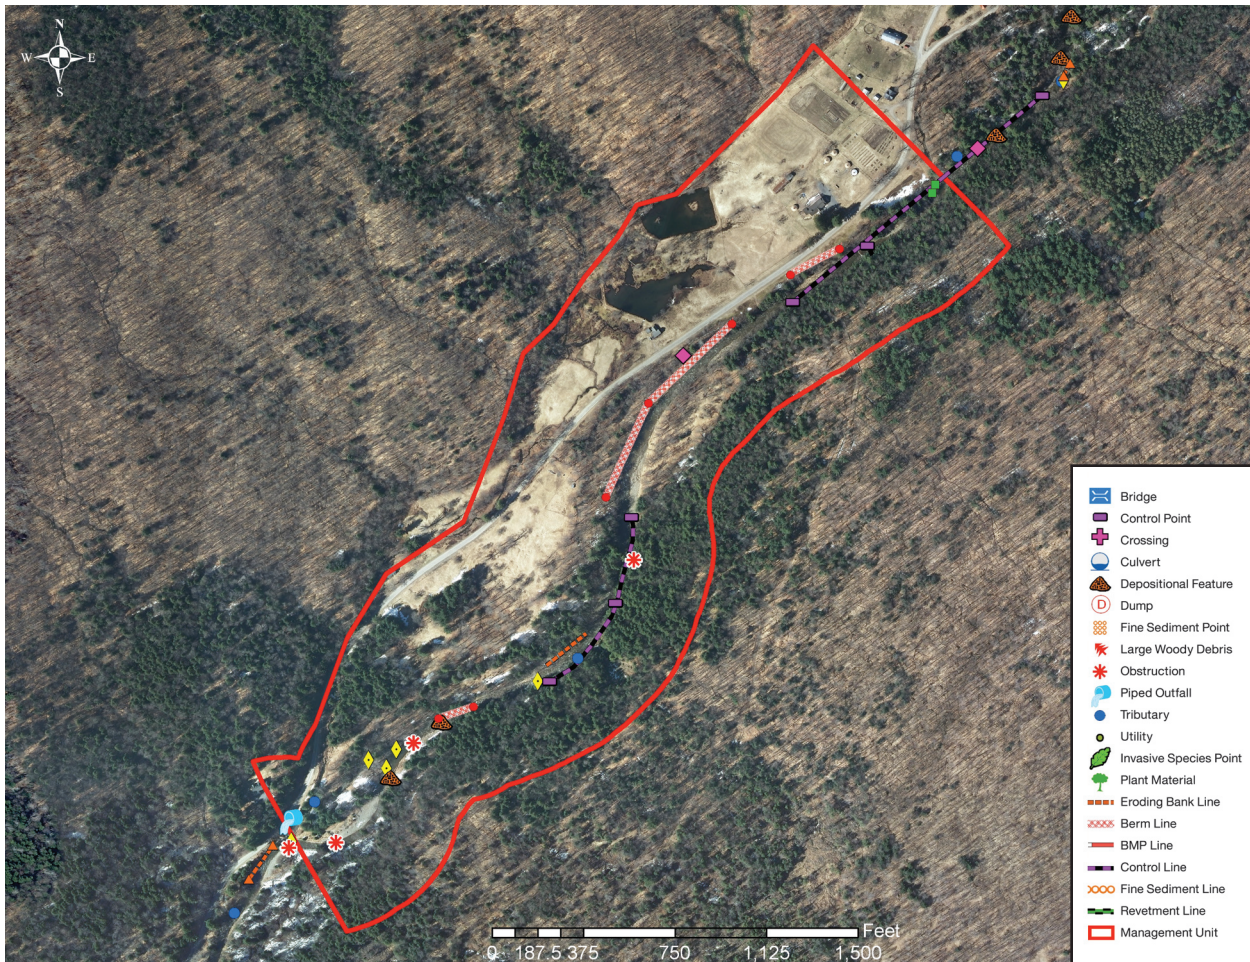
Stream Feature Inventory 2010 (Figure 1)

- 3 % of stream length is experiencing erosion
- 0.44 % of stream length has been stabilized
- 28.69 acres of inadequate vegetation within the riparian buffer
- None of the stream length is within 50 ft. of the road
- Two structures are located within the 100-year floodplain boundary

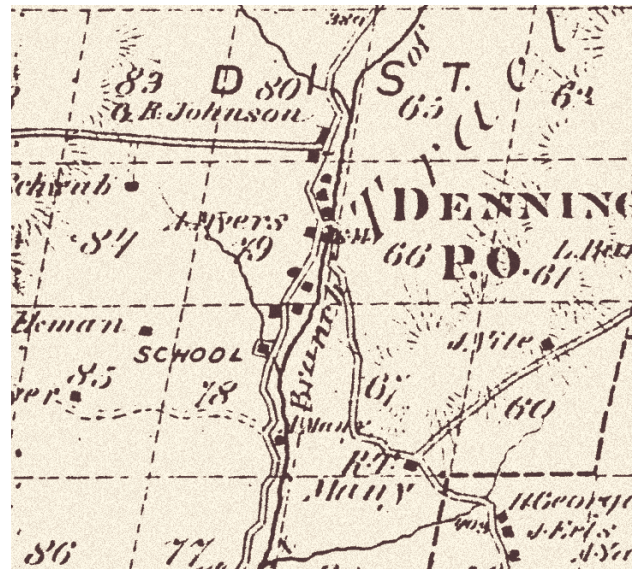
Excerpt from 1875 Beers Map (Figure 2)

The 1875 Beers Atlas of this area indicates that by that time, the stream had been harnessed for manufacturing, primarily saw mills, woodworking shops and tanneries (Figure 2). Raceways were built in the floodplains to divert water to ponds for use as needed. Floodplains were profoundly altered in the process, as these watercourses also became areas of preferential channelized flow when floodwaters inundated the floodplains. When woody debris jams blocked the primary channels, these raceways sometimes eroded out to become major secondary channels, or even took over the full flow to become a new primary watercourse.
