Neversink River Main Branch

MANAGEMENT UNIT 3

MAIN BRANCH MANAGEMENT UNIT 3
BETWEEN STATION 9300 AND STATION 6300

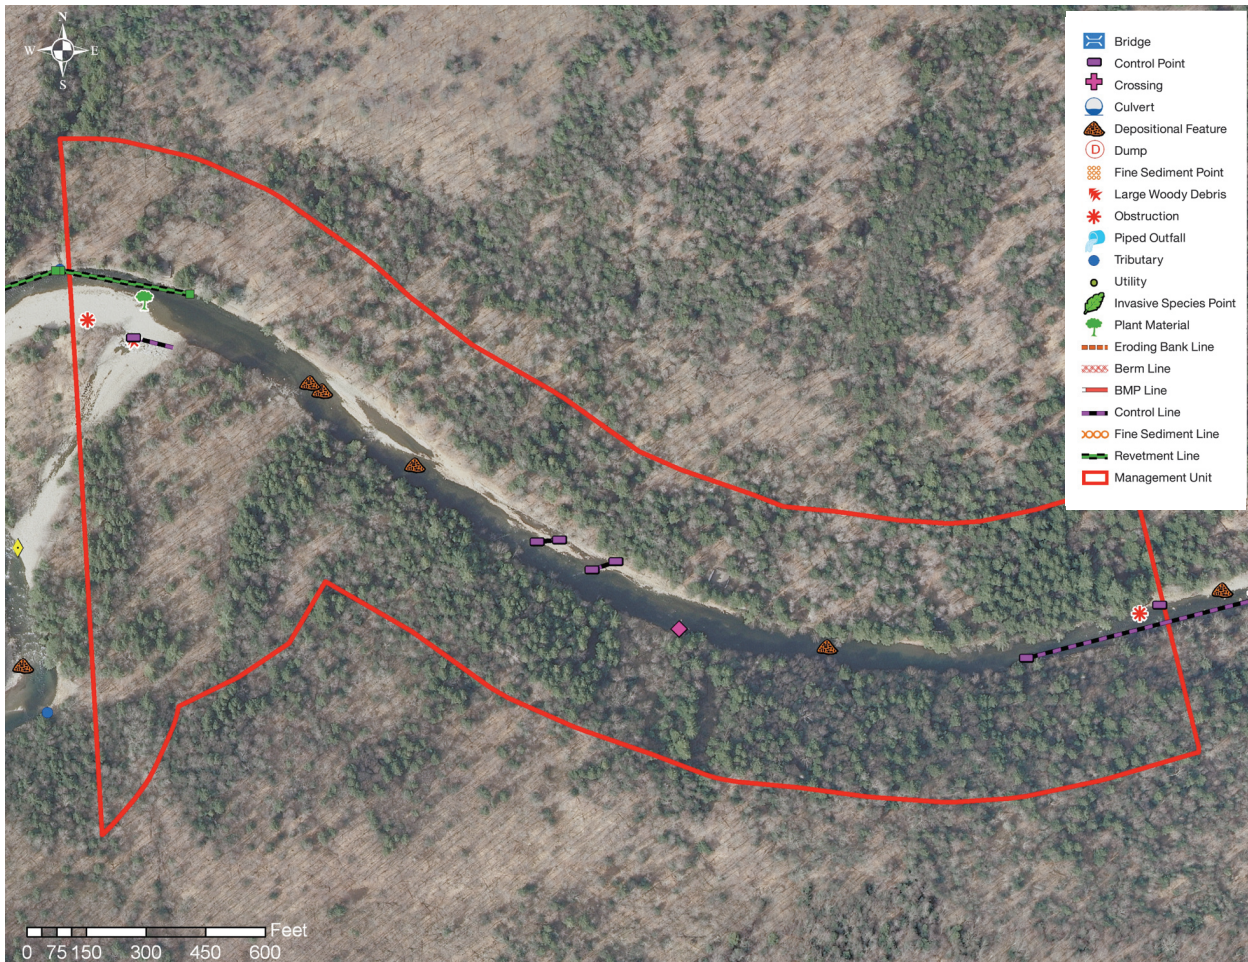
Stream Feature Inventory 2010 (Figure 1)

- None of the stream length is experiencing erosion
- 5.45% of stream length has been stabilized
- 2.05 acres of inadequate vegetation within the 100 ft. buffer
- None of stream is within 50 ft. of the road
- There are three structures located within the 100-year floodplain boundary

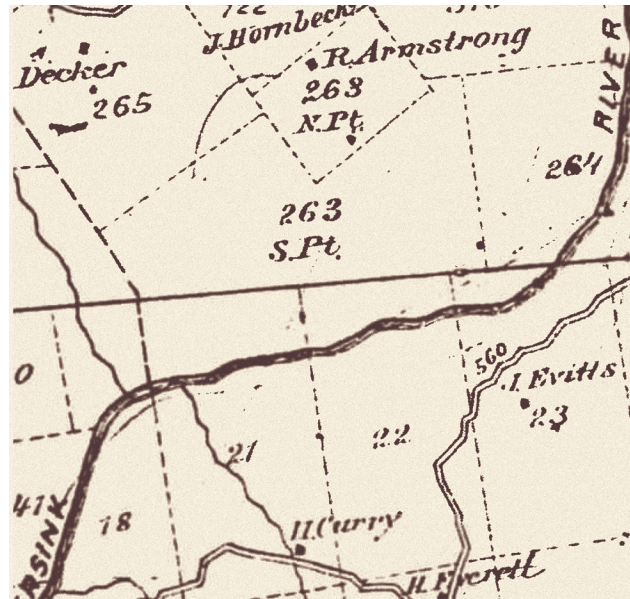
Excerpt from 1875 Beers Map (Figure 2)

The 1875 Beers Atlas of this area indicates that by that time, the stream had been harnessed for manufacturing, primarily saw mills, woodworking shops and tanneries (Figure 2). Raceways were built in the floodplains to divert water to ponds for use as needed. Floodplains were profoundly altered in the process, as these watercourses also became areas of preferential channelized flow when floodwaters inundated the floodplains. When woody debris jams blocked the primary channels, these raceways sometimes eroded out to become major secondary channels, or even took over the full flow to become a new primary watercourse.
