Neversink River Main Branch

MANAGEMENT UNIT 4

MAIN BRANCH MANAGEMENT UNIT 4
BETWEEN STATION 11700 AND STATION 9300

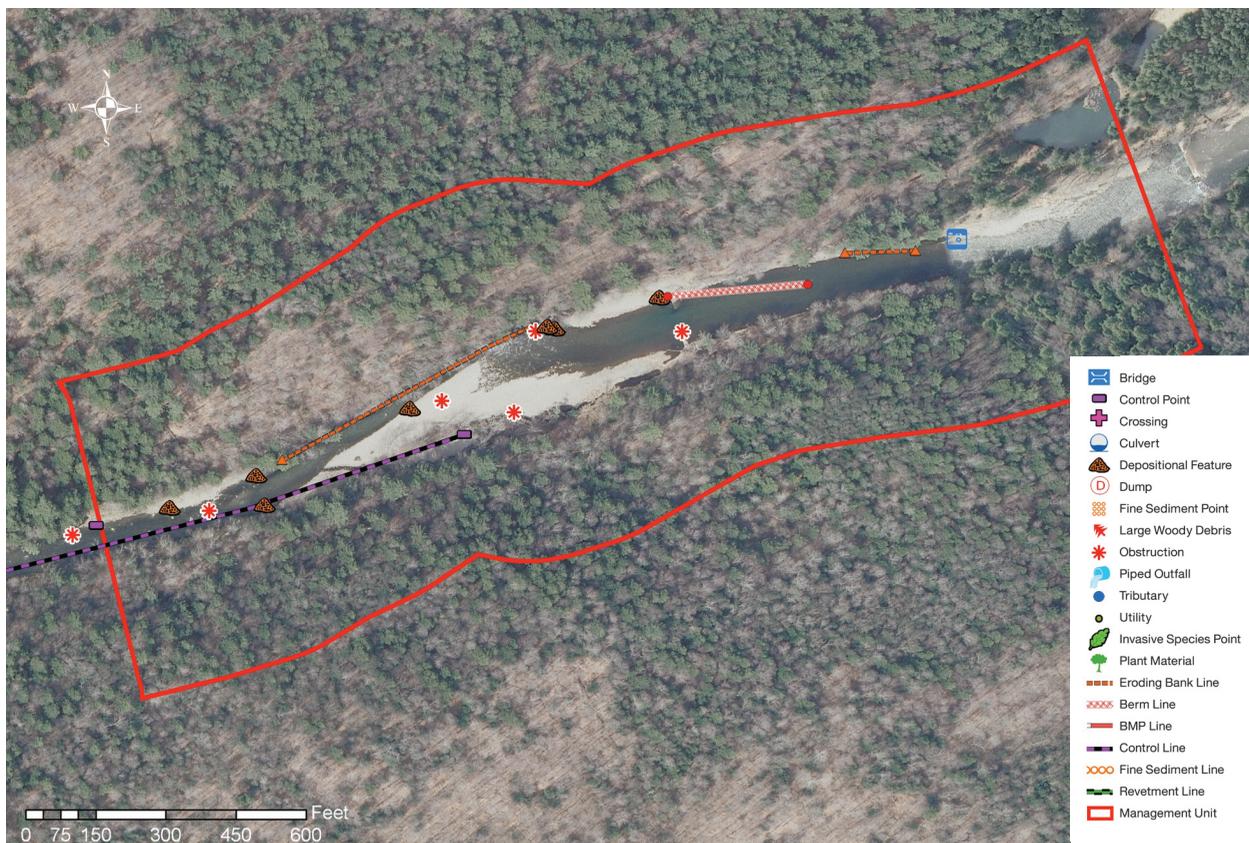
Stream Feature Inventory 2010 (Figure 1)

- 16% of stream length is experiencing erosion
- None of stream length has been stabilized
- 2.15 acres of inadequate vegetation within the 100 ft. buffer
- None of stream is within 50 ft. of the road
- There are no houses located within the 100-year floodplain boundary
