# Neversink River Main Branch

## MANAGEMENT UNIT 5

MAIN BRANCH MANAGEMENT UNIT 5  
BETWEEN STATION 14800 AND STATION 1170

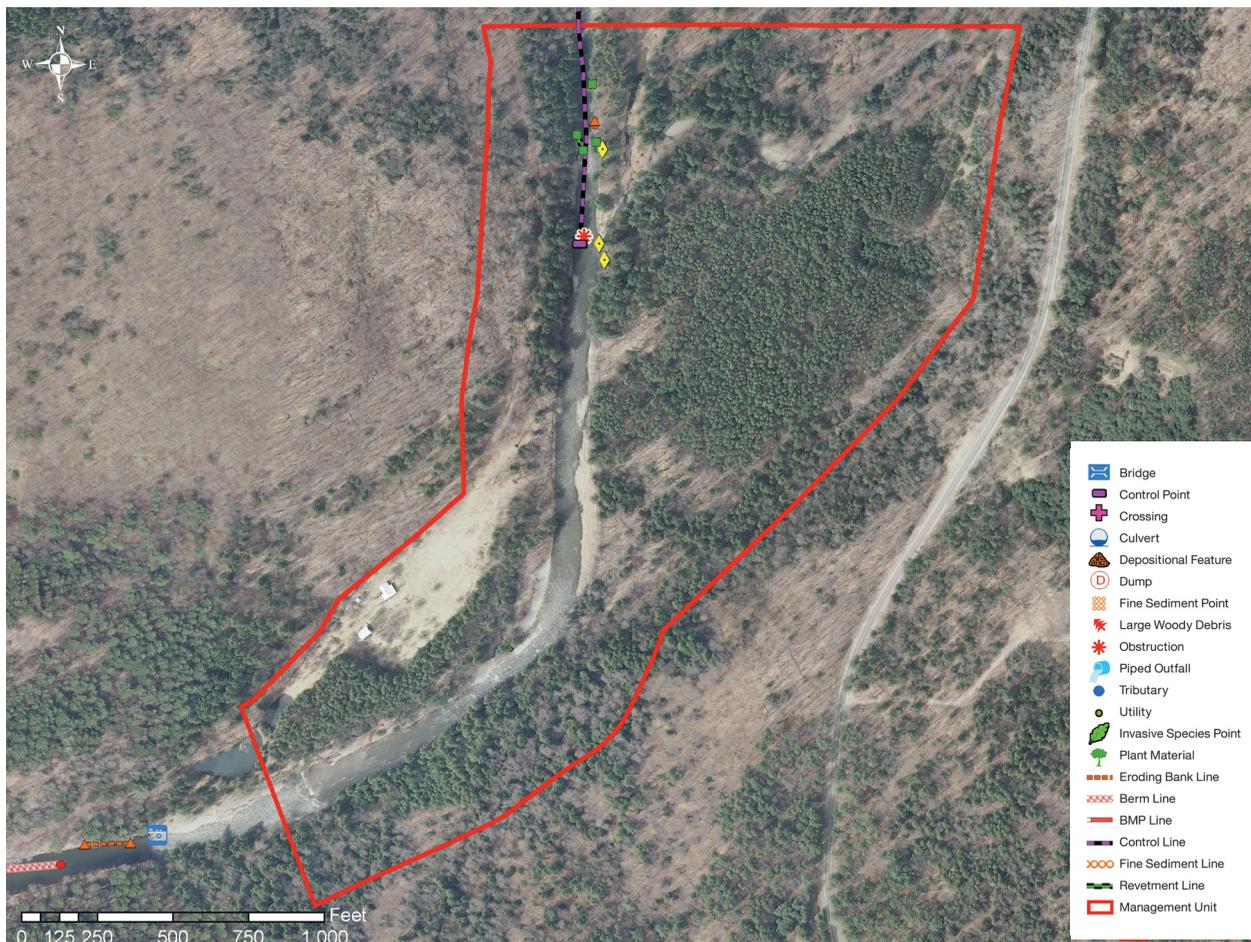
*Stream Feature Inventory 2010 (Figure 1)*

- 1% of stream length is experiencing erosion
- 1.87% of stream length has been stabilized
- 6.97 acres of inadequate vegetation within the 100 ft. buffer
- None of stream is within 50 ft. of the road
- There are no structures located within the 100-year floodplain boundary

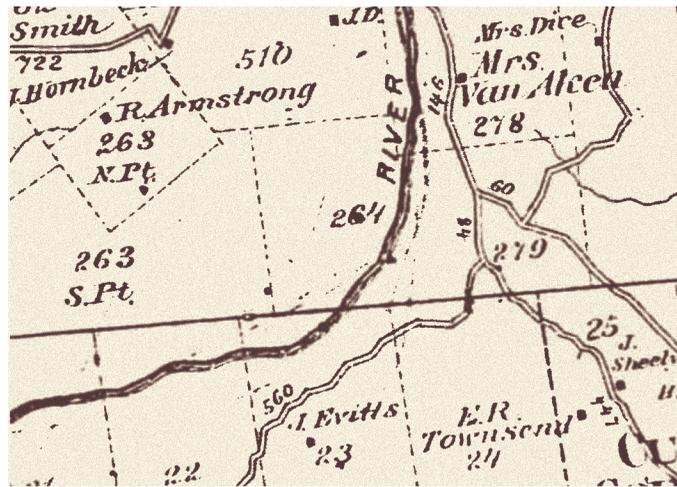
Excerpt from 1875 Beers Map (Figure 2)

The 1875 Beers Atlas of this area indicates that by that time, the stream had been harnessed for manufacturing, primarily saw mills, woodworking shops and tanneries (Figure 2). Raceways were built in the floodplains to divert water to ponds for use as needed. Floodplains were profoundly altered in the process, as these watercourses also became areas of preferential channelized flow when floodwaters inundated the floodplains. When woody debris jams blocked the primary channels, these raceways sometimes eroded out to become major secondary channels, or even took over the full flow to become a new primary watercourse.
