Neversink River West Branch

MANAGEMENT UNIT 1

WEST BRANCH MANAGEMENT UNIT 1
BETWEEN STATION 0 AND STATION 2200

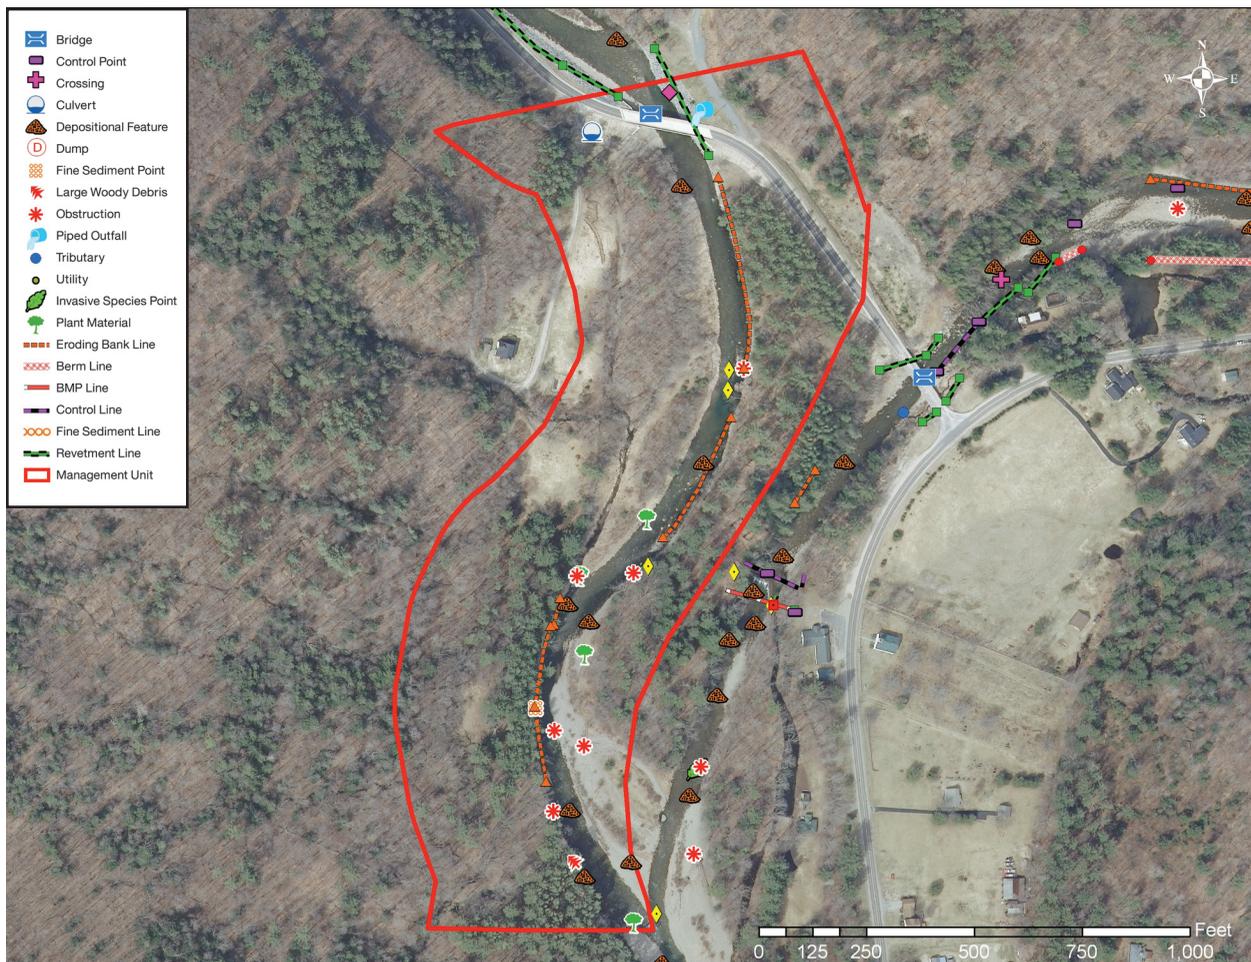
Stream Feature Inventory 2010 (Figure 1)

- 27.00% of stream length is experiencing erosion
- 4.48% of stream length has been stabilized
- 4.56 acres of inadequate vegetation within the 100 ft. buffer
- None of stream is within 50 ft. of the road
- No structures are located within the 100-year floodplain boundary

floodplain numerous times in many locations. A comparison of historical channel alignments (*Figure 3*) and in-stream observations made during a stream feature inventory in 2010 (*Figure 1, page 1*) indicate significant lateral channel instability. According to records available from the NYSDEC DART database 25 NYS Article 15 stream disturbance permits have been issued in this management unit. These permits pertain to activities which have the potential to significantly impact stream function, such as bank stabilization, stream crossings, habitat enhancement, and logging practices. database (<http://www.dec.ny.gov/cfm/xtapps/envapps/>).

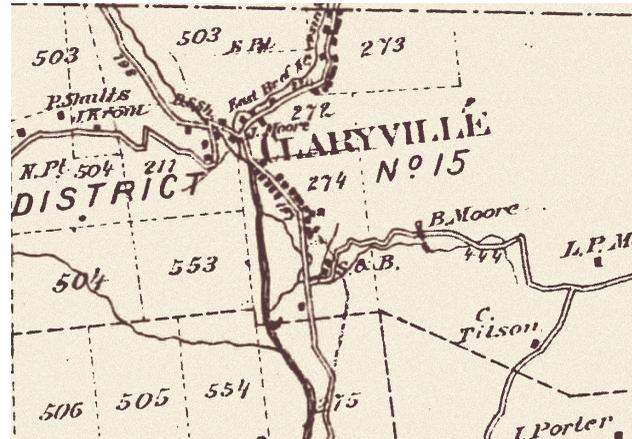
Excerpt from 1875 Beers Map (Figure 2)

The 1875 Beers Atlas of this area indicates that by that time, the stream had been harnessed for manufacturing, primarily saw mills, woodworking shops and tanneries (Figure 2). Raceways were built in the floodplains to divert water to ponds for use as needed. Floodplains were profoundly altered in the process, as these watercourses also became areas of preferential channelized flow when floodwaters inundated the floodplains. When woody debris jams blocked the primary channels, these raceways sometimes eroded out to become major secondary channels, or even took over the full flow to become a new primary watercourse.
