Neversink River West Branch

MANAGEMENT UNIT 13

WEST BRANCH MANAGEMENT UNIT 13
BETWEEN STATION 49100 AND STATION 54200

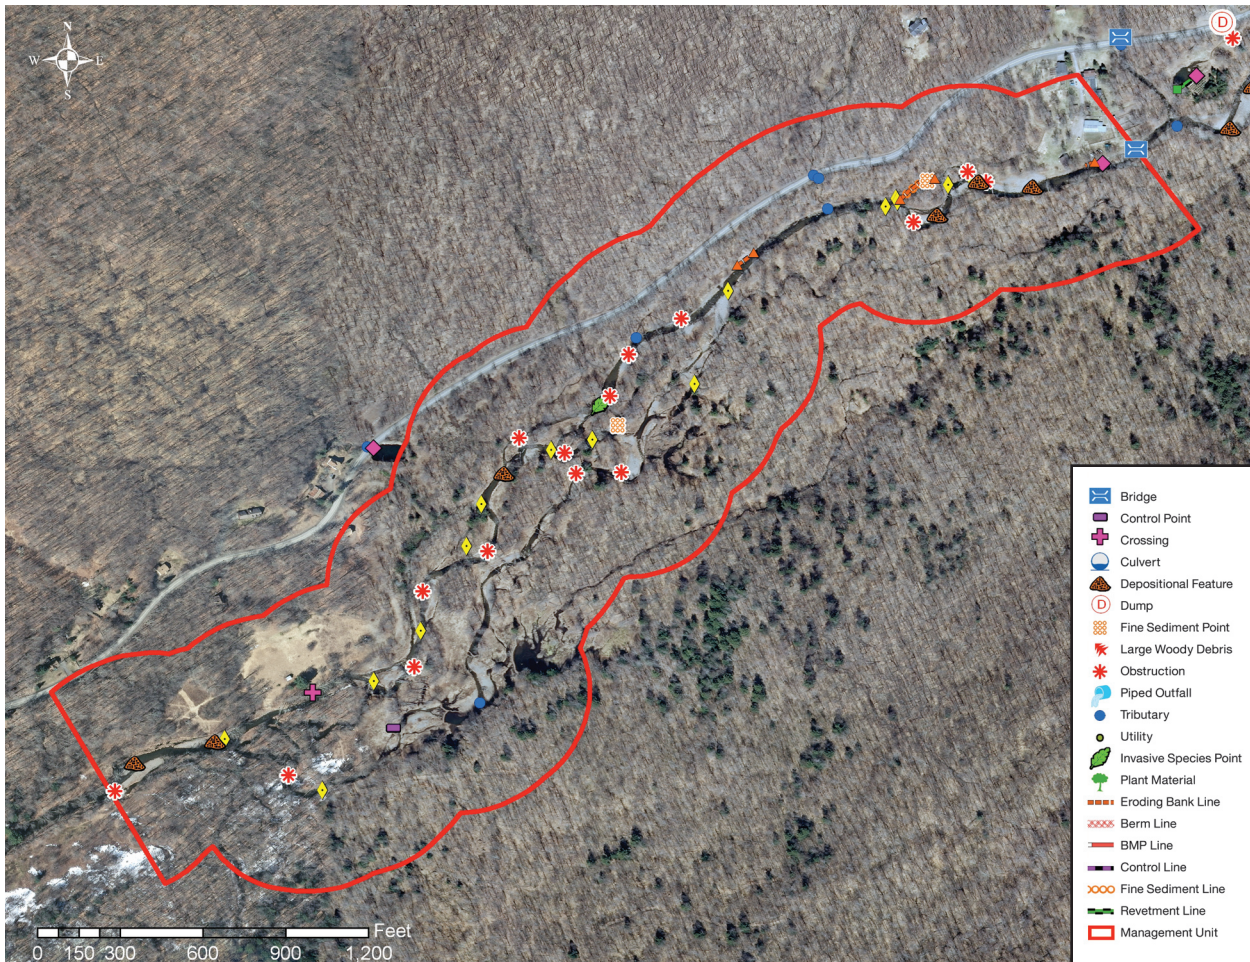
Stream Feature Inventory 2010 (Figure 1)

- 3.00% of stream length is experiencing erosion
- 0.00% of stream length has been stabilized
- 15.47 acres of inadequate vegetation within the 100 ft. buffer
- None of stream is within 50 ft. of the road
- There are four building structures located within the 100-year floodplain boundary

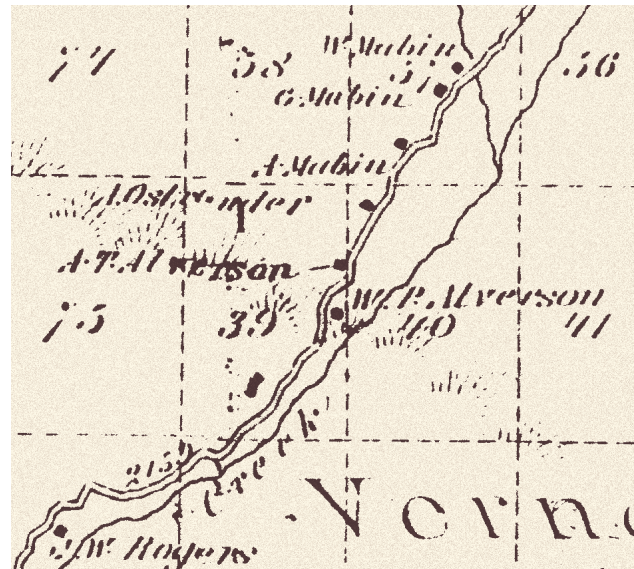
Excerpt from 1875 Beers Map (Figure 2)

The 1875 Beers Atlas of this area indicates that by that time, the stream had been harnessed for manufacturing, primarily saw mills, woodworking shops and tanneries (Figure 2). Raceways were built in the floodplains to divert water to ponds for use as needed. Floodplains were profoundly altered in the process, as these watercourses also became areas of preferential channelized flow when floodwaters inundated the floodplains. When woody debris jams blocked the primary channels, these raceways sometimes eroded out to become major secondary channels, or even took over the full flow to become a new primary watercourse.

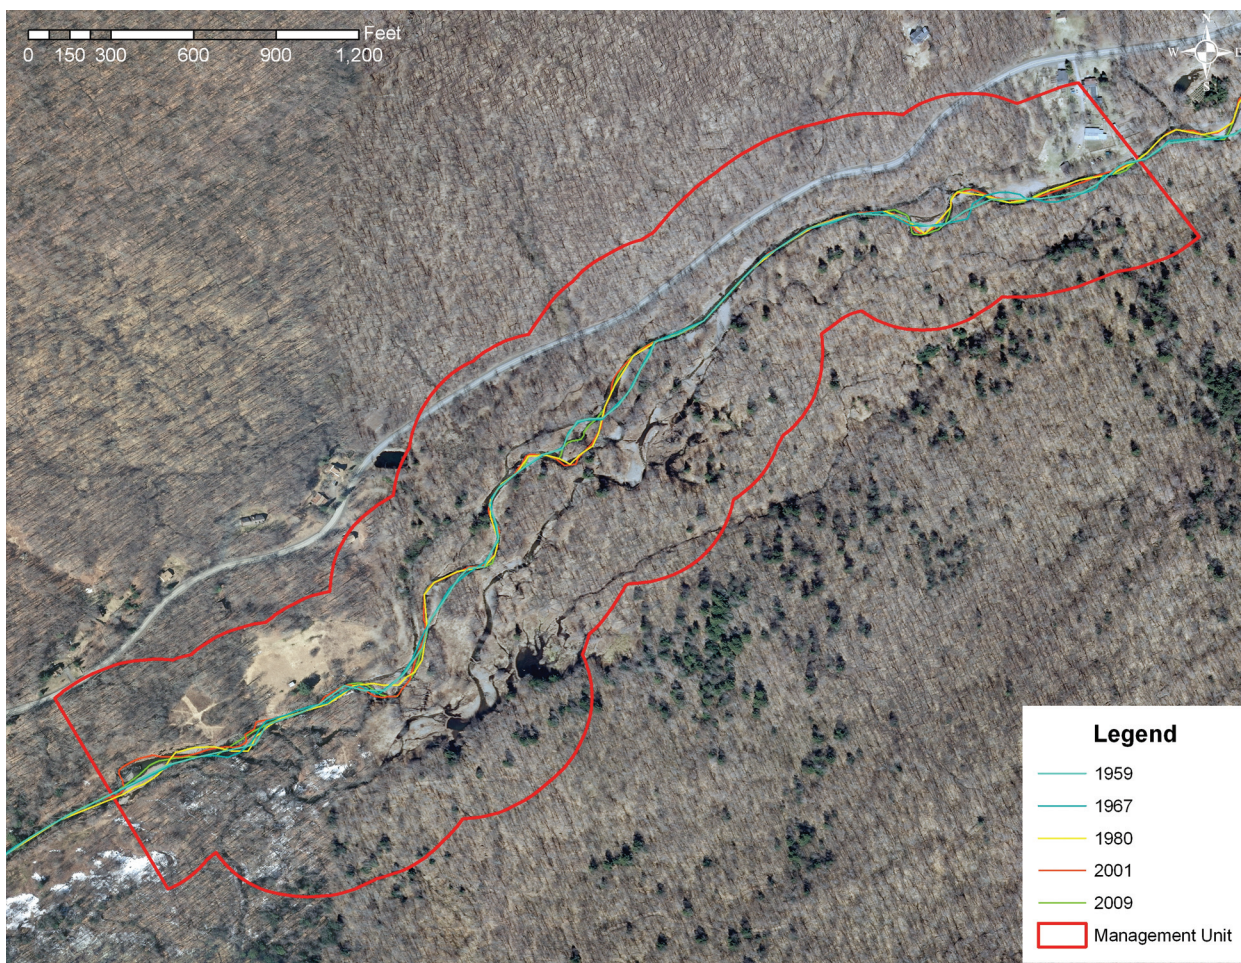
Historical channel alignments from five selected years (Figure 3)

The 1959 stream alignment (Figure 3, above) in this location features fewer meander bends in the main channel, which was located near the left bank in this location. It is likely that the main channel has migrated throughout the valley floor in this location shaped by the sediment deposition pattern formed by flood events and large woody debris
