Neversink River West Branch

MANAGEMENT UNIT 14

WEST BRANCH MANAGEMENT UNIT 14
BETWEEN STATION 54300 AND STATION 59000

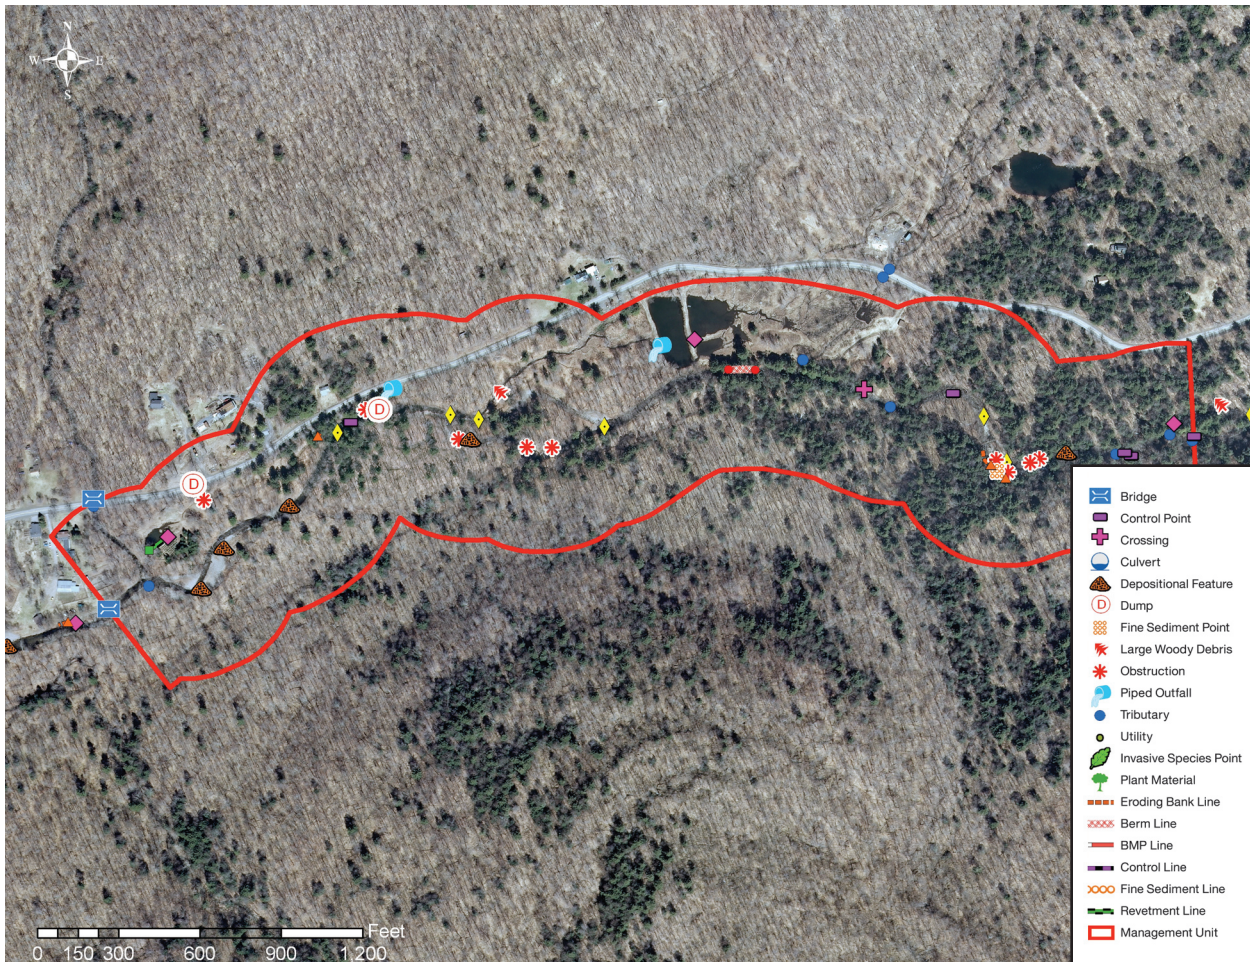
Stream Feature Inventory 2010 (Figure 1)

STREAM FEATURE STATISTICS

- 2.00% of stream length is experiencing erosion
- 0.88% of stream length has been stabilized
- 7.44 acres of inadequate vegetation within the 100 ft. buffer
- None of stream is within 50 ft. of the road
- There is one structure located within the 100-year floodplain boundary

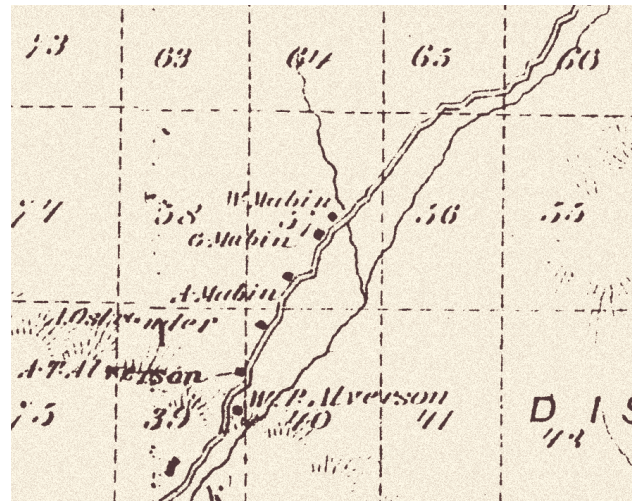
Excerpt from 1875 Beers Map (Figure 2)

The 1875 Beers Atlas of this area indicates that by that time, the stream had been harnessed for manufacturing, primarily saw mills, woodworking shops and tanneries (Figure 2). Raceways were built in the floodplains to divert water to ponds for use as needed. Floodplains were profoundly altered in the process, as these watercourses also became areas of preferential channelized flow when floodwaters inundated the floodplains. When woody debris jams blocked the primary channels, these raceways sometimes eroded out to become major secondary channels, or even took over the full flow to become a new primary watercourse.
