# Neversink River West Branch

## MANAGEMENT UNIT 16

WEST BRANCH MANAGEMENT UNIT 16  
BETWEEN STATION 69700 AND STATION 64300

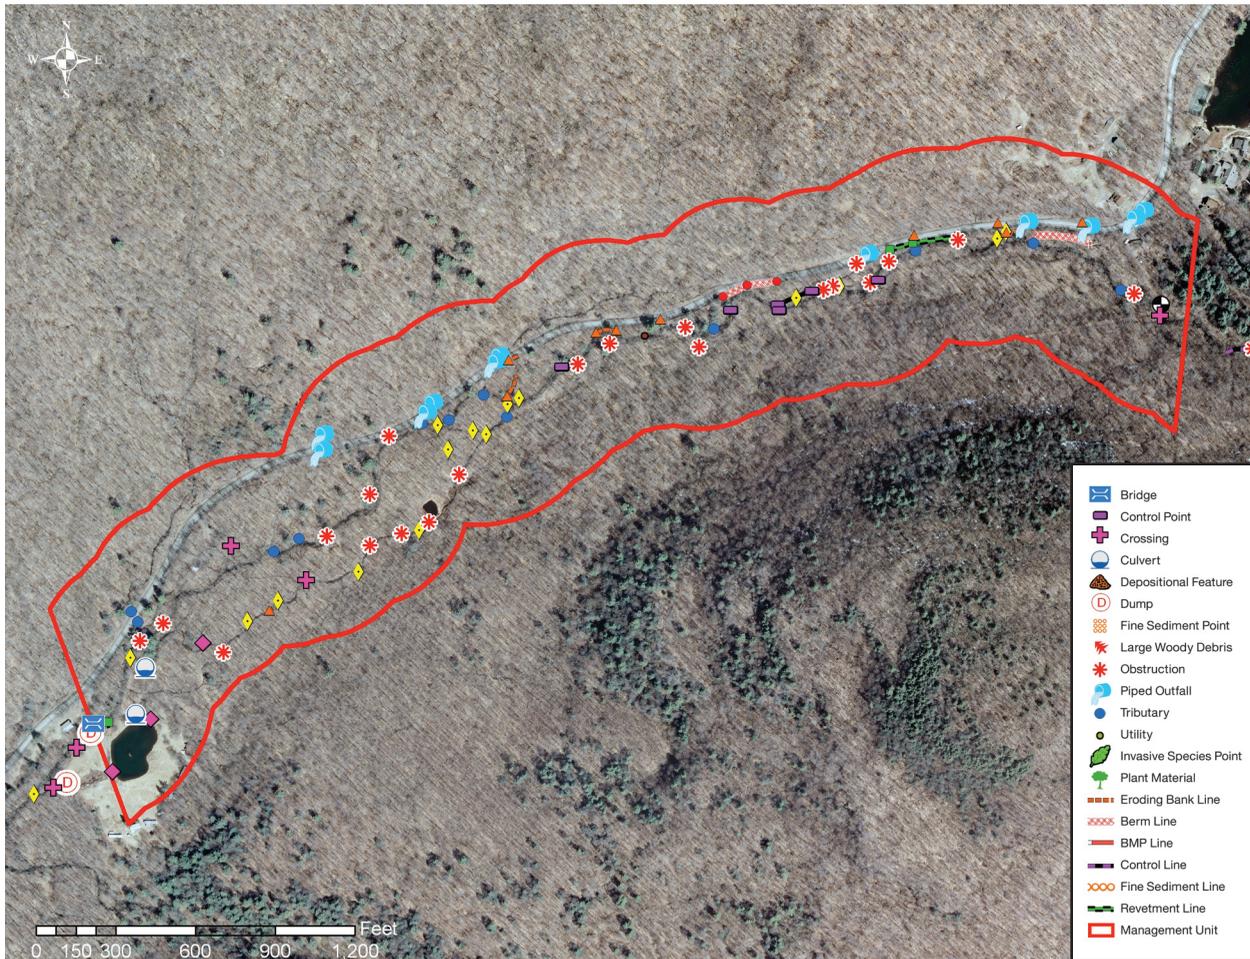
Stream Feature Inventory 2010 (Figure 1)

- 4 % of stream length is experiencing erosion
- 2.87 % of stream length has been stabilized
- 6.66 acres of inadequate vegetation within the 100 ft. buffer
- None of stream is within 50 ft. of the road
- No building structures are located within the 100-year floodplain boundary

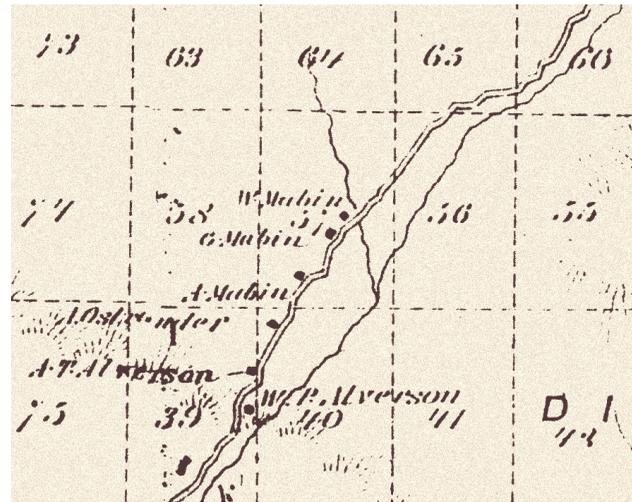
Excerpt from 1875 Beers Map (Figure 2)

The 1875 Beers Atlas of this area indicates that by that time, the stream had been harnessed for manufacturing, primarily saw mills, woodworking shops and tanneries (Figure 2). Raceways were built in the floodplains to divert water to ponds for use as needed. Floodplains were profoundly altered in the process, as these watercourses also became areas of preferential channelized flow when floodwaters inundated the floodplains. When woody debris jams blocked the primary channels, these raceways sometimes eroded out to become major secondary channels, or even took over the full flow to become a new primary watercourse.
