**Management Unit 5**  
Greene County - Town of Hunter  
Cross Section 90 to Cross Section 107

**Management Unit Description**

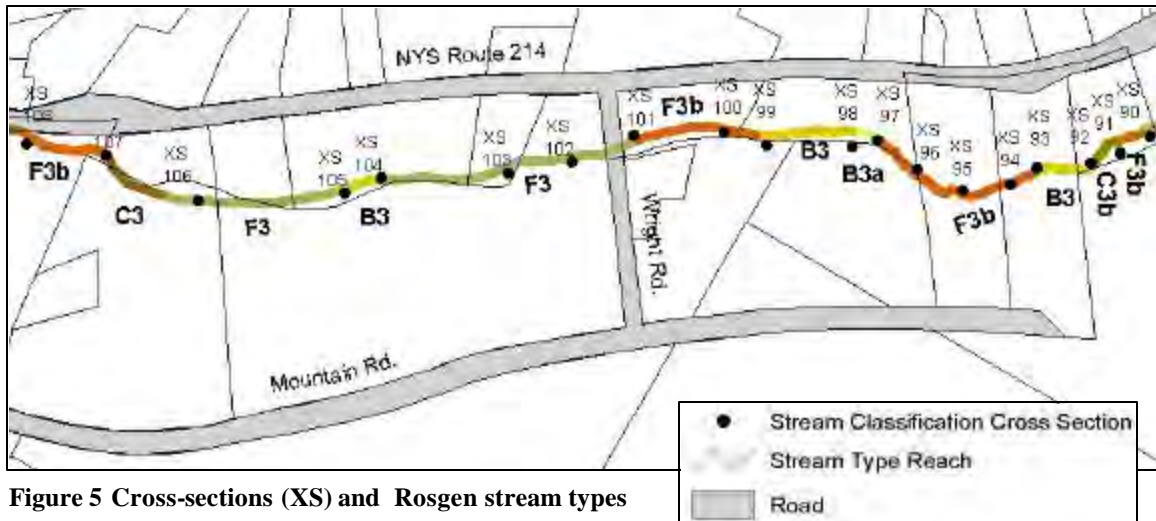
**Figure 5 Cross-sections (XS) and Rosgen stream types**

Management unit #5 begins with a short 21 ft. reach of F3 stream type. The channel is *entrenched*, or confined within the stream banks during high flood events, which can result in *degradation*. This reach, however, appears stable with its current morphology, exhibiting a gentle 1.7% slope and its cobble size bed material.

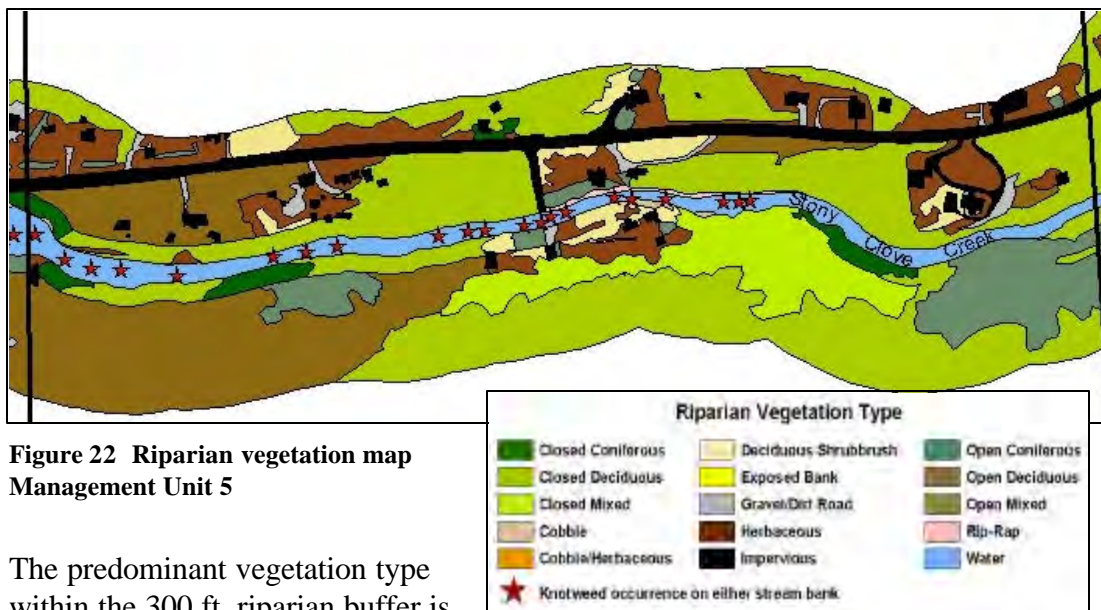
**Figure 22 Riparian vegetation map Management Unit 5**

The predominant vegetation type within the 300 ft. riparian buffer is forested (76%) followed by herbaceous (12%). The areas of herbaceous (non-woody) vegetation present opportunities to improve the riparian buffer with plantings of more flood-resistant species. *Impervious* area (7%) within this unit's buffer is primarily the NYS Route 214 roadway and private residences.

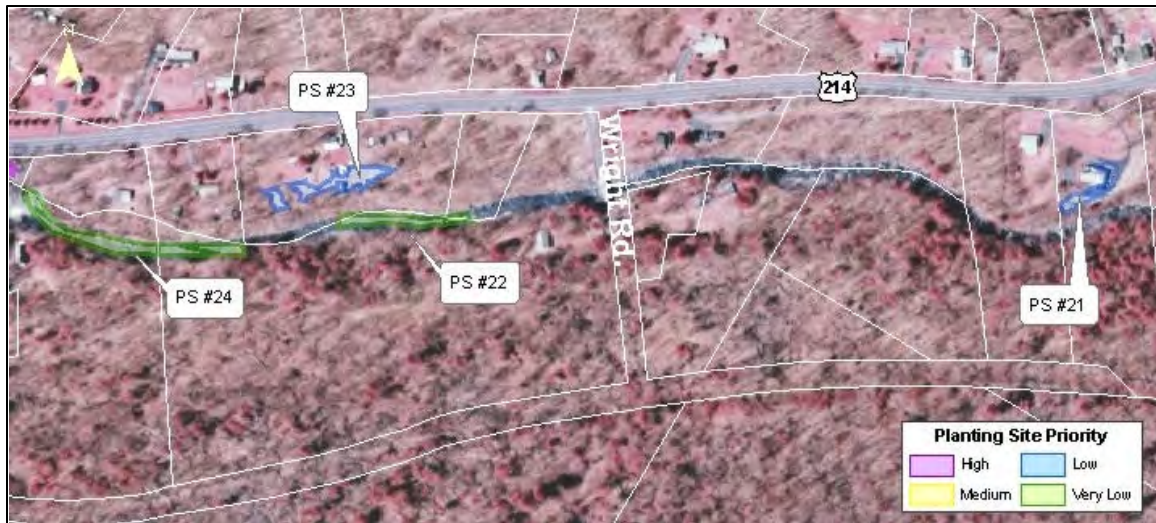
**Figure 23 Planting sites location map for Management Unit 5**

Planting site #21 (no photo available) is located on the right bank at the Zahartos residential property. This property has grass planted to the edge of the stream bank with some trees along the bank. Additional tree and shrub plantings are recommended to increase the density of the upland stream buffer.

Planting site #22 is an in-channel planting area located between cross-section 103 and 104 (Fig. 24). This reach of stream channel is overwide and shallow. Overwide channels are considered unstable because they often aggrade, which eventually causes bank erosion by increasing the stream velocity against the stream bank. Overwide channels also provide poor fish habitat due to generally warmer water temperatures and a lack of deep pools. Willows have begun to establish along the right bank. There is some apparently inactive erosion on the left bank which should be treated with willow and other native plantings. If not planted, this reach should be monitored to determine the stream's capacity to re-vegetate on its own.

Planting site #23 (no photo available) is located on the right bank at the series of red & white cabins along NYS Route 214. This property has a large grass lawn planted to the edge of the stream bank. Japanese Knotweed is prevalent along the right bank. Additional tree and shrub plantings are recommended to increase the density of the upland stream buffer. It is also recommended to remove the Japanese Knotweed, which

Planting site #24 is an in-channel planting area beginning between cross-sections 105 & 106 and ending at the bridge at the end of the management unit (Fig. 25). This reach of stream is overwide and shallow. Overwide channels are considered unstable because they often aggrade, which eventually causes bank erosion by increasing the stream velocity against the stream bank. Overwide channels also provide poor fish habitat due to generally warmer water temperatures and a lack of deep pools.

In-channel plantings of native willows and sedges is recommended along the toe of each bank. These plantings may allow the stream to narrow into a more stable morphology. Japanese Knotweed and *Multiflora Rose* (*Rosa multiflora*) are prevalent along the right bank. It is recommended to remove these species, which are invasive non-native species. Japanese Knotweed does not provide adequate erosion protection because it has a very shallow rooting system.

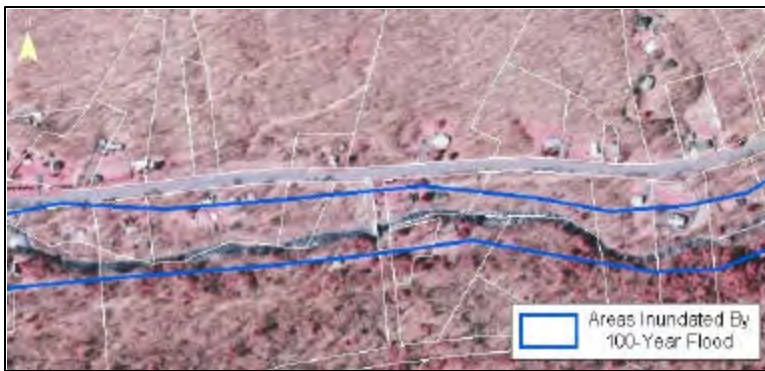
**Figure 26 100-year floodplain boundary in Management Unit 5**

According to the NFIP maps, there are eighteen houses located within the 100-year flood boundary in this management unit (Fig. 26). The current NFIP maps are available for review at the Greene and Ulster County Soil & Water Conservation District offices.

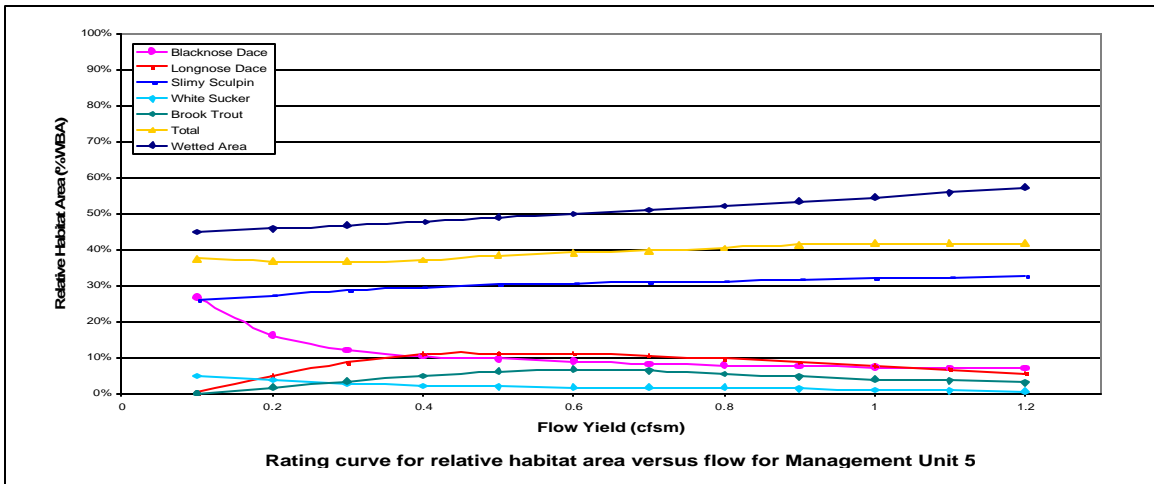
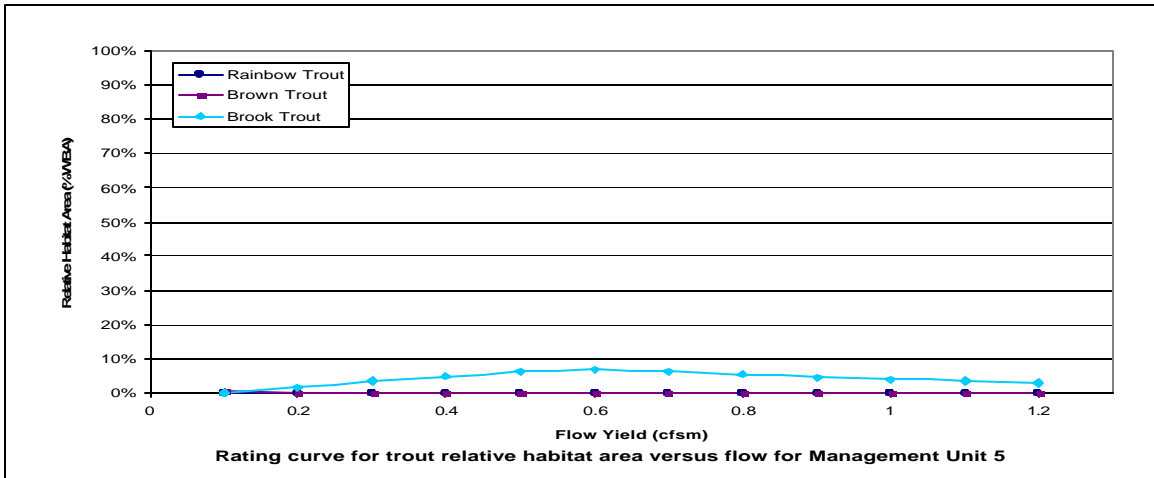
Figure 28 MesoHABSIM habitat rating curves for Management Unit 5

Management Unit #5 consists mostly of fast flowing, shallow habitats (riffles, glides and rapids) with abundant boulders, but almost no woody debris. *Wetted area* is only about half of the bankfull wetted area across all measured flows, increasing slightly with flow. Therefore, as flow increases, it generally becomes deeper and faster, turning into runs. The hydro-morphological units are also larger than those in Management Unit #4. Nevertheless, the overall habitat stays at a relatively constant level, covering the majority of wetted area. As flows get faster, the habitat becomes less suitable for blacknose dace. White sucker and brook trout habitat stay at very low levels, though the latter's habitat increases slightly at flows close to 0.6 cfs. Similar to previous sections, brown and rainbow trout have very little prime habitat, but plentiful low quality habitat. Improving overhead cover in the unit with joint plantings installed at rip-rap revetments would enhance habitat quality. (See general recommendations for aquatic habitat improvement in Section 6.6)
