**Management Unit 7**  
 Greene County - Town of Hunter  
 Cross Section 107 to Cross Section 116

**Management Unit Description**

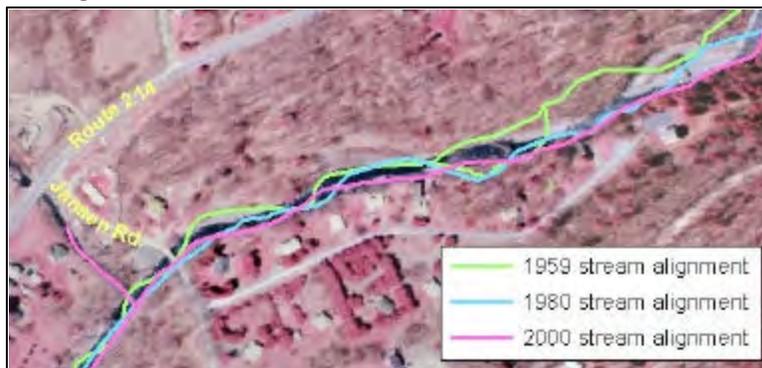
**Figure 6 Historical stream alignments of Management Unit 7**

As seen from the historical stream alignments, this management unit has experienced significant channel migration/manipulation over the years (Fig. 6). The most dramatic change evident in the period for

which we have aerial photography appears to have taken place at the top of the management unit, sometime between 1959 and 1980. In 1959, the stream is shown as

following a different *meander* pattern, approximately 150 ft. to the right of where the channel is presently located. In the middle of this unit, the channel was split into two channels and rejoined roughly 300 ft. downstream.

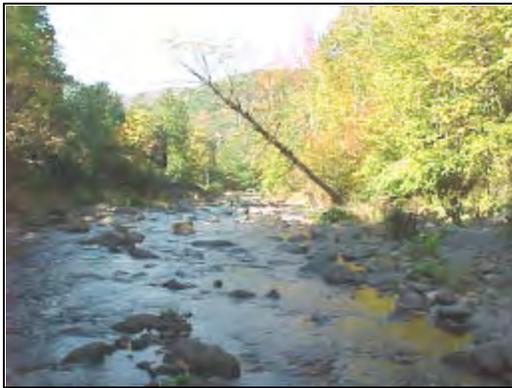
**Figure 9 Cross-section 117  
Stream Type F3**

Continuing downstream, the channel becomes *entrenched*, or confined within the stream banks during high flood events, which often results in channel *incision*. The slope decreases to 1.6% over this entire 1,059 ft. reach of F3 stream type (Fig. 9 & Fig. 11).

The *shear stress*, or the force of flowing water, is eroding the toe of this bank during high flow events. This erosion has caused a 99 ft. long bank failure and left the bank raw and vulnerable. At the top of this 17 ft. high bank sits a private residence which is seriously threatened, as the bank continues to erode. According to the landowner, rip-rap was installed on this bank in the early 1980's, but has since been washed away. The landowner has also noted a significant lowering of the stream bed elevation since the 1980's. This observation is consistent with incision of entrenched stream systems, particularly downstream of bedrock controls, as in this setting.

The Bank Erodibility Hazard Index (BEHI) score of site #15.5 is ranked “Very High”, the second highest prioritization category in terms of its vulnerability to erosion. This bank erosion site is considered a high priority for restoration because of its imminent threat to the residence.

Recommendations to restore this site include moving the active stream channel away from the left stream bank, and installing a *rock vane* and a well vegetated bench and bank. Rock vanes are often used in stream restoration projects to direct stream flows away from the banks. In-depth survey and design would be required to plan a stream restoration project at this site.

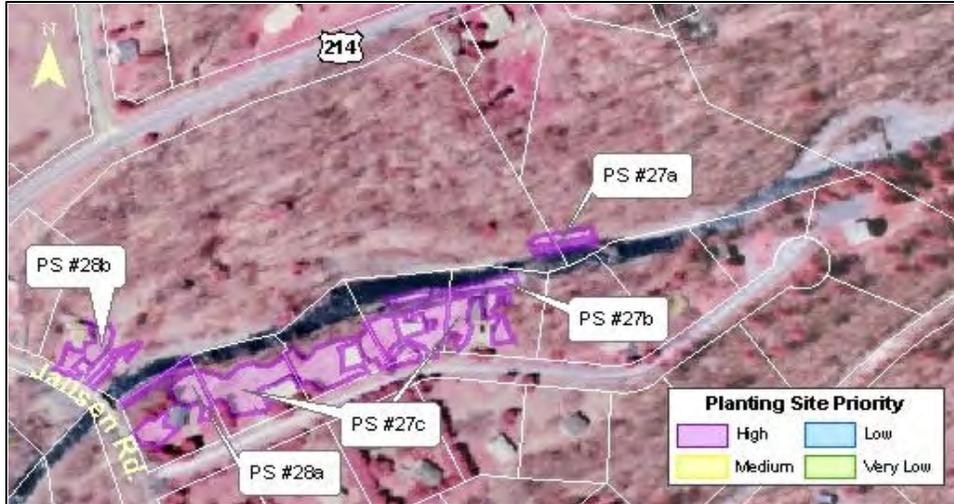
**Figure 15 Planting sites location map for Management Unit 7**

In June 2003, suitable riparian improvement planting sites were identified through a watershed-wide field evaluation of current riparian buffer conditions and existing stream channel morphology (Fig. 15). These locations indicate where plantings of trees and shrubs on and near stream banks can help reduce the threat of serious bank erosion, and can help improve aquatic habitat as well. In some cases, eligible locations include stream banks where rock rip-rap has already been placed, but where additional plantings could significantly improve stream channel stability in the long-term, as well as biological integrity of the stream and floodplain. Areas with serious erosion problems where the stream channel requires extensive reconstruction to restore long-term stability have been eliminated from this effort. In most cases, these sites can not be effectively treated with riparian enhancement alone, and full restoration efforts would include re-vegetation components. Two appropriate planting sites were documented within this management unit.

Planting site #27a is located at bank erosion site #16 (Fig. 16 & Inset C). This erosion site is 108 ft. long with a 6 ft. high bank. The top of the stream bank is well vegetated with trees but the face has been stripped of vegetation.

Recommendations for this site include stabilizing the toe of the bank with willow *fascines*. It will be necessary to prepare the stream bank for plantings by either importing topsoil or scalping topsoil from the top of the bank. The stream bank should be vegetated with native willows and shrubs, and the water's edge with native sedges.

Planting site #27b is located along 490 ft. of rip-rap (Fig. 17 & Inset G). Inserting plant materials into the soil between rip-rap rocks, or *joint planting*, is recommended at this site. Joint planting will strengthen and increase the longevity of the rip-rap. These plantings will also improve the aquatic habitat by cooling water temperatures through providing shade.

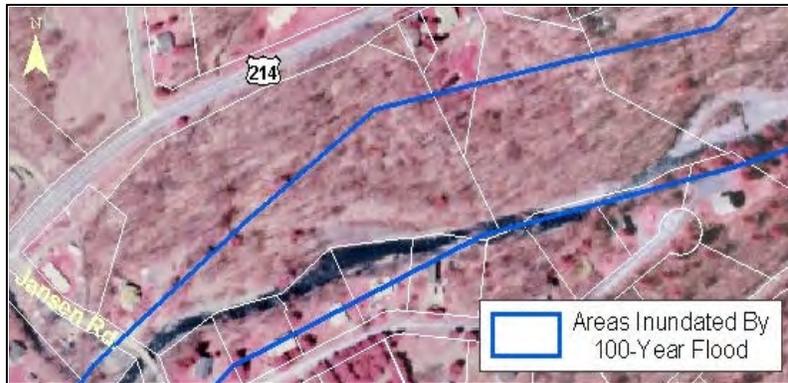
**Figure 20 100-year floodplain boundary map in Management Unit 7**

According to the NFIP maps, there are no houses located within 100-year floodplain boundary in this management unit (Fig. 20). The current NFIP maps are available for review at the Greene and Ulster County Soil & Water Conservation District offices.
