Management Unit 8
Greene County - Town of Hunter
Jansen Road to Cross Section 131

Management Unit Description

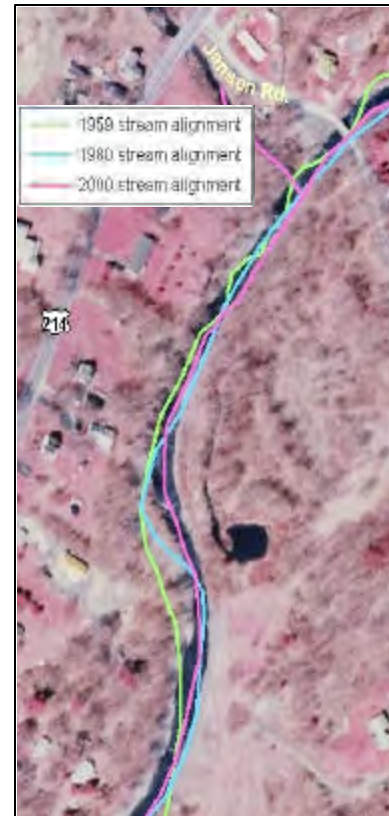
Figure 4 Historical stream channel alignments at top of

As seen from the historical stream alignments, this management unit's channel has been somewhat unstable historically. There are two particular reaches where channel migration has occurred. The first reach, shown in Figure 4, is located downstream from Jansen Road. Since 1959, the stream's meander pattern has migrated to the left, increasing pressure on the left stream bank.

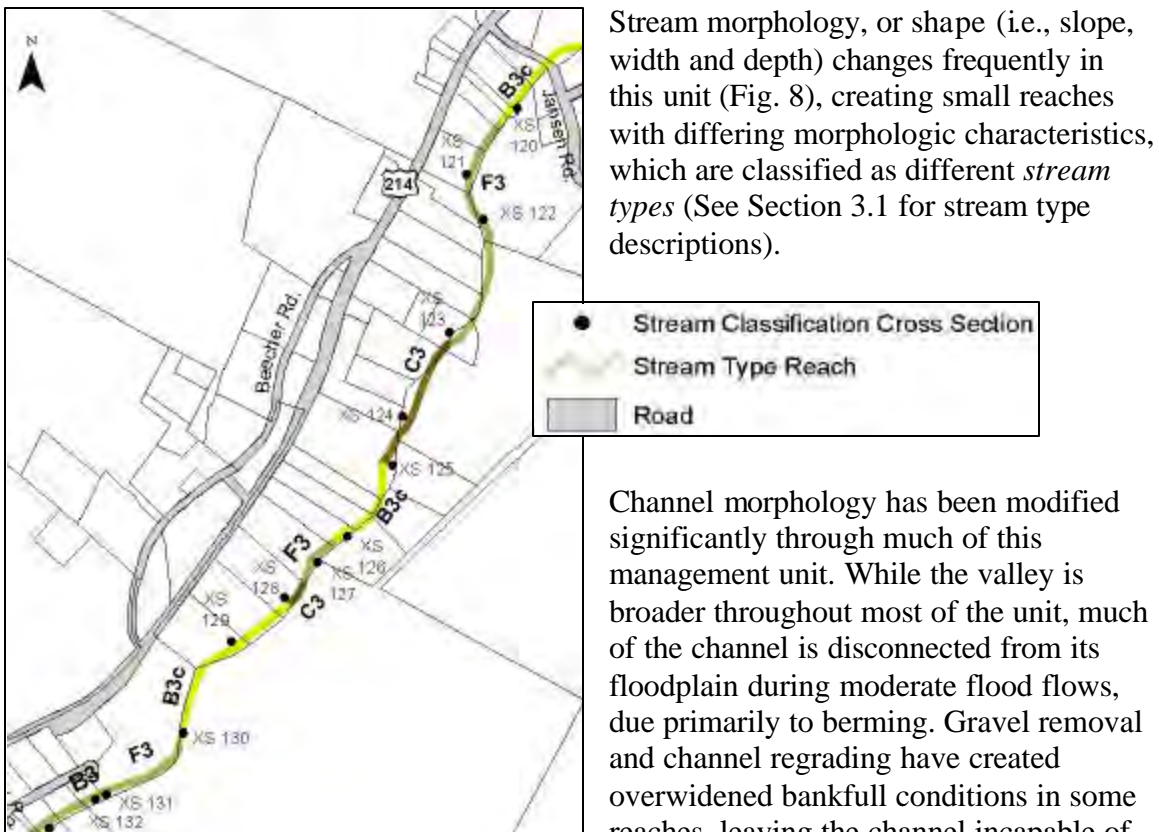
Figure 8 Cross-sections and Rosgen stream types for Management Unit 8

Stream morphology, or shape (i.e., slope, width and depth) changes frequently in this unit (Fig. 8), creating small reaches with differing morphologic characteristics, which are classified as different *stream types* (See Section 3.1 for stream type descriptions).

Channel morphology has been modified significantly through much of this management unit. While the valley is broader throughout most of the unit, much of the channel is disconnected from its floodplain during moderate flood flows, due primarily to berming. Gravel removal and channel regrading have created overwidened bankfull conditions in some reaches, leaving the channel incapable of passing sediment adequately. As a consequence, several locations where streambank cohesiveness is limited by inadequate riparian vegetation have experienced significant erosion during flood events. This has led to *aggradation* and limited natural recovery potential. Cobble dominates the bed material throughout the unit. Nonetheless, *entrenched* conditions at higher flows predominate this management unit, presenting significant threats under large flood conditions.

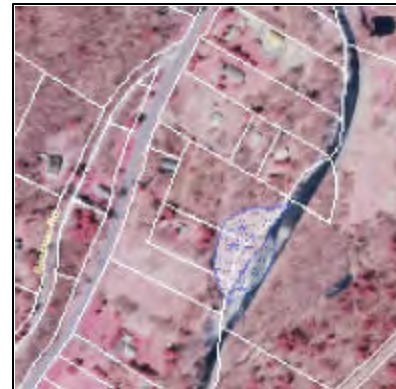
Figure 14 Federally Designated Wetlands

In the middle of this reach are two federally designated wetlands (Fig. 14). The larger wetland, which is 0.9 acres in size, is a riverine upper perennial, with an unconsolidated shore, and is temporarily flooded. The smaller wetland, which is 0.3 acres in size, is classified as palustrine scrub-shrub, broad-leaf deciduous, and temporarily flooded. (See Section 2.6 wetland type descriptions and regulations)

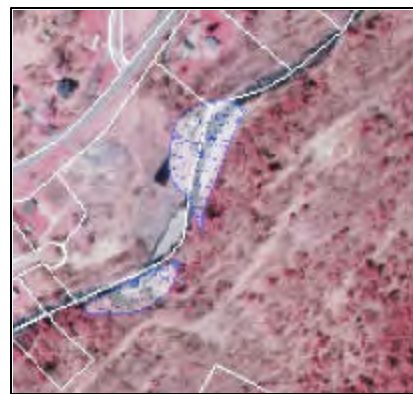
**Figure 18 Federally Designated
Wetlands**

Near this tributary confluence is a 1.4 acre federally designated wetland (Fig. 18). This wetland is classified as riverine upper perennial, unconsolidated shore, temporarily flooded. Another 0.6 acres of the same wetland type are mapped a short distance downstream. (See Section 2.6 wetland type descriptions and regulations)

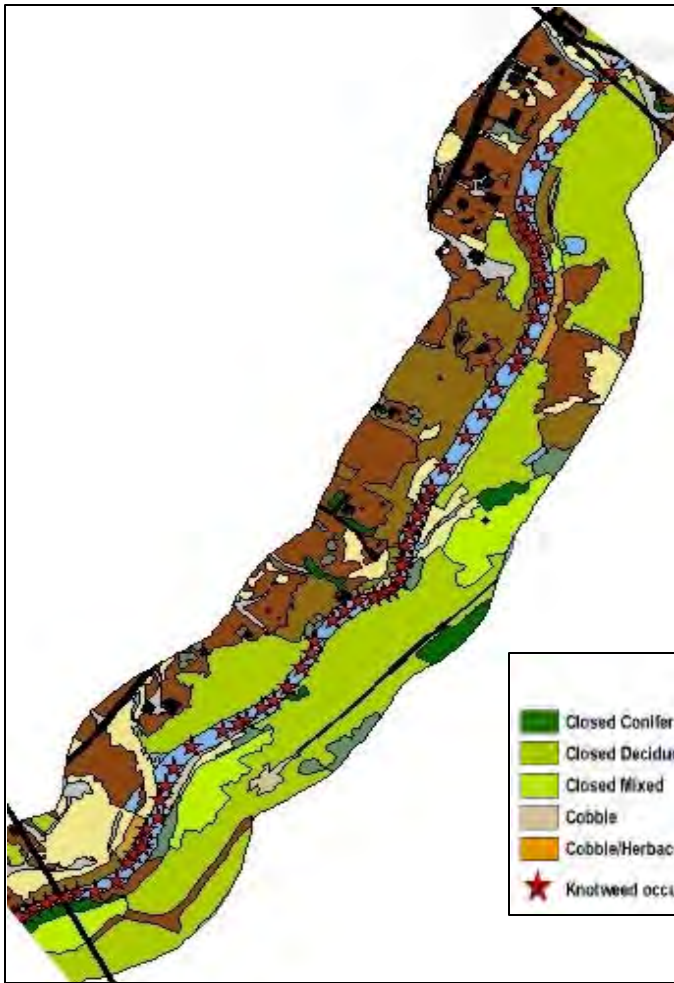
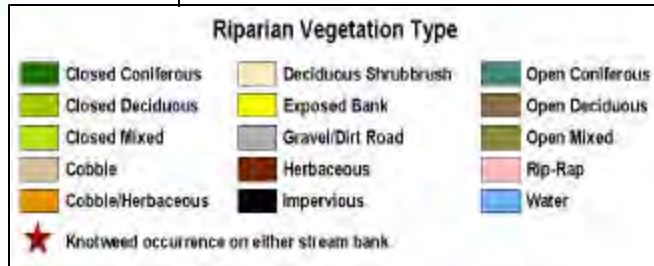
Figure 21 Riparian vegetation map of Management Unit 8

An analysis of vegetation was conducted using aerial photography from 2001 and field inventories (Fig. 21 & Appendix A). Japanese knotweed occurrences were documented as part of the MesoHABSIM aquatic habitat inventory conducted during the summer of 2002 (Appendix B).

The predominant vegetation type within the 300 ft. riparian buffer is forested (59%) followed by herbaceous (22%). Areas of herbaceous (non-woody) vegetation present opportunities to improve the riparian buffer with plantings of more flood-resistant species. *Impervious* area (4%) within this unit's buffer is primarily the NYS Route 214 roadway and private residences.

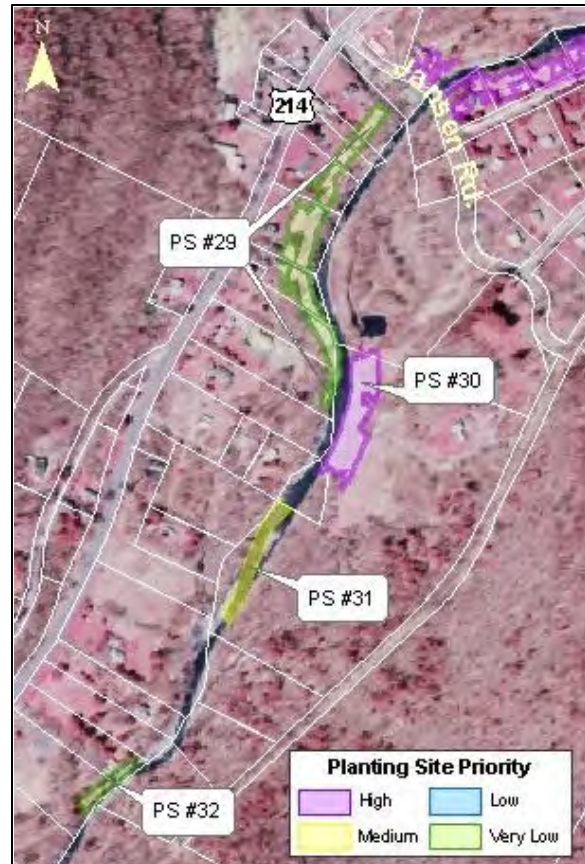
Figure 22 Planting sites location map for Management Unit 8

In June 2003, suitable riparian improvement planting sites were identified through a watershed-wide field evaluation of current riparian buffer conditions and existing stream channel morphology (Fig. 22). These locations indicate where plantings of trees and shrubs on and near stream banks can help reduce the threat of serious bank erosion, and can help improve aquatic habitat as well. In some cases, eligible locations include stream banks where rock rip-rap has already been placed, but where additional plantings could significantly improve stream channel stability in the long-term, as well as biological integrity of the stream and floodplain. Areas with serious erosion problems where the stream channel requires extensive reconstruction to restore long-term stability have been eliminated from this effort. In most cases, these sites can not be effectively treated with riparian enhancement alone, and full restoration efforts would include re-vegetation components. Four appropriate planting sites were documented within this management unit.

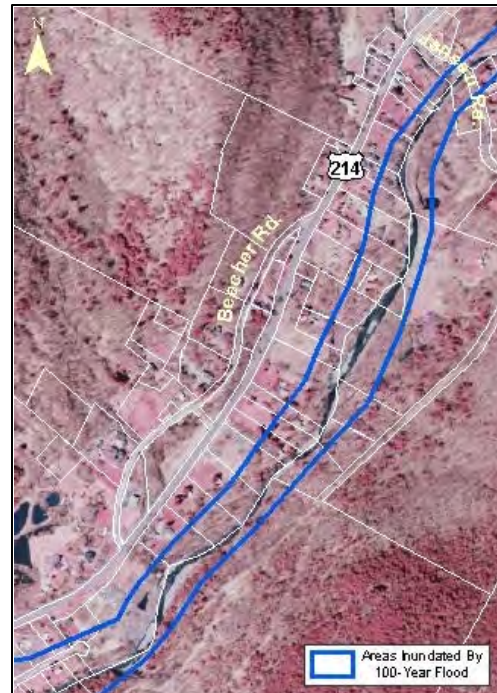
Figure 27 100-year floodplain boundary in Management Unit 8

According to the NFIP maps, there are fourteen houses located within the 100-year floodplain boundary in this management unit (Fig. 27). The current NFIP maps are available for review at the Greene and Ulster County Soil & Water Conservation District offices.

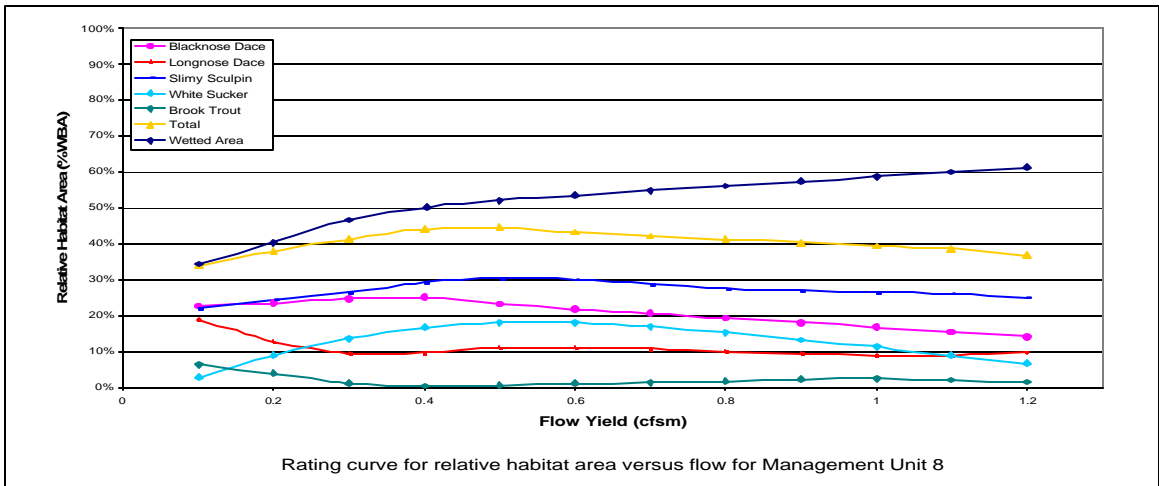
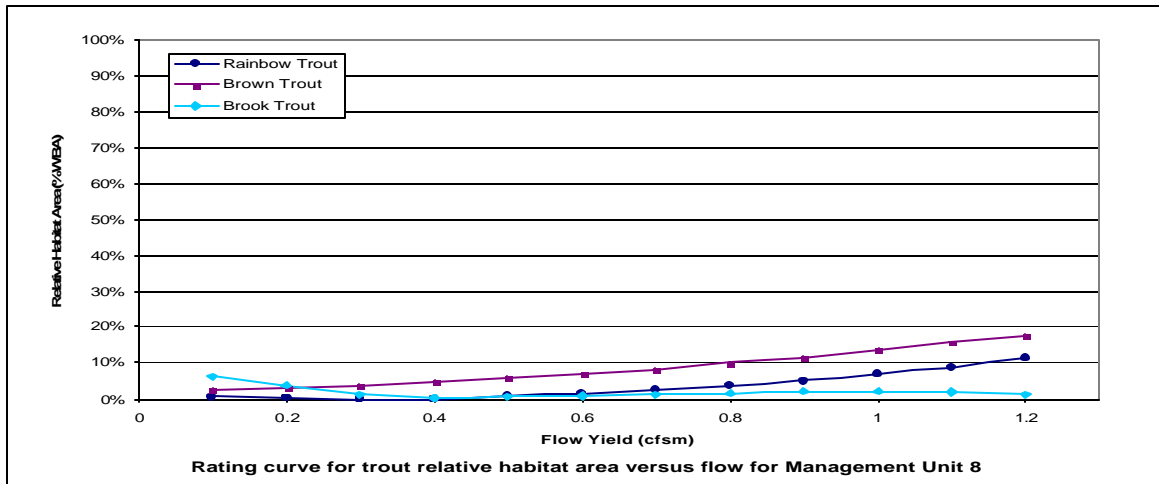
Figure 28 MesoHABSIM habitat rating curves for Management Unit 8

Management unit #8 runs between two roads and is shallow and faster than the unit upstream. It consists mostly of fast-flowing shallow habitats (riffles and runs) with many shallow margins. The dominant substrate in this unit is smaller in size than that in management unit #7. It changes into mostly fast *runs* and *ruffles* when flow increases. At mapped flows, the *wetted area* increases from 30% to 70% of the bankfull wetted area, with an inflection point between 0.4 cfs/m and 0.8 cfs/m. At this point, the overall habitat begins to decline. Almost the entire wetted area is suitable for the target fauna at low flow. Slimy sculpin, blacknose dace, and longnose dace have the best habitat conditions under these circumstances. Interestingly, the levels of suitable habitat for blacknose and longnose dace cross at higher flows. White sucker habitat peaks between 0.4 cfs/m and 0.8 cfs/m and then proceeds to decline towards zero. Again, brook trout has very low habitat levels in this unit, even low quality habitat is scarce. Brown and rainbow trout have very low levels of excellent habitat and moderate levels of usable habitat. (See general recommendations for aquatic habitat improvement in Section 6.6)
