**Management Unit 8**  
Greene County - Town of Hunter  
Jansen Road to Cross Section 131

**Management Unit Description**

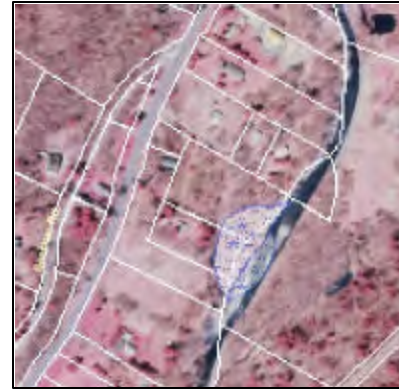
**Figure 14 Federally Designated Wetlands**

In the middle of this reach are two federally designated wetlands (Fig. 14). The larger wetland, which is 0.9 acres in size, is a riverine upper perennial, with an unconsolidated shore, and is temporarily flooded. The smaller wetland, which is 0.3 acres in size, is classified as palustrine scrub-shrub, broad-leaf deciduous, and temporarily flooded. (See Section 2.6 wetland type descriptions and regulations)

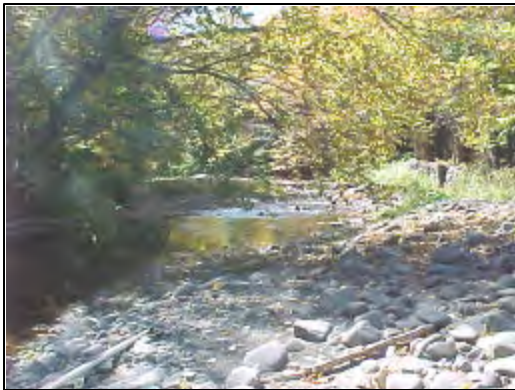
**Figure 15 Cross-section 126  
Stream Type B3c**

becomes moderately entrenched, as the stream type changes to B3c for the next 514 ft. (Fig. 15). Channel slope remains fairly flat at 1.4%. At the beginning of the reach is a small unnamed tributary entering from the left stream bank. This tributary is not classified under the NYS DEC best usage classification system.

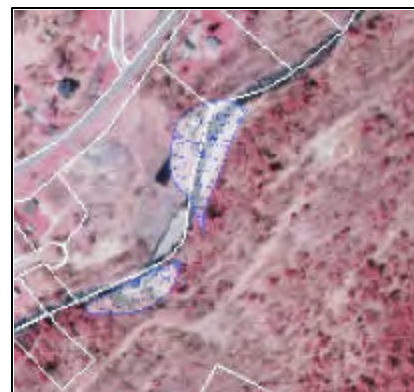
**Figure 18 Federally Designated  
Wetlands**

Near this tributary confluence is a 1.4 acre federally designated wetland (Fig. 18). This wetland is classified as riverine upper perennial, unconsolidated shore, temporarily flooded. Another 0.6 acres of the same wetland type are mapped a short distance downstream. (See Section 2.6 wetland type descriptions and regulations)

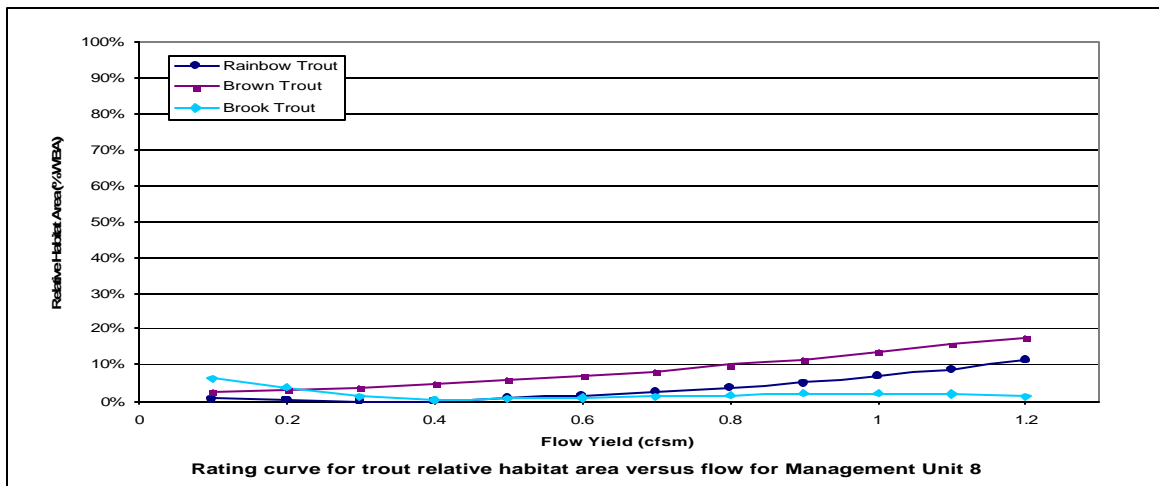
Figure 28 MesoHABSIM habitat rating curves for Management Unit 8

Management unit #8 runs between two roads and is shallow and faster than the unit upstream. It consists mostly of fast-flowing shallow habitats (riffles and runs) with many shallow margins. The dominant substrate in this unit is smaller in size than that in management unit #7. It changes into mostly fast *runs* and *ruffles* when flow increases. At mapped flows, the *wetted area* increases from 30% to 70% of the bankfull wetted area, with an inflection point between 0.4 cfs/m and 0.8 cfs/m. At this point, the overall habitat begins to decline. Almost the entire wetted area is suitable for the target fauna at low flow. Slimy sculpin, blacknose dace, and longnose dace have the best habitat conditions under these circumstances. Interestingly, the levels of suitable habitat for blacknose and longnose dace cross at higher flows. White sucker habitat peaks between 0.4 cfs/m and 0.8 cfs/m and then proceeds to decline towards zero. Again, brook trout has very low habitat levels in this unit, even low quality habitat is scarce. Brown and rainbow trout have very low levels of excellent habitat and moderate levels of usable habitat. (See general recommendations for aquatic habitat improvement in Section 6.6)
