Management Unit 9
Greene County - Town of Hunter
Cross Section 131 to Cross Section 135

Management Unit Description

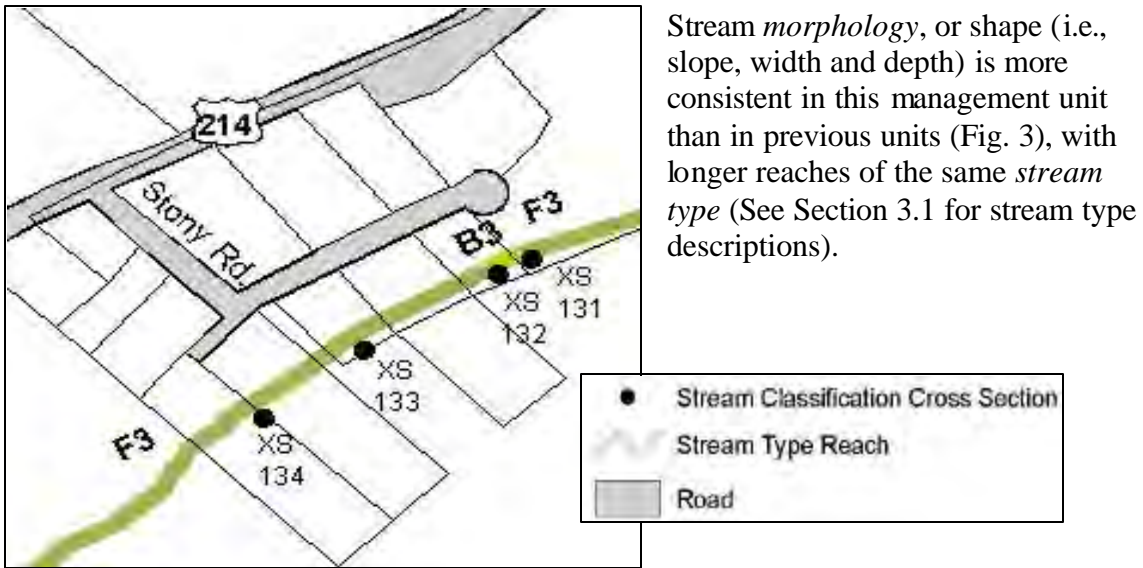
Figure 3 Cross-section and Rosgen stream types in Management Unit 9

The predominant stream type in this unit is “F” channel, which are usually deeply *incised* with flat channel slopes, and subject to sediment supply fluctuations. This unit however appears to be relatively stable with minimal sediment yield from the bed and banks.

Management unit #9 begins downstream from cross-section 131, with a short 19 ft. reach of F3 stream type. This stream reach is *entrenched*, or it is confined within the stream banks during high flow events. Channel slope is fairly flat at 1.9% and the dominant bed material is cobble.

As channel entrenchment moderates, stream type changes to B3 for another short reach totaling 73 ft. in length. The slope of this reach increases significantly to 2.8%.

Continuing downstream, the channel once again becomes entrenched as it transitions back into a F3 stream type for the remaining 975 ft. of this management unit. The channel is overwide, shallow, and flat with a slope of 1.3%.

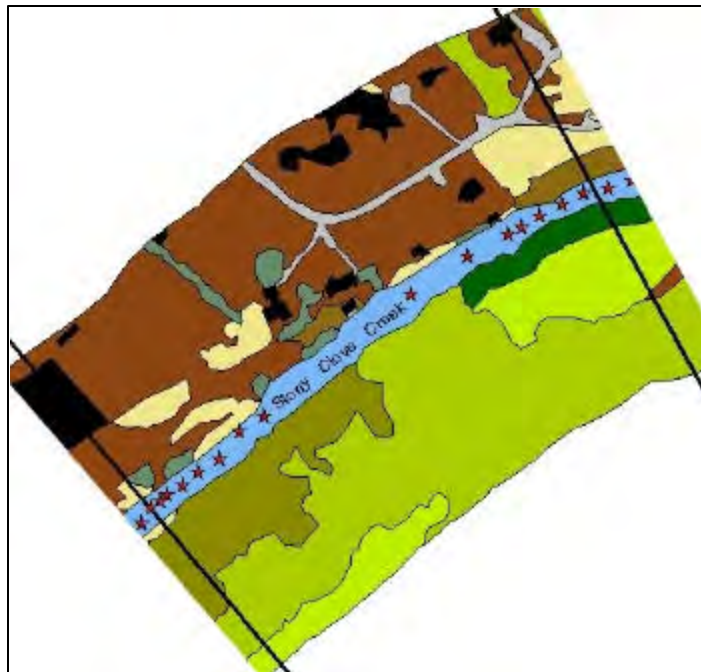
Figure 7 Riparian vegetation map for Management Unit 9

The predominant vegetation type within the 300 ft. riparian buffer is forested (53%) followed by herbaceous (34%). Areas of herbaceous (non-woody) cover present opportunities to improve the riparian buffer with plantings of more flood-resistant species. *Impervious* area (4%) within this unit's buffer is primarily the NYS Route 214 roadway and private residences.

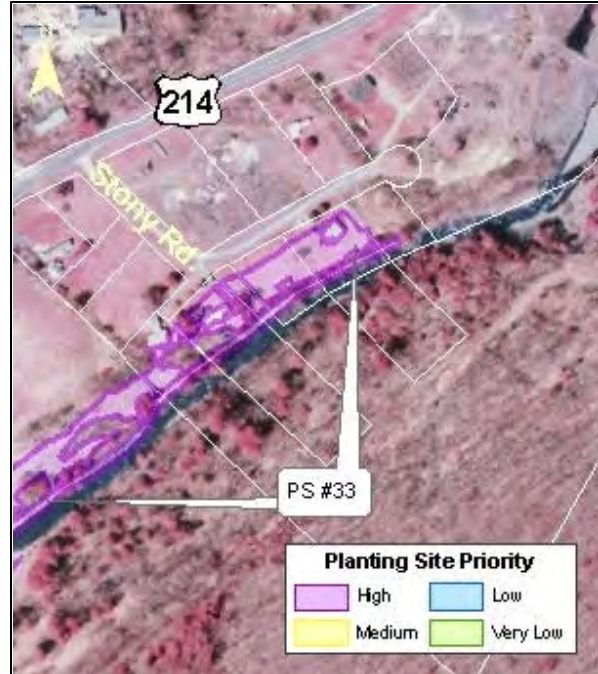
Figure 8 Planting site location map for Management Unit 9

In June 2003, suitable riparian improvement planting sites were identified through a watershed-wide field evaluation of current riparian buffer conditions and existing stream channel morphology (Fig. 8). These locations indicate where plantings of trees and shrubs on and near stream banks can help reduce the threat of serious bank erosion, and can help improve aquatic habitat as well. In some cases, eligible locations include stream banks where rock rip-rap has already been placed, but where additional plantings could significantly improve stream channel stability in the long-term, as well as biological integrity of the stream and floodplain. Areas with serious erosion problems where the stream channel requires extensive reconstruction to restore long-term stability have been eliminated from this effort. One appropriate planting site was documented within this management unit.

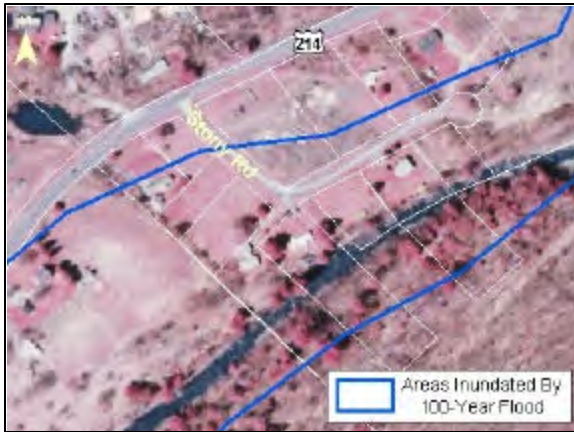
Figure 10 100-year floodplain boundary in Management Unit 9

floodplain boundary in this management unit (Fig. 10). The current NFIP maps are available for review at the Greene and Ulster County Soil & Water Conservation District offices.

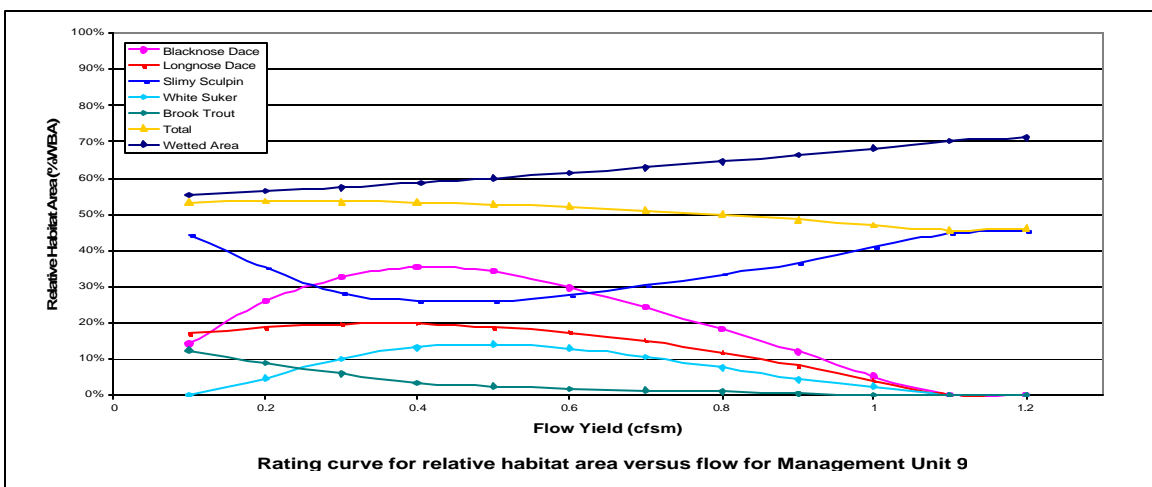
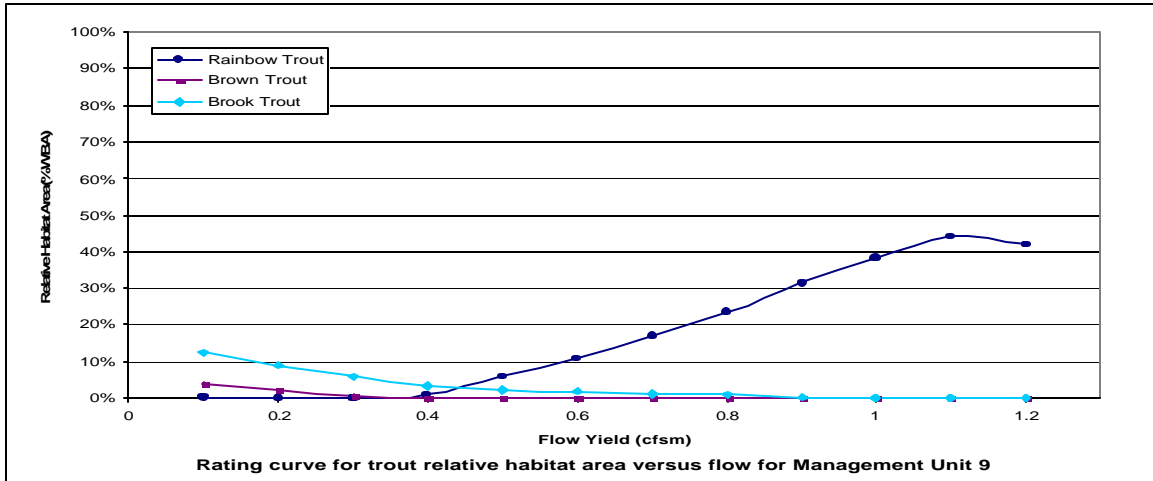
Figure 11 MesoHABSIM habitat rating curves for Management Unit 9

Management unit #9 contains boulders, a small amount of overhanging vegetation, and substrate that is small in size. At investigated flows, the water covers from 55% to 80% of the bankfull *wetted area*. Wetted area increases steadily as flow increases, but hydro-morphological units change dramatically. This is reflected in the strong habitat suitability changes for individual species across the flows, even though the overall amount of habitat stays constant. Slimy sculpin loses habitat and then gains it back at higher flows. Both dace species and white sucker species show habitat increases until 0.3 cfs, and then a complete loss above 1.0 cfs. Brook trout has very little habitat except at very low flows, however, this habitat is probably useless due to thermal impacts. The brown trout has low levels of poor habitat and only rainbow trout shows a significant increase in habitat suitability at higher flow levels. Overall, this unit has poor habitat conditions due to constant hydro-morphological fluctuations and a lack of permanently available habitat.

Implementation of planting recommendations in this unit would provide significant benefit to habitat quality. These plantings would encourage deeper holding pools to develop while mitigating thermal impacts. (See Section 6.6 general recommendations for aquatic habitat improvement)
